Repair and rehabilitation: three case studies in Bucharest

Repair and Rehabilitation - Three Case Studies in Bucharest

Strengthening solutions of three buildings in Bucharest are presented. Two buildings are part of the Technical University of Civil Engineering and the third is a warehouse for high value equipment. They have been affected by three major earthquakes: in 1977, 1986 and 1990. The strengthening solutions were adopted after an accurate analysis on seismic structural performances. The three buildings have different static and spatial shape. The structural models are spatial, with uni- and bidimensional finite elements. The structural analysis was performed in elastic range with a common programme.

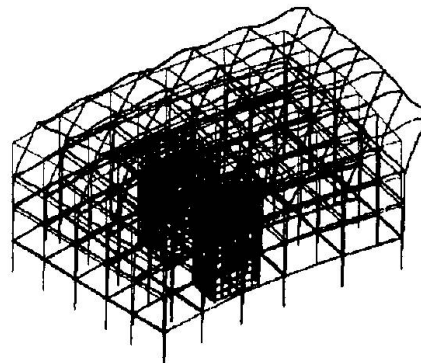
The magnitude of the interstory drifts are of ca. 3.5 times larger than those required by the Code. The most stressed columns are: for Section A those in the corners of the buildings; for section B those of the outside bay. The structure has no redundant reserves and requires strengthening

Proposed solution for the rehabilitation is the same for both sections aiming to reduce the interstory deflection to that accepted by the Code. The solution consist of newly-added structural reinforced concrete walls interacting with existing frames. The displacements and the moments were greatly reduced in the existing structure. The maximum interstory drift is 0.0073 and is almost as with that required by the Code (0.0070). The sum of maximum displacements of the two sections is less than the size of the expansion/contraction joint. Fig. 2 presents the deformed shape of the strengthened Section B.
