Corrosion of lead sheathed cables in plastics multiway ducts. Part I

Autor(en): **Brunold, Armin**

Zeitschrift: **Technische Mitteilungen / Schweizerische Post-, Telefon- und Telegrafienbetriebe = Bulletin technique / Entreprise des postes, téléphones et télégraphes suisses = Bollettino tecnico / Azienda delle poste, dei telefoni e dei telegrafi svizzeri**

Band (Jahr): **57 (1979)**

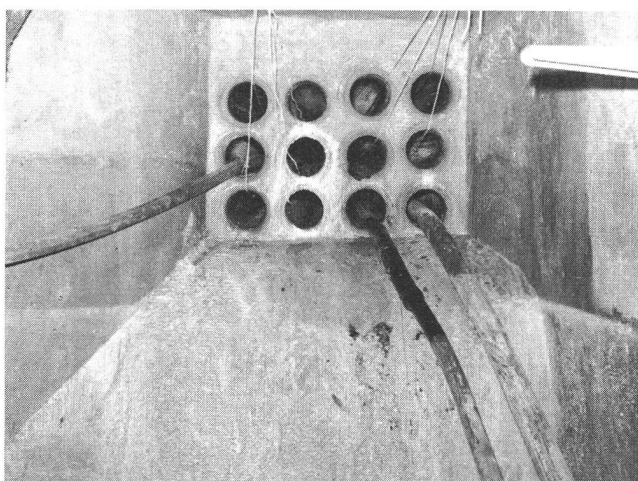
Fig. 1
Multiway duct at Auvernier, site of fault

Water is entering the jointing chamber chiefly through the lower joint between the multiway duct and the concrete inlet funnel. Thick layers of lime sediment have been deposited on the arch of the funnel. The area of greater thickness, painted black, shows where the corroded lead sheath had to be mended

1970 for the duct installation, nevertheless temporarily contained so much water that it could drain off through the lowest row of ducts of the twelve-duct block into the next jointing chamber in the direction of Colombier which is located at a lower level. At the time of inspection the jointing chamber had been largely emptied of water. The maximum water level could however be clearly determined from the marks remaining on the chamber walls. We were informed that the drainage system in this jointing chamber had failed because the outlet pipe had been blocked by extraordinary mud deposits. Although the jointing chamber had been cleaned, considerable amounts of fine lime sediment could again be seen on the floor. Thick crusts of precipitated material had been deposited particularly on the lower arch of the concrete inlet funnel through which the cables enter the jointing chamber from the direction of Neuchâtel as is shown in *Figure 1*. It was quite obvious that the water which flows over the funnel arch in large amounts enters the jointing chamber mainly through the lower connection joint between the inlet funnel and the multiway duct. However, some of the water enters the jointing chamber via the plastics tubes. As can be seen from *Figure 1*, only three of the 12 ducts are occupied by one cable each. Illumination of the individual ducts allowed inspection to a depth of approximately 3 m, revealing that only five of the 12 duct pipes were dry and free of sediment while six contained, as far as it was possible to see, a white, wet deposit with a small stream of water trickling along. In the case of one duct pipe, sediment had been deposited at the inlet only. Some of the ducts affected by sediment can be identified in *Figure 1* by the white traces of the deposit.

While the cable from Neuchâtel to Areuse is located in a clean and dry duct (centre row, left) and therefore does not show any signs of corrosion, the ducts containing junction cable 20084 and long distance cable 20010 (bottom row, ducts 3 and 4) carry some water. The lead sheaths of these cables are affected by corrosion not so much in the region of the ducts as immediately after the duct outlet and particularly in where the cable sheaths

rest on the arc of the concrete inlet funnel. The junction cable was corroded through at that point and had to be mended by means of a lead pipe insert. The lead sheath of the long distance cable is affected to a depth of approximately 1 mm at the area of contact with the inlet funnel but is not yet perforated. Slope pressure water has penetrated even into the three next following jointing chambers in the direction of Colombier where the terrain slopes gently. For example, *Figure 2* shows the entry of the ducts in one of these neighbouring jointing chambers. The white traces of lime deposit show that in this case water has seeped through all the connection joints between the multiway duct and the concrete inlet funnel and also between the plastics ducts and the surrounding concrete.

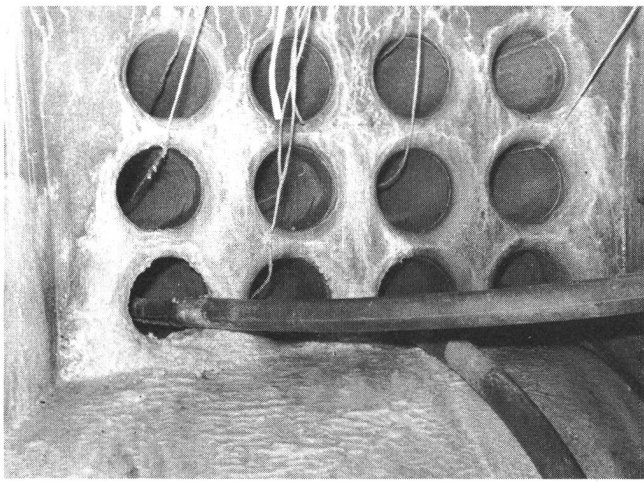
Fig. 2
Multiway duct at Auvernier
The white traces show that lime-precipitating water is penetrating through all the joints of a chamber adjacent to the site of the fault

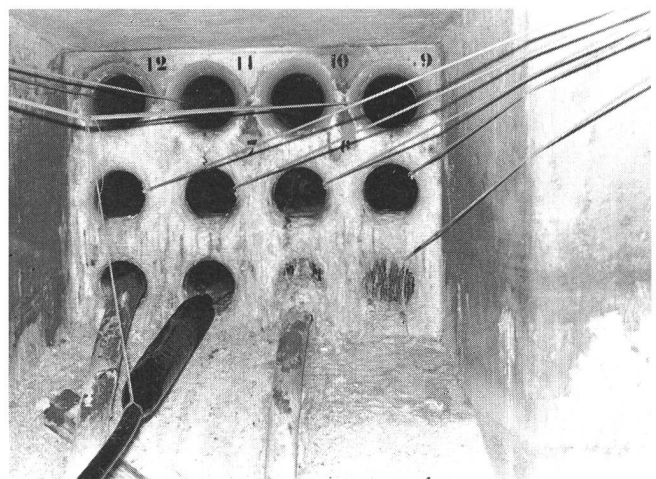
Fig. 3
Multiway duct at Arbon, site of fault
The front of the multiway duct is largely covered by a thick lime crust. In some places, stalactite-type structures have formed. Highly basic water is flowing into the jointing chamber between the layers of lime and in the stalactite tubules. All the cables are corroded at the point of contact with the arch of the concrete funnel. The area of increased thickness which is painted black shows where the corroded cable has been mended

sections coming from the exchange are shown in Figure 3. Duct section 2 is occupied by junction cable 60139 St. Gall—Romanshorn. Duct sections 3 and 4 contain subscriber cables. The corrosion breakthrough at the 100-pair subscriber cable has been repaired by means of a lead pipe as can be seen from the illustration. The junction cable and an 800-pair subscriber cable pass through the opposite jointing chamber wall (Fig. 4) using the same duct section numbers as before, while the 100-pair subscriber cable is divided into four smaller Type B cables which leave the multiway duct system by two unnumbered outlets.

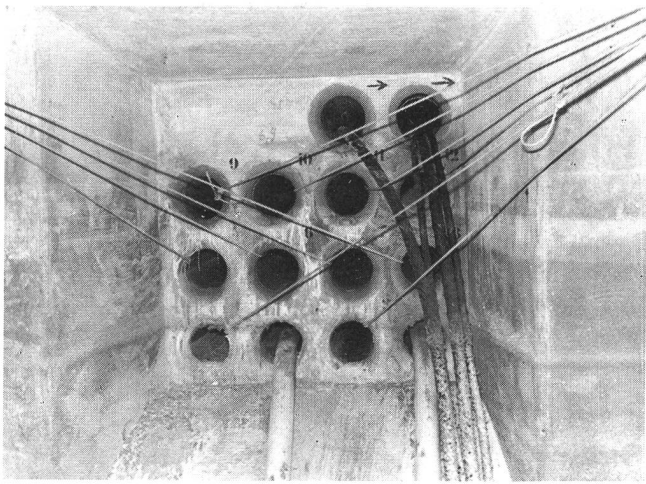
Fig. 4
Multiway duct at Arbon

At the multiway duct inlet opposite to the fault site, white traces of lime show that, at times, small quantities of water have seeped through between the plastics ducts and the concrete block. Lime sediment precipitated from the accumulated water in the jointing chamber due to atmospheric carbonic acid is deposited on the arch of the concrete funnel and on the cables

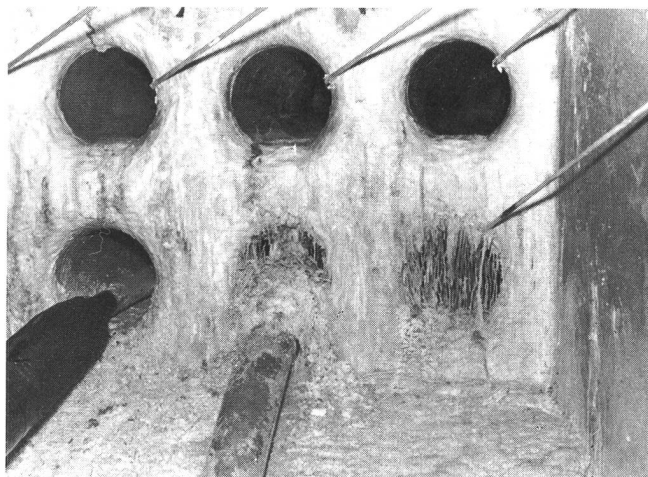
Fig. 5
Multiway duct at Arbon, fault site

Here, the thick lime crusts deposited round the plastics duct inlets can be recognized particularly clearly. Water-carrying stalactite-type lime tubules overhang two of the duct section inlets

If one breaks off the stalactites, clearly visible in Figure 5, one can observe that these are of the form of tubules and contain dripping water which, if tested by means of indicator paper, exhibits a considerably stronger alkaline reaction than the water flowing in the duct sections. Wiping off the stalactites revealed a «water spring». The hand in Figure 6 points at this site from which approximately 0.25 l of water were obtained within about five minutes. The fact that water emerges between the plastics inlet funnels and the concrete in which they are packed is obvious from the opposite wall (Fig. 4) because it is only slightly encrusted so that one can see exactly how the white traces of eliminated lime emanate from the boundary line between the external surface of the plastics duct and the concrete.

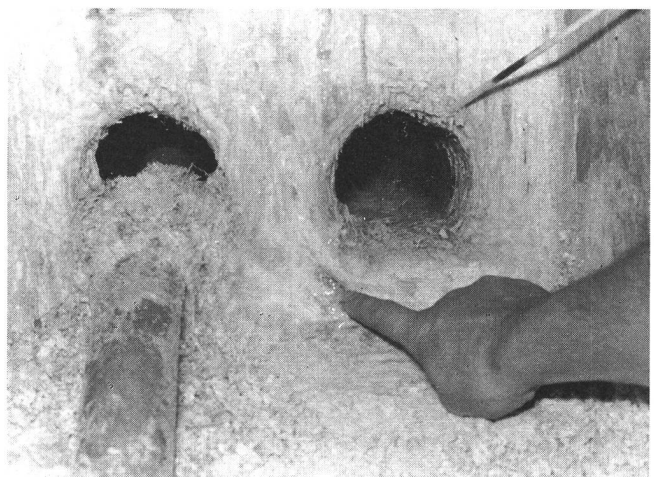
Fig. 6
Multiway duct at Arbon, fault site

The hand in this illustration points at a «water spring» which appeared when the stalactites had been wiped away. The highly basic water (pH 12.6) is emerging between the plastics inlet funnel and the concrete packing

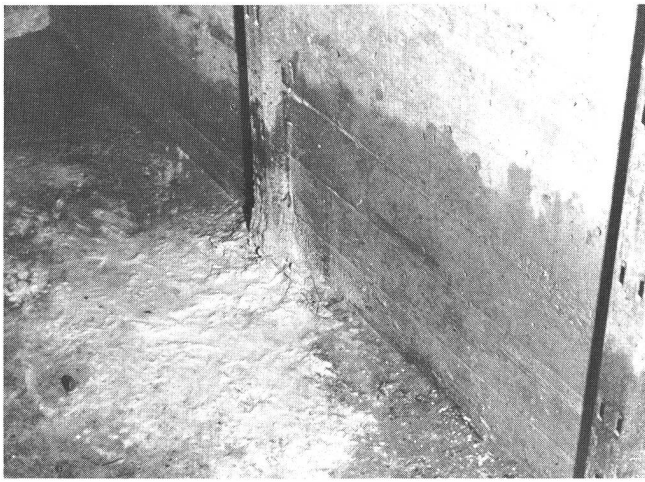
Fig. 7
Multiway duct at Egnach
 In this chamber, water has penetrated at the point where the steel profile has been set into the floor of the chamber, as can be seen from the lime crust formation

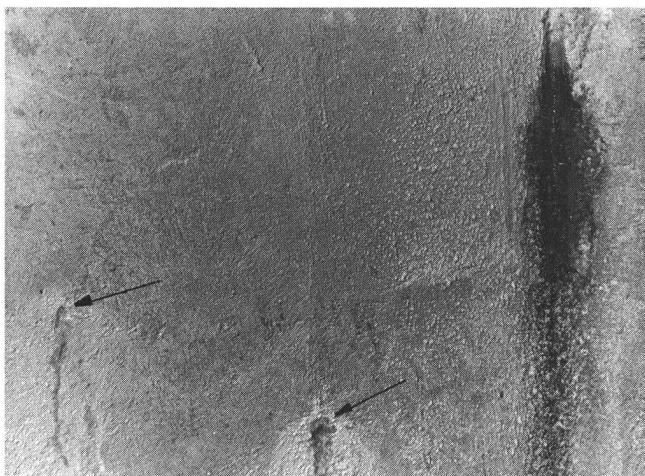
Fig. 8
Multiway duct at Egnach
 In another chamber, strongly basic water penetrates the concrete at two points on a longitudinal wall — marked by two arrows in the Figure

chamber had been pumped dry the floor was covered once more with water to a depth of 7 cm. This corresponds to a water inflow of about 20 litres per hour. *Figure 8* provides proof that water can break through massive concrete walls. Here, water is penetrating at a rate of about 2 l per hour at two points in the chamber wall. In addition, water is flowing at the rate of 5 l/h by capillary action between the plastics duct no 5 and the concrete in the same chamber, as is indicated in *Figure 9* (arrow). In spite of this, the cable fault in a subscriber cable did not occur in the area of the chamber inlet but instead 30 m inside the duct, where an obstacle had to be avoided by means of a soft polyethylene insert. In this installation, the bare lead sheaths had been protected two years previously against direct contact with water emerging at the vulnerable outlet points by means of polyethylene hose sections slit open and wrapped around the cable sheaths.

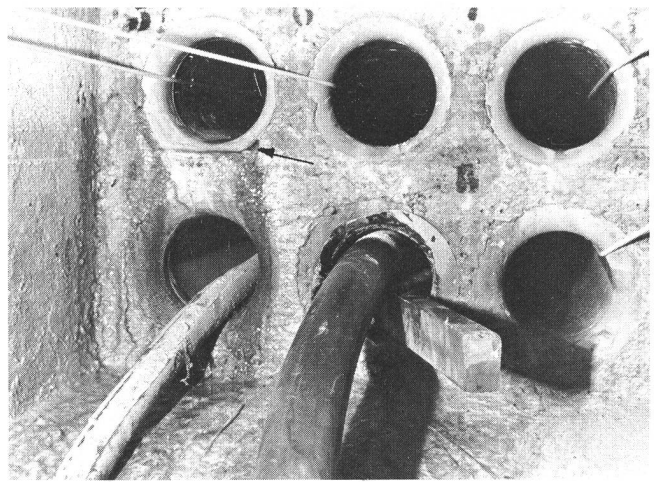
Fig. 9
Multiway duct at Egnach
 In the same chamber as that shown in Figure 8 about 5 l of water per hour flow into the chamber at duct no 5 between the plastics tube and concrete packing (arrow)

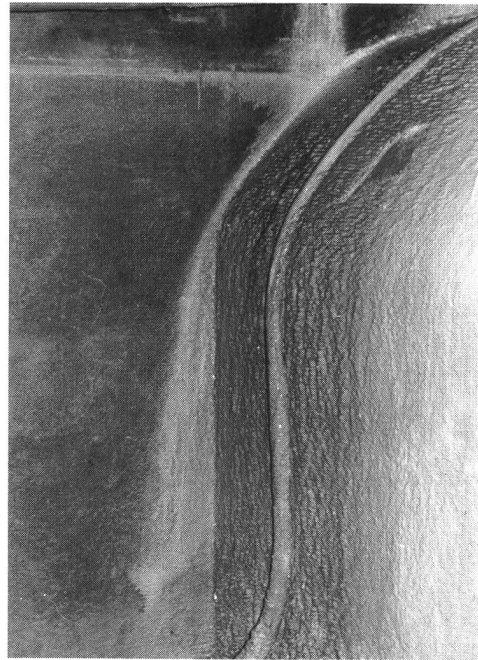
Fig. 10

ter entered mainly through the ventilation pipe. Level marks and lime sediments on the walls and in the upper ducts show that an even higher water level prevailed for a sometime. A particularly gross example of lime deposits produced by water seepage was encountered in chamber 28 where the water had spread and rippled down over the whole width of the concrete inlet funnel and formed centimetre thick lime crusts so that the cable resting on the funnel was virtually petrified as can be seen in *Figure 10*.

In this chamber strongly basic water flows into the chamber distributed over the full width of the concrete inlet funnel so that the precipitating lime crust has virtually petrified the cable resting on the funnel
