**Zeitschrift:** Schweizerische Bauzeitung  
**Herausgeber:** Verlags-AG der akademischen technischen Vereine  
**Band:** 83 (1965)  
**Heft:** 42: Prof. G. Schnitter zum 65. Geburtstag, 1. Heft

**Artikel:** Design and construction of Mänika Dam  
**Autor:** Bjerrum, Laurits / Kjaernsli, Björn  
**DOI:** <https://doi.org/10.5169/seals-68283>

## Introduction

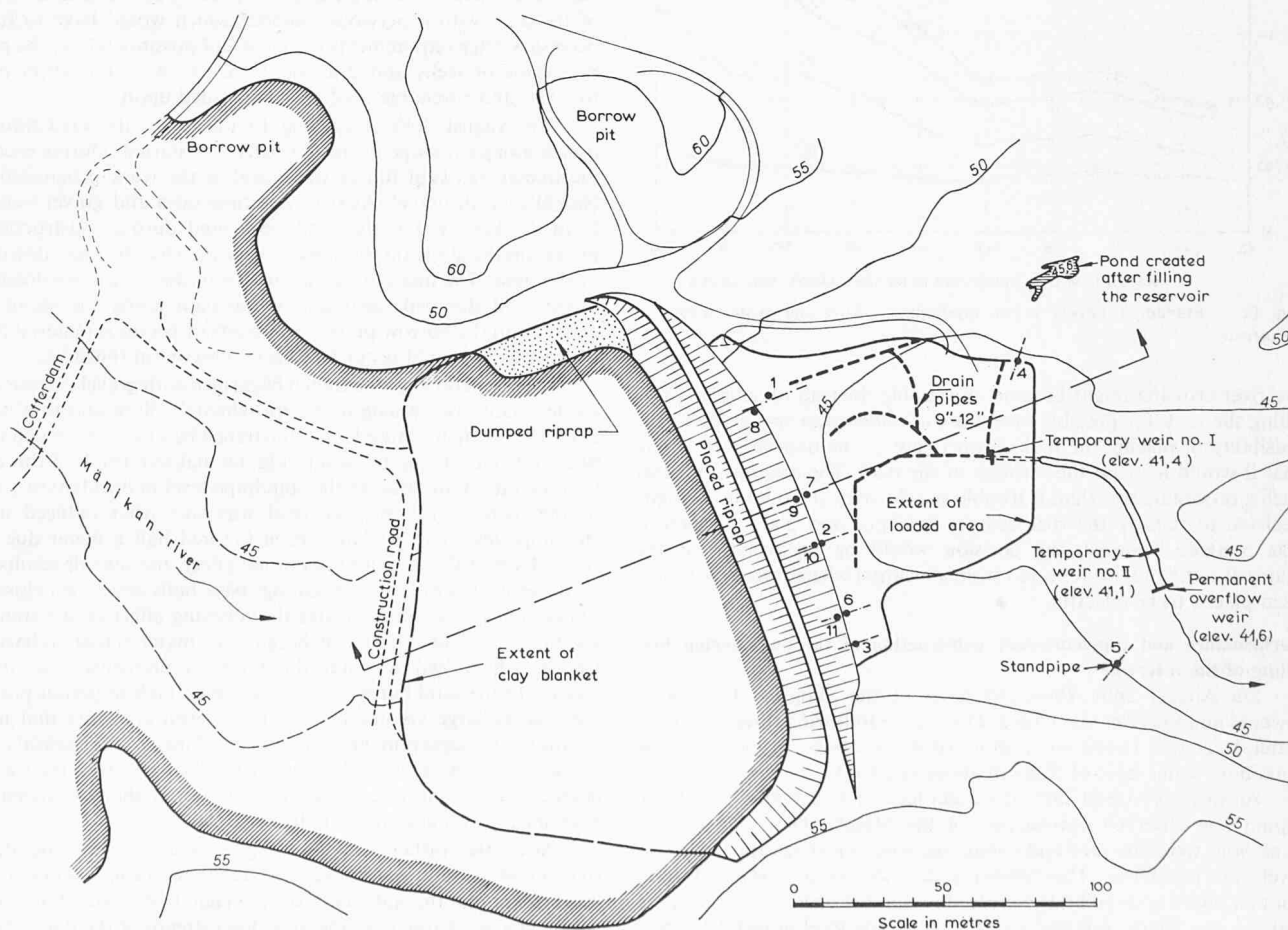
Fig. 5. Mänika Dam in Plan, scale 1:2500

Two overflow weirs were constructed downstream of the dam for seepage measurements and five standpipes, numbers 1 to 5 in Fig. 5, were installed for measuring the ground water level downstream of the dam.
