**Artikel:** Strengthening the foundations of a building in Helsinki (Finland)  
**Autor:** Varstela, I. / Roitto, P. / Haapala, M.  
**DOI:** <https://doi.org/10.5169/seals-20917>

## 8. Strengthening the Foundations of a Building in Helsinki (Finland)

**Owner:** *Säästöpankkien Keskus-Osake-Pankki SKOP*  
**Architectural planning:** *Järvinen Simo & Co.*  
**Structural planning:** *Heiskanen RJ & Co. Ky*  
**Building contractor:** *YIT-Yhtymä Oy*  
**Execution time:** *13 months*  
**Execution year:** *1986*

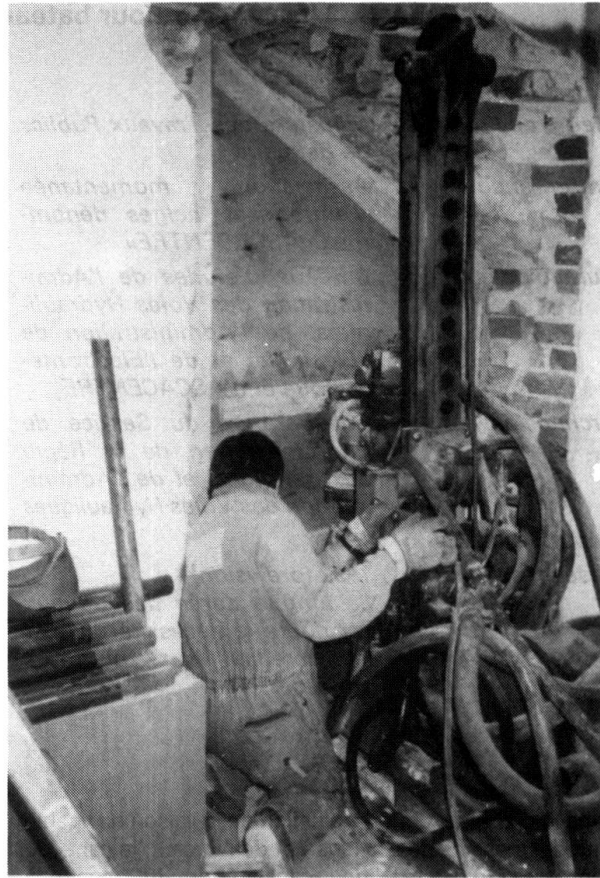
*Fig. 2 Through excavations in the supportive brick walls holes were sunk vertically through the basement walls.*
