Zeitschrift:	IABSE structures = Constructions AIPC = IVBH Bauwerke
Band:	12 (1988)
Heft:	C-47: Repair and rehabilitation of bridges: case studies II
Artikel:	Strengthening of bridge slab at Kami-Imasu Bridge (Japan)
Autor:	Inokuma, Yasuo
DOI:	https://doi.org/10.5169/seals-20938

8. Strengthening of Bridge Slab at Kami-Imasu Bridge (Japan)

Owner:	Japan poratio	Highway on	Public	Cor-
Engineer:	Japan poratio	Highway on	Public	Cor-
Daete of Construction:	1964			
Date of Repair:	1976

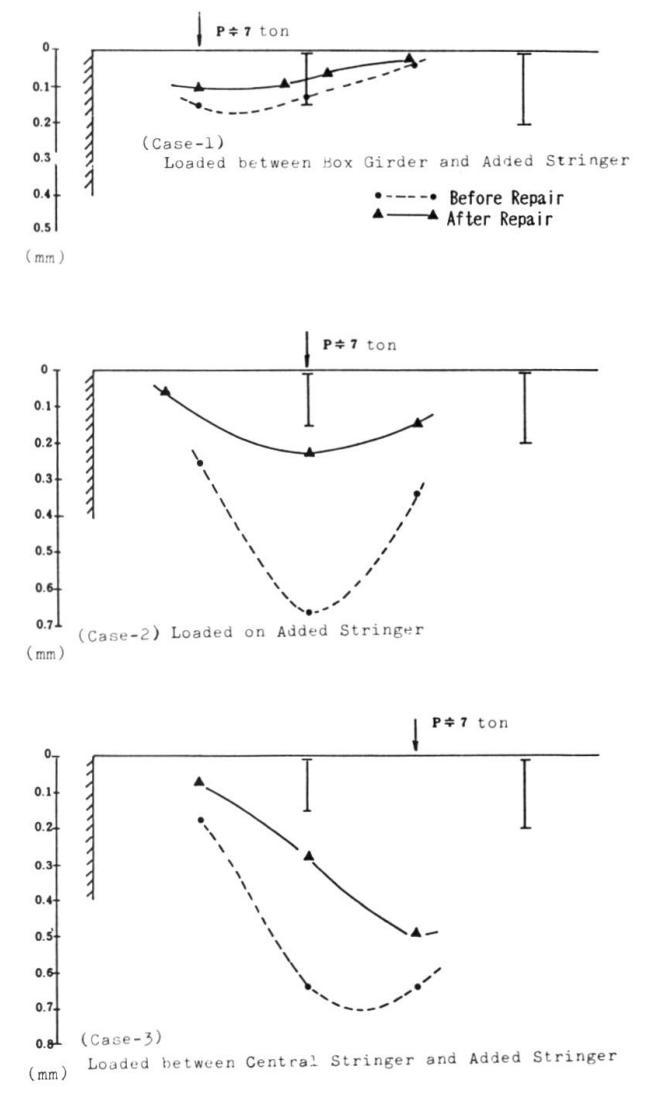
A loading test was conducted, using a truck with a 7-ton rear wheel load in order to measure the difference of deflections before and after the strengthening. The result is shown in Fig. 2.

In cases where the wheel was located between the main box girder and the added stringer (Case-1), on the added stringer (Case-2) and between the original stringer and the added stringer (Case-3), the deflections at the loading points after repair were decreased to 60%, 66% and 78%, respectively. The repair work is, thus, estimated as successful.

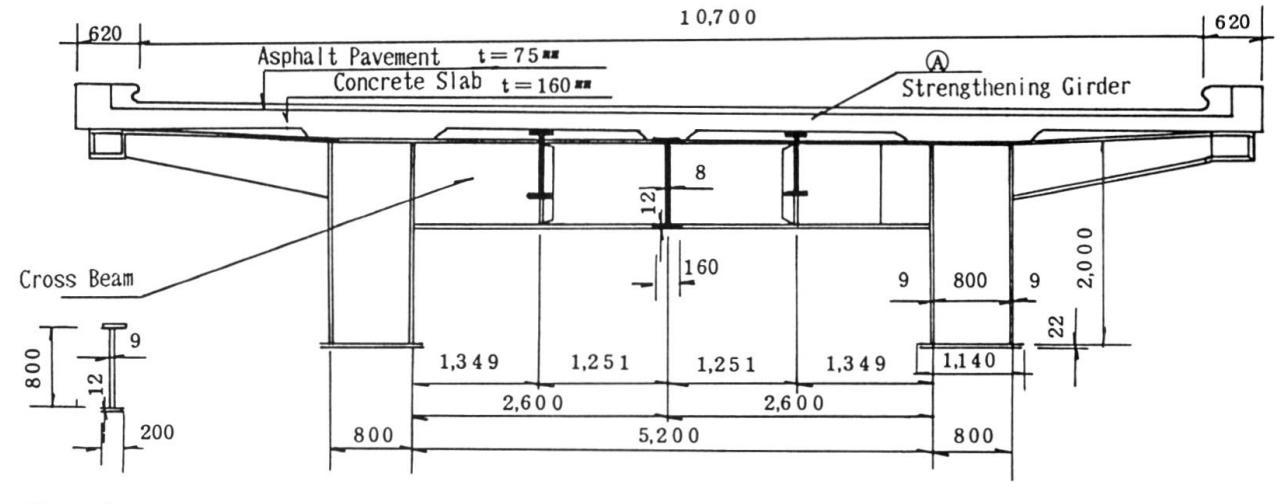
Fig. 1 Structure

After ten years of service, cracks in the slab increased to such an extent that it had to be repaired and strengthened. Finally it was decided to install stringers in between the original main box girders and the original central stringers as shown in Fig. 1. The reasons for the adoption of this method are as follows:

- The traffic volume was so large that it was difficult to conduct the repair work on the upper side of te slab.
- It was expected to be sufficiently effective on decrease of the bending moment of the slab.

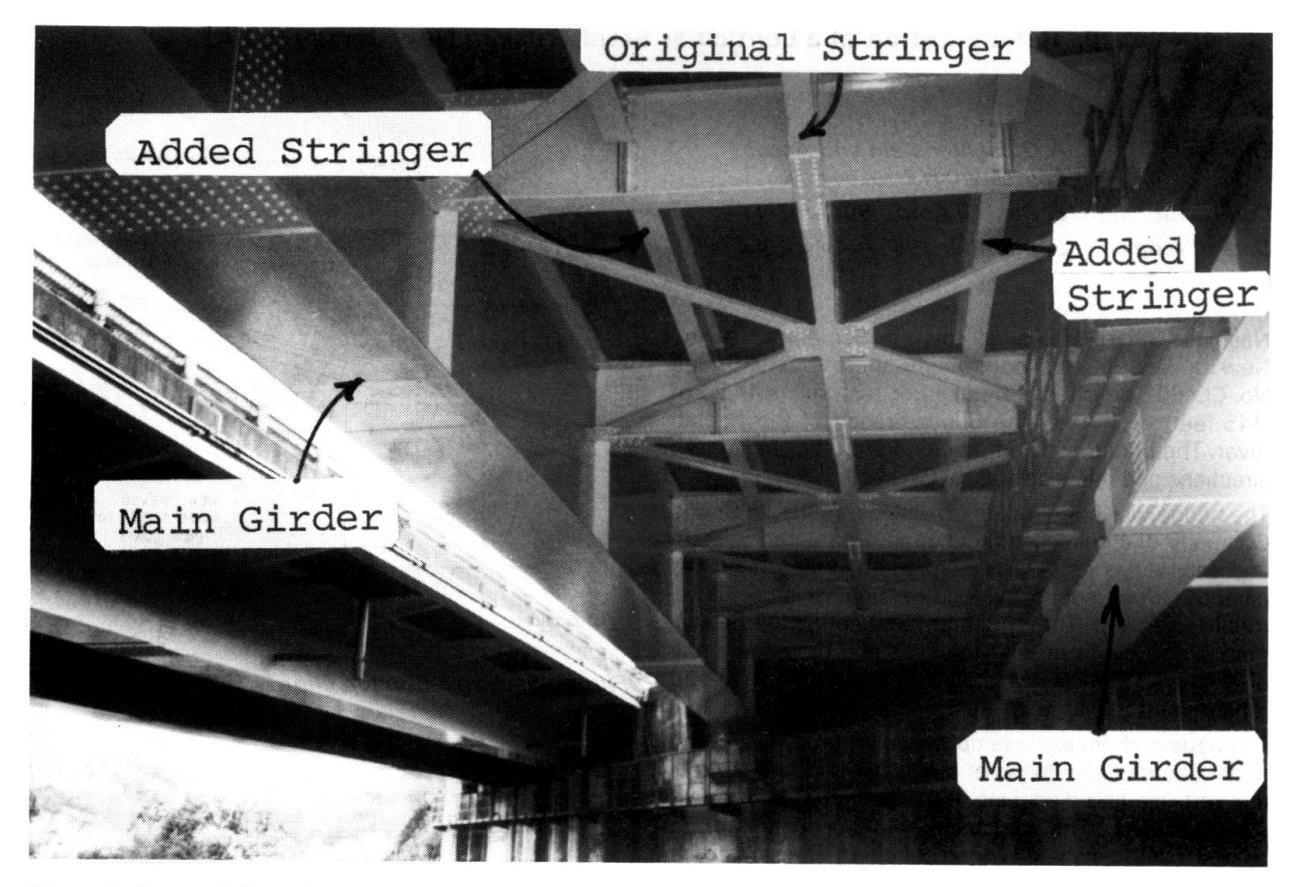
Photo 1 General View of Strengthening

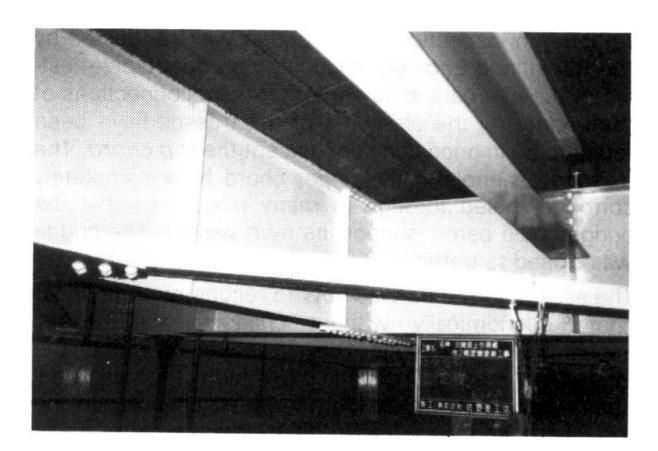
Photo 2 Detail of Added Stringer
