The Collapse and Reconstruction of a Prestressed Concrete Box-Section Girder

Hugo Bachmann

Werner Horisberger,

SUMMARY

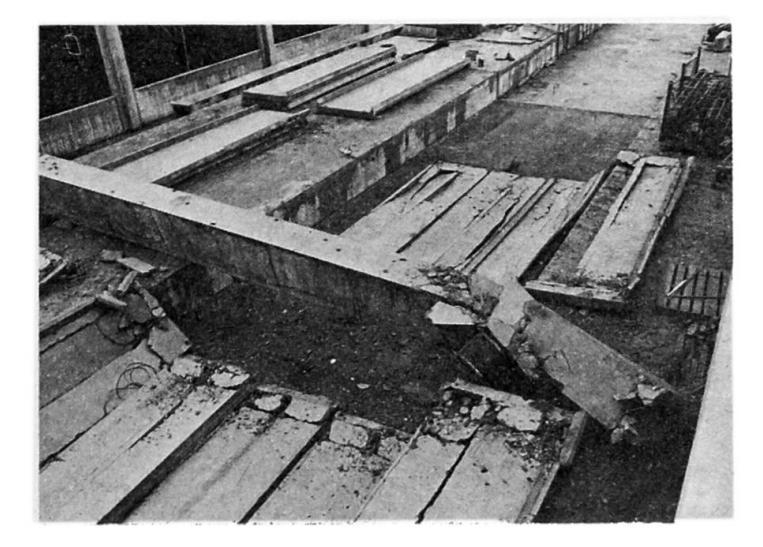
Fig. 2

View from E/9 towards the collapsed box-section girder. In front and behind are the collapsed roof slab units.

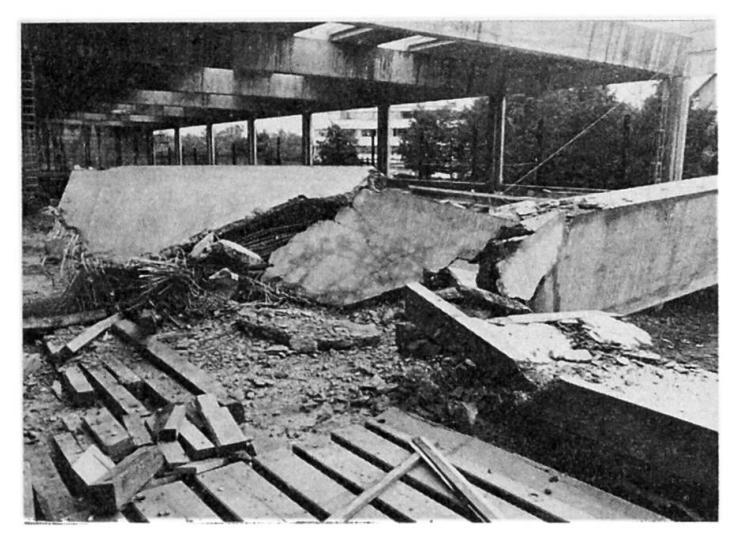
Fig. 3

View from E/11 towards the collapsed girder. The prestress wires of the bottom flange were fully exposed in the collapse.

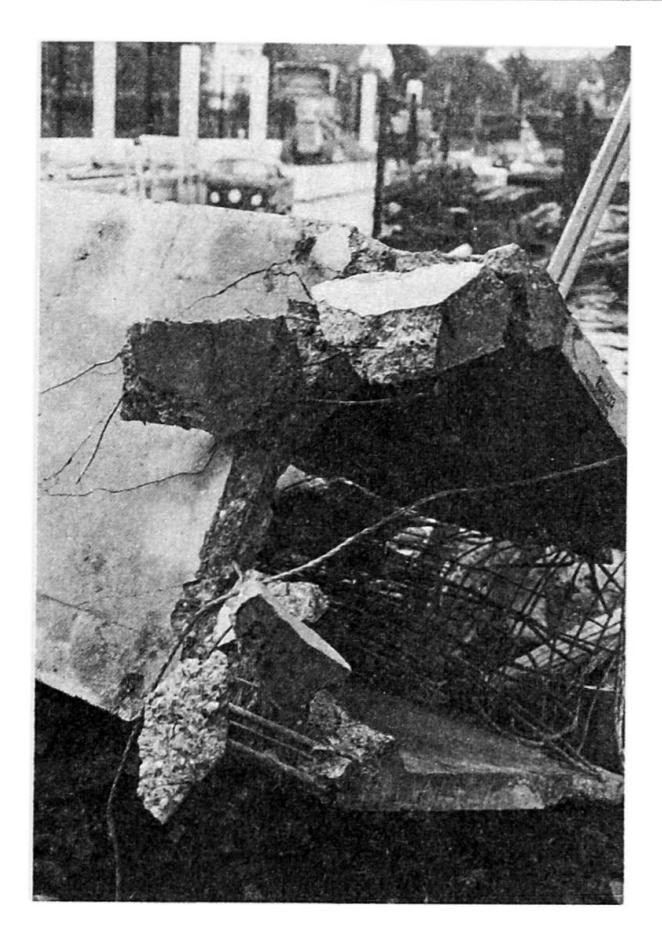
View of girder end E/10. The girder has broken through the bottom and top flanges at the support.

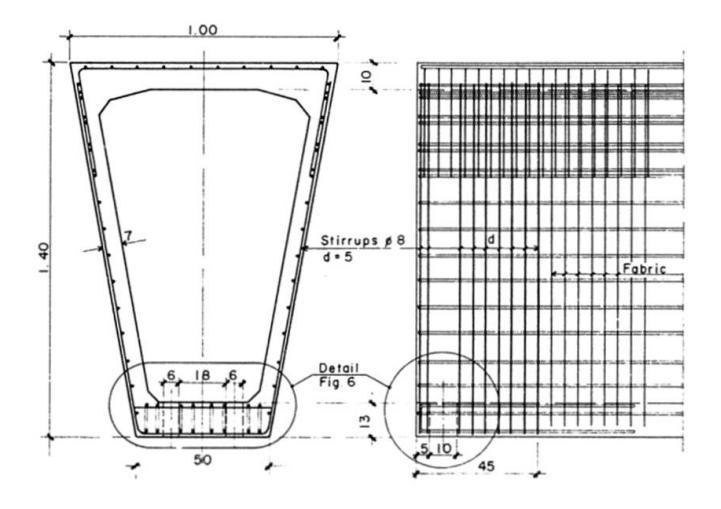
Fig. 5

Dimensions and reinforcement of the girder support region.

end. However this value could be reduced to nearly 7 cm when measurement variations were taken into account. This was the case with the collapsed girder. The workers on site informed that the bolts had scarcely fitted through the holes in the girder. In the transverse direction the support points did not sit beneath the webs, but were about 10 cm within the cross-section.

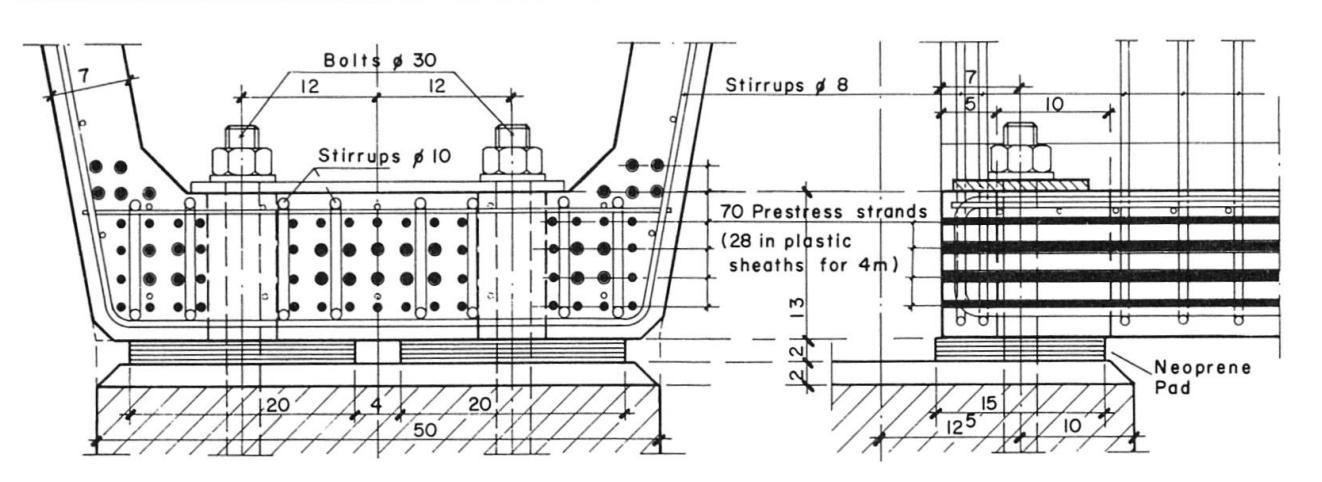
Fig. 6 Layout of the support region. Support in extreme situation.

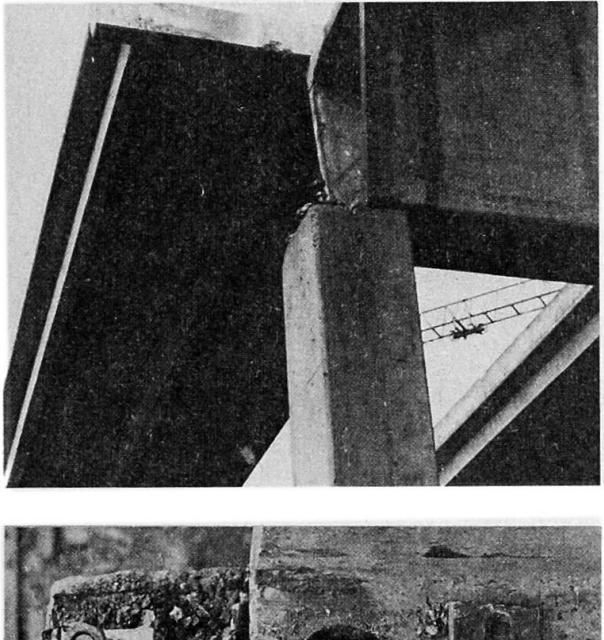
Fig. 7

View from beneath towards the column head E/10. Right is the girder 10/C-E. Left was the collapsed girder 10/E-G.

View from above of the column head E/10. Righthand end of the beam 10/C-E with holes in the bottom flange and removed nuts and steel plate. Remainder of lefthand end of the collapsed girder 10/E-G with the still present nuts and top steel plate. Beneath the rubble are both the neoprene pads.

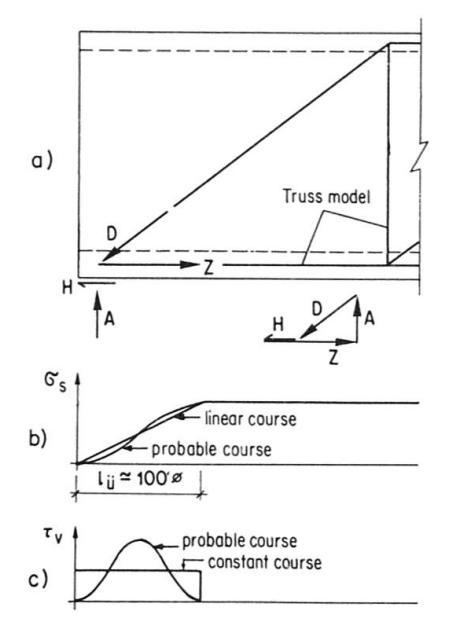
Fig. 11 End anchorage: internal forces following from the introduction of the support reaction (truss model); steel stresses and bond stresses from the prestress force. The bond stresses of this size should only be added into the calculation for the pretensioned wires at the end of the girder if the following are met:

These stipulations were in the discussed case either not at all or insufficiently fulfilled. The wires were cut through one after another with a power cutter. This led to a considerable disturbance of bond. Between various prestressed wires and parallel running end stirrups present the spacing was only a few millimeters. This did not everywhere keep to the well-known rule which states that the spacing of the placed steel should not be less than the the maximum aggregate diameter (here 15 mm).

From these points it can be assumed that the steel stress at the girder end was under proportional and only further into the girder interior increased to over proportional (Fig. 11b). Correspondingly the bond stress at the girder end was relatively small (Fig. 11c). With plausible assumptions the anchorage force comes within the region of 270 to 380 kN. Here the vertical end stirrups \emptyset 8 mm lying parallel to the prestress wires were not investigated. The bond of this steel with the concrete must, in consequence of the small spacing, have been relatively bad.

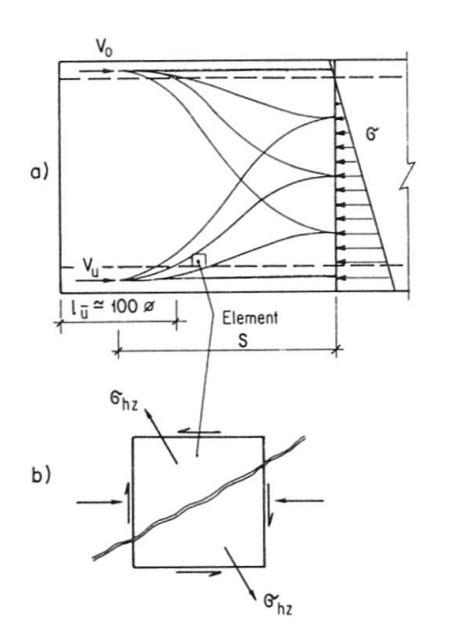
Fig. 12

At the transition of the lower flange to the webs there is a calculated shear stress τ of 4.0 - 6.0 N/mm². This is based upon reasonable assumptions for an uncracked concrete cross-section. The corresponding considerably smaller main tensile stress $\sigma_{\rm hz}$ has the tendency to produce the cracks shown in Fig. 12b.

Stresses and tendency to crack formation in consequence of introduction of prestress force.

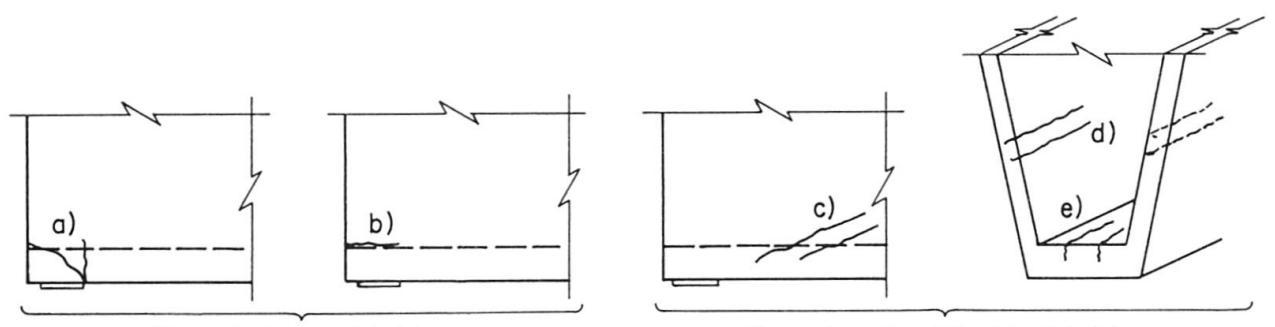
Fig. 13 Crack Types observed on the Girders.

These dangerous shearing-off cracks arise from insufficient end anchorage (cf. 3.4).

These cracks stem from the effects of transverse bending with concentric and eccentric loads (cf. 3.2 and 3.3).

These inclined cracks arise from the spreading of the prestress force from the bottom flange to the web.

<u>Crack Type d)</u>: These longitudinal cracks arise probably through shrinkage. There was an adequately strong reinforcement only on the outside of the webs. In addition to this the girders during fabrication were warmed with steam from the inside in order to accelerate hardening.

These cracks can be explained in the same way as the Type d) cracks. They were however considerably wider and longer with the erected girders as with those not yet erected. This comes from the additional effect of the transverse bending (cf. 3.2 and 3.3).

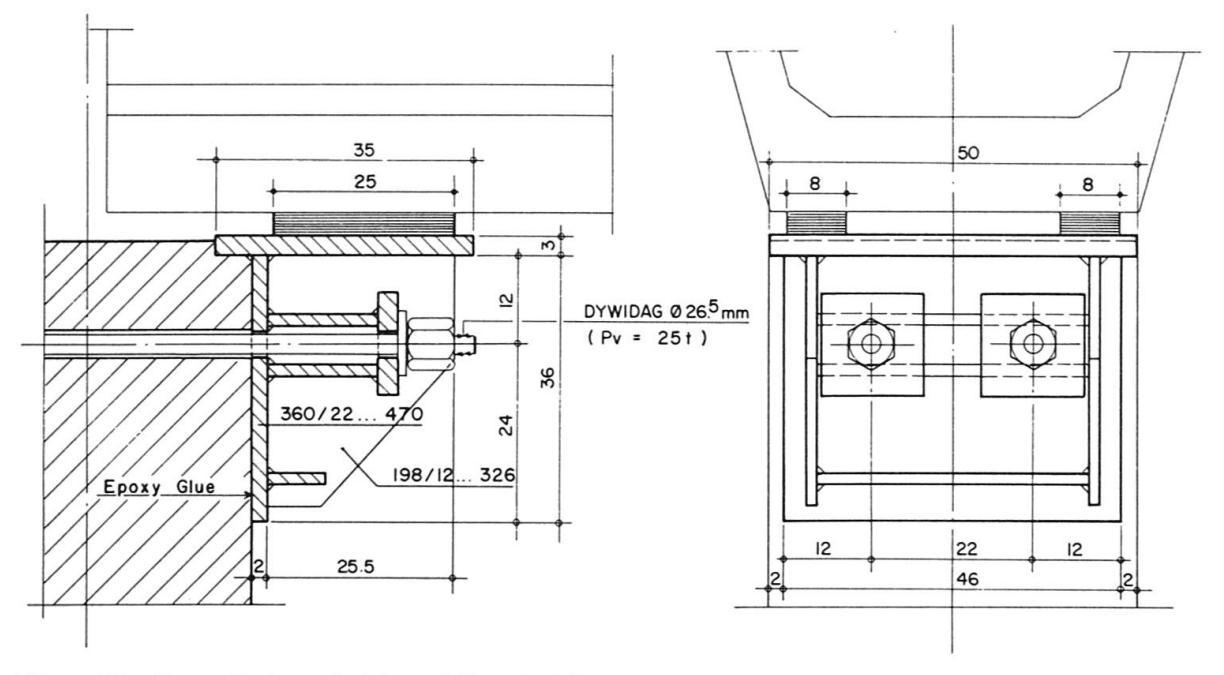
Fig. 15 Remedial solution "Steel Nib"

Two problems stand with this solution. Firstly, there is the introduction of eccentric nib loads to the edge columns. Then secondly there is the taking up of torsional effects on the girder stemming from one sided loading during erection. There are also the further disadvantages of high costs, difficult realisation with the already erected sections and dissatisfactory aesthetics. Therefore this variant was not taken any further.

A further possible remedial solution consists of sitting the girders upon steel nibs as shown in Fig. 15. If the deformation of the support surface is away from the end then sufficient end anchorage is guaranteed. The choice of special small neoprene pads allows the transference of the support forces directly beneath the webs. This largely eliminates the transverse bending. The steel nibs are connected to the in-situ concrete columns with post-tensioned rods.

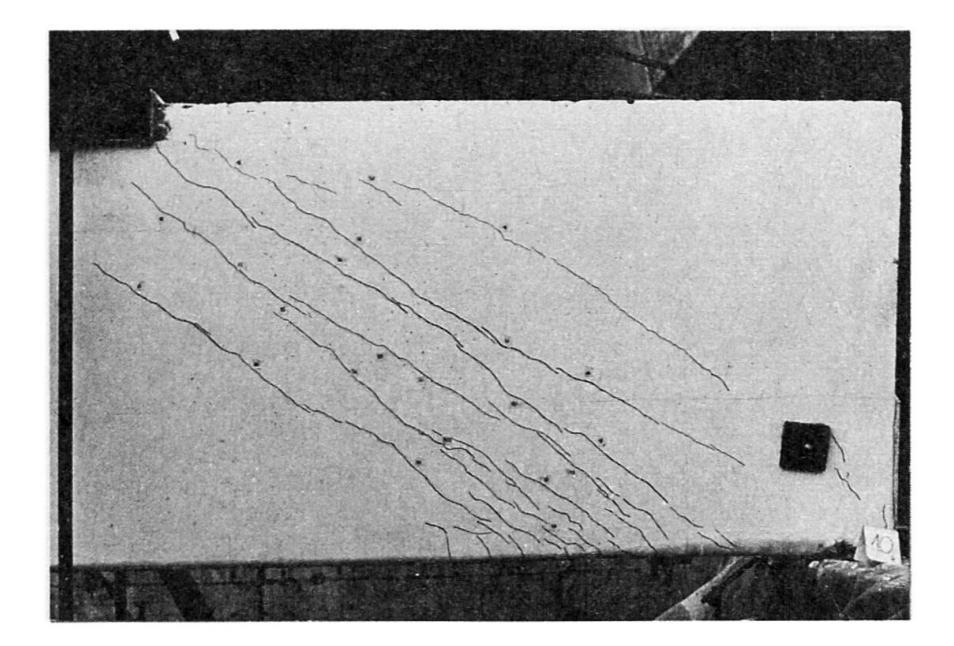
Fig. 21 Crack pattern at girder end A

In the inside of the beam cracks also occurred at the vertical contact surface between the concrete infill and the webs. They could be observed on the upper edge of the new concrete section. The cracking began at the girder end with about 1.5Q(g+p). With about 1.9Q(g+p) the contact surface was cracked through right along the girder. A maximum crack width of 0.4 mm and significant deformations between the new concrete section and the web could be observed. Between the variants A and B there was no significant difference. There was no sign of a failure beginning in the support regions. The girder came through the test excellently and it was possible to use it again in the building.
