# Techniques for Testing, Analyzing and Rehabilitation of Terra-Cotta

**Sven E. THOMASEN** Consultant Wiss, Janney, Elstner Assoc. Emeryville, CA, USA

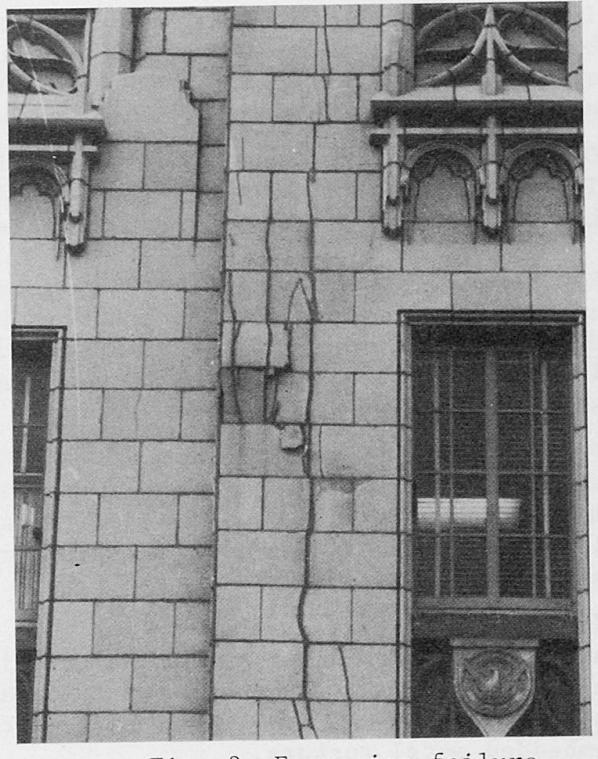
Spalling of the glaze and cracks caused by expansion allows water to enter the wall and results in further damage to the terracotta from freeze/thaw action. The moisture corrodes the anchors and the pressure from the volume expansion of the rust cracks the blocks, as seen in Figure 3.

Fig. 3: Terra-cotta spalling caused by corrosion of shelf angle.

Corroded or missing shelf angles and wall anchors are replaced. New anchors and angles should be given rust protection or be of stainless steel, especially in walls with past leakage problems. Consideration should also be given to installing flashing and weep holes in the wall cladding.

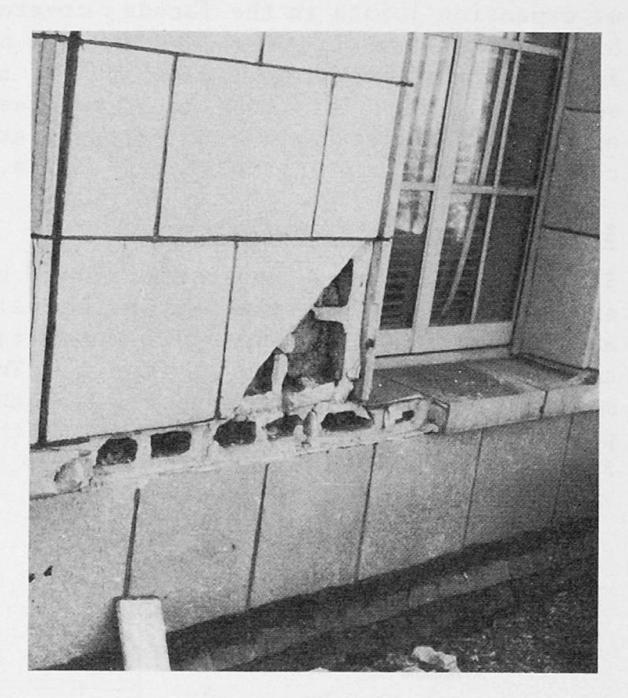
Fig. 4: Inspection opening

Inspection openings, as seen in Figure 4, are the best method to verify the location and the condition of the wall supports, and especially, to detect corrosion of the embedded metal anchors.

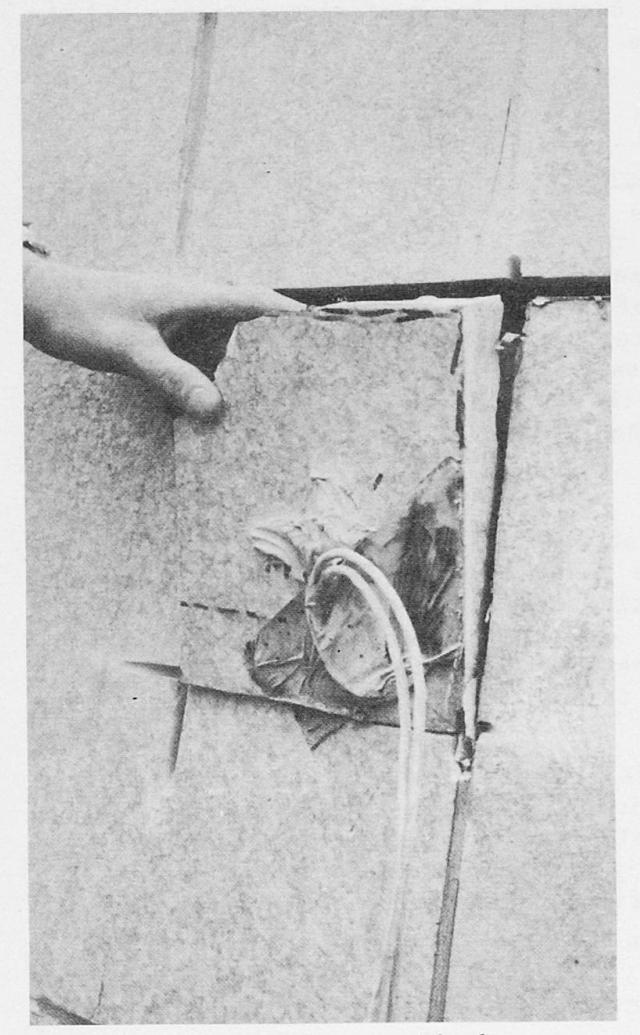
Electrical resistance strain gages are attached to the terra-cotta surface and the gages are read. Then the terra-cotta block, with the gages attached, is cut loose from the wall and the gages are read again, as seen in Figure 6. The change in gage reading is a measure of the strain in the block. The stress in the block is found by multiplying the measured strain difference by the modulus of elasticity, as determined by laboratory tests.

Fig. 6: Terra-cotta block, with strain gages attached, is cut loose.

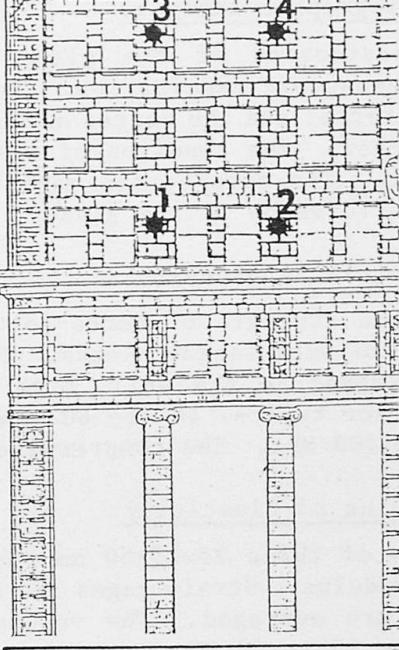
Fig.	5:	Strain	reliet	test
------	----	--------	--------	------

STRAIN RELIEF TEST DATA						
	VERTICAL		HORIZONTAL			
GAGE	$\frac{\text{STRAIN}}{\mu \text{ cm}/\text{ cm}}$	STRESS kPa	$\frac{\text{STRAIN}}{\mu \text{ cm/cm}}$	STRESS kPa		
1	450	9315	50	345		
2	283	5858	24	497		
3	320	6624	30	621		
4	171	3540	7	145

Compressive vertical stresses as high as 23 MPa have been recorded. This is close to the compressive strength of the terracotta wall. From multiple strain measurements, a stress map can be made for the exterior elevation. The map is used to evaluate if cutting of expansion joints into the facade will relieve the built-up terra-cotta stresses.

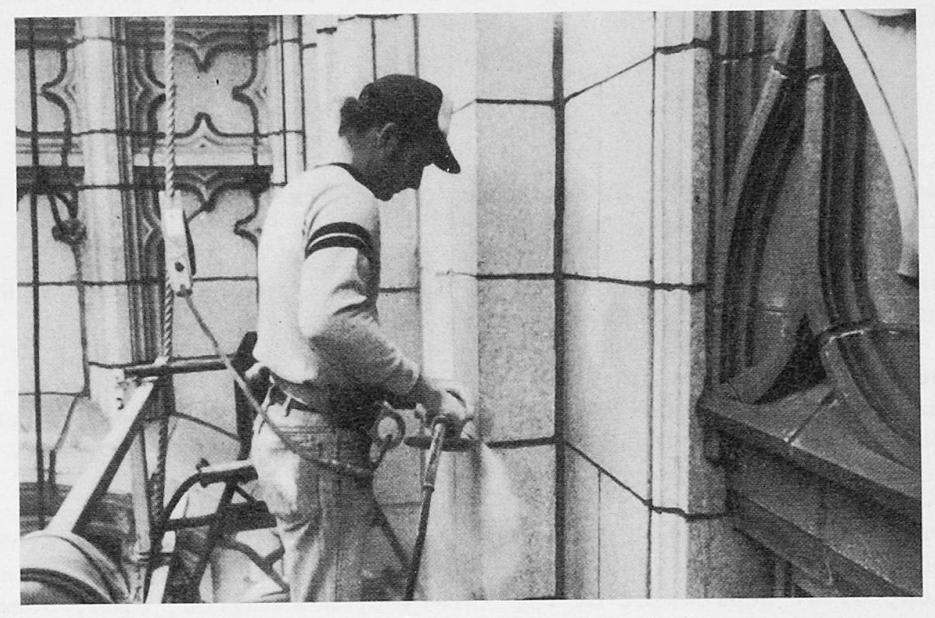
Fig. 7: Cutting of new expansion joints.

Vertical expansion joints are generally cut near corners and wall returns, while horizontal expansion joints are cut below reliveing angles, as seen in Figure 7. The joint location is determined from stress measurements of the terra-cotta. The joints are made watertight with elastomeric sealants. Cutting of expansion joints can disturb the fastening of the terra-cotta and will often require the installation of new anchors.
