Corrosion of Lead Sheathed Cables in Plastics Multiway Ducts (Part I)¹

Armin BRUNOLD, Berne

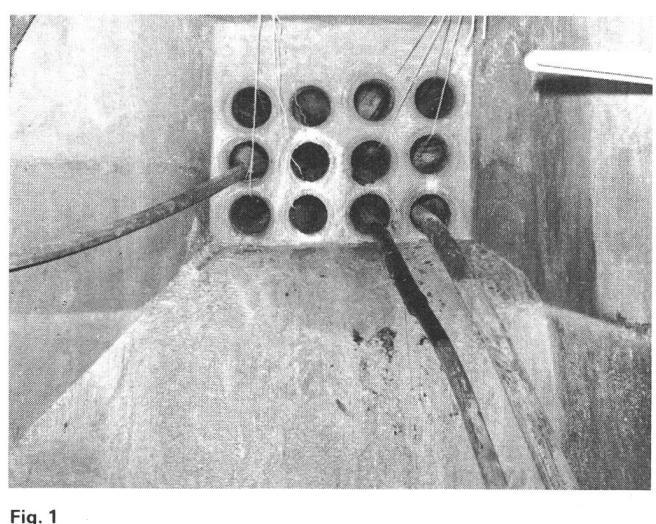
Multiway duct at Auvernier, site of fault

Water is entering the jointing chamber chiefly through the lower joint between the multiway duct and the concrete inlet funnel. Thick layers of lime sediment have been deposited on the arch of the funnel. The area of greater thickness, painted black, shows where the corroded lead sheath had to be mended

1970 for the duct installation, nevertheless temporarily contained so much water that it could drain off through the lowest row of ducts of the twelve-duct block into the next jointing chamber in the direction of Colombier which is located at a lower level. At the time of inspection the jointing chamber had been largely emptied of water. The maximum water level could however be clearly determined from the marks remaining on the chamber walls. We were informed that the drainage system in this jointing chamber had failed because the outlet pipe had been blocked by extraordinary mud deposits. Although the jointing chamber had been cleaned, considerable amounts of fine lime sediment could again be seen on the floor. Thick crusts of precipitated material had been deposited particularly on the lower arch of the concrete inlet funnel through which the cables enter the jointing chamber from the direction of Neuchâtel as is shown in Figure 1. It was guite obvious that the water which flows over the funnel arch in large amounts enters the jointing chamber mainly through the lower connection joint between the inlet funnel and the multiway duct. However, some of the water enters the jointing chamber via the plastics tubes. As can be seen from Figure 1, only three of the 12 ducts are occupied by one cable each. Illumination of the individual ducts allowed inspection to a depth of approximately 3 m, revealing that only five of the 12 duct pipes were dry and free of sediment while six contained, as far as it was possible to see, a white, wet deposit with a small stream of water trickling along. In the case of one duct pipe, sediment had been deposited at the inlet only. Some of the ducts affected by sediment can be identified in Figure 1 by the white traces of the deposit.

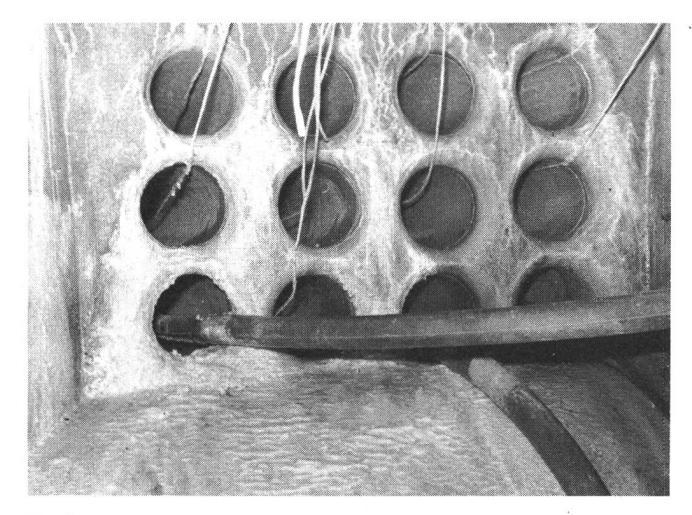
Fig. 2

While the cable from Neuchâtel to Areuse is located in a clean and dry duct (centre row, left) and therefore does not show any signs of corrosion, the ducts containing junction cable 20084 and long distance cable 20010 (bottom row, ducts 3 and 4) carry some water. The lead sheaths of these cables are affected by corrosion not so much in the region of the ducts as immediately after the duct outlet and particularly in where the cable sheaths

Multiway duct at Auvernier The white traces show that lime-precipitating water is penetrating through all the joints of a chamber adjacent to the site of the fault

rest on the arc of the concrete inlet funnel. The junction cable was corroded through at that point and had to be mended by means of a lead pipe insert. The lead sheath of the long distance cable is affected to a depth of approximately 1 mm at the area of contact with the inlet funnel but is not yet perforated. Slope pressure water has penetrated even into the three next following jointing chambers in the direction of Colombier where the terrain slopes gently. For example, *Figure 2* shows the entry of the ducts in one of these neighbouring jointing chambers. The white traces of lime deposit show that in this case water has seeped through all the connection joints between the multiway duct and the concrete inlet funnel and also between the plastics ducts and the surrounding concrete.

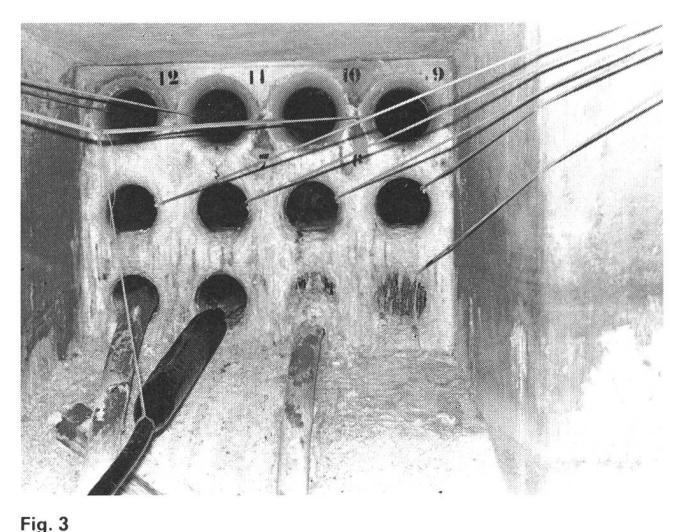
The multiway duct system was completed about one year prior to pulling in the cables. The lead sheath of the subscriber cable, which is 2 mm thick, was corroded through within less than two years. *Figures 3* and 4 show the condition found in E. 6, the jointing chamber containing the fault, on 24. 8. 1972. The inlets of the duct

Multiway duct at Arbon, site of fault

The front of the multiway duct is largely covered by a thick lime crust. In some places, stalactite-type structures have formed. Highly basic water is flowing into the jointing chamber between the layers of lime and in the stalactite tubules. All the cables are corroded at the point of contact with the arch of the concrete funnel. The area of increased thickness which is painted black shows where the corroded cable has been mended

sections coming from the exchange are shown in Figure 3. Duct section 2 is occupied by junction cable 60139 St. Gall—Romanshorn. Duct sections 3 and 4 contain subscriber cables. The corrosion breakthrough at the 100-pair subscriber cable has been repaired by means of a lead pipe as can be seen from the illustration. The junction cable and an 800-pair subscriber cable pass through the opposite jointing chamber wall (Fig. 4) using the same duct section numbers as before, while the 100-pair subscriber cable is divided into four smaller Type B cables which leave the multiway duct system by two unnumbered outlets.

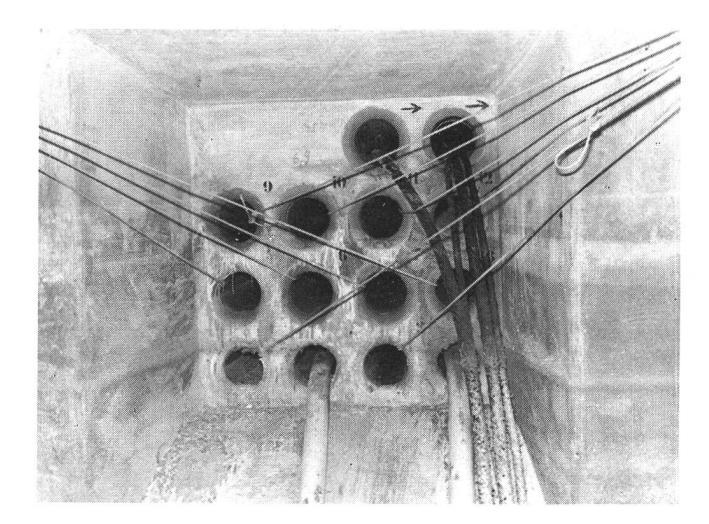
Fig. 4 Multiway duct at Arbon

At the multiway duct inlet opposite to the fault site, white traces of lime show that, at times, small quantities of water have seeped through between the plastics ducts and the concrete block. Lime sediment precipitated from the accumulated water in the jointing chamber due to atmospheric carbonic acid is deposited on the arch of the concrete funnel and on the cables

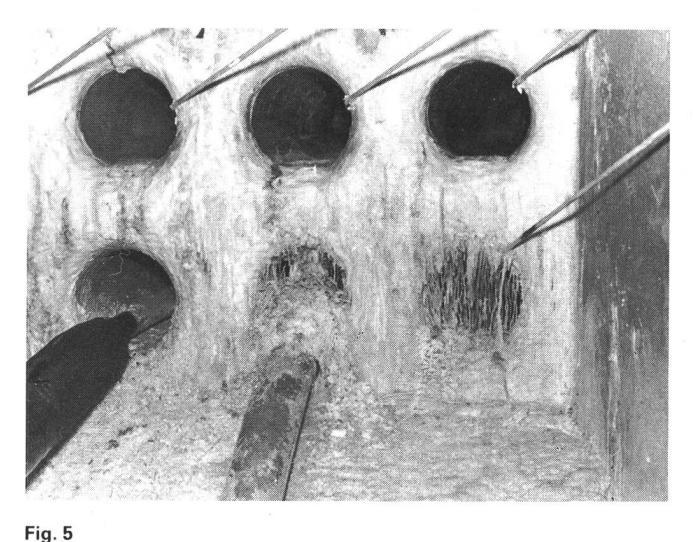
If one breaks off the stalactites, clearly visible in *Figure 5*, one can observe that these are of the form of tubules and contain dripping water which, if tested by means of indicator paper, exhibits a considerably stronger alkaline reaction than the water flowing in the duct sections. Wiping off the stalactites revealed a «water spring». The hand in *Figure 6* points at this site from which approximately 0.251 of water were obtained within about five minutes. The fact that water emerges between the plastics inlet funnels and the concrete in which they are packed is obvious from the opposite wall (Fig. 4) because it is only slightly encrusted so that one can see exactly how the white traces of eliminated lime emanate from the boundary line between the external surface of the plastics duct and the concrete.

Multiway duct at Arbon, fault site

Here, the thick lime crusts deposited round the plastics duct inlets can be recognized particularly clearly. Water-carrying stalactite-type lime tubules overhang two of the duct section inlets

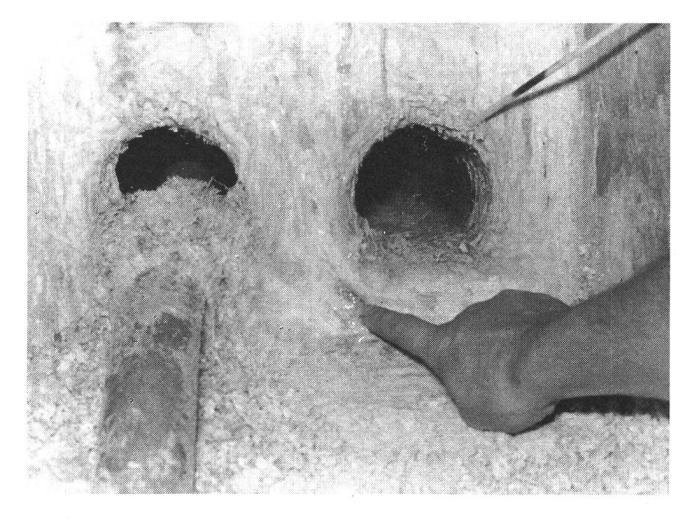
Fig. 6 Multiway duct at Arbon, fault site

The hand in this illustration points at a «water spring» which appeared when the stalactites had been wiped away. The highly basic water (pH 12.6) is emerging between the plastics inlet funnel and the concrete packing

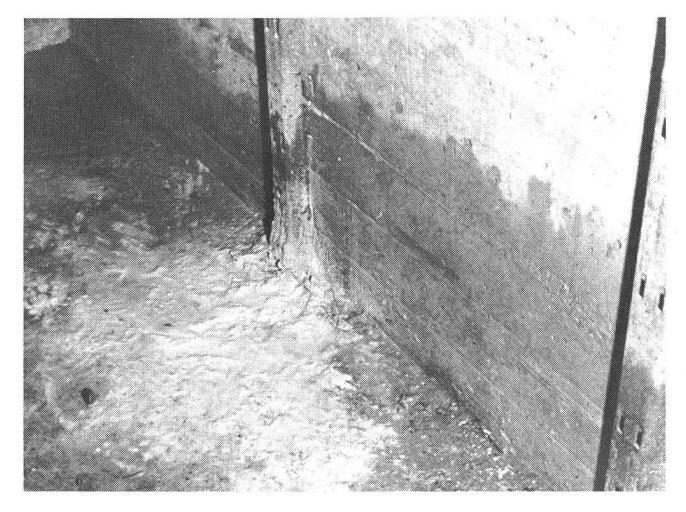
Fig. 7

Multiway duct at Egnach

In this chamber, water has penetrated at the point where the steel profile has been set into the floor of the chamber, as can be seen from the lime crust formation

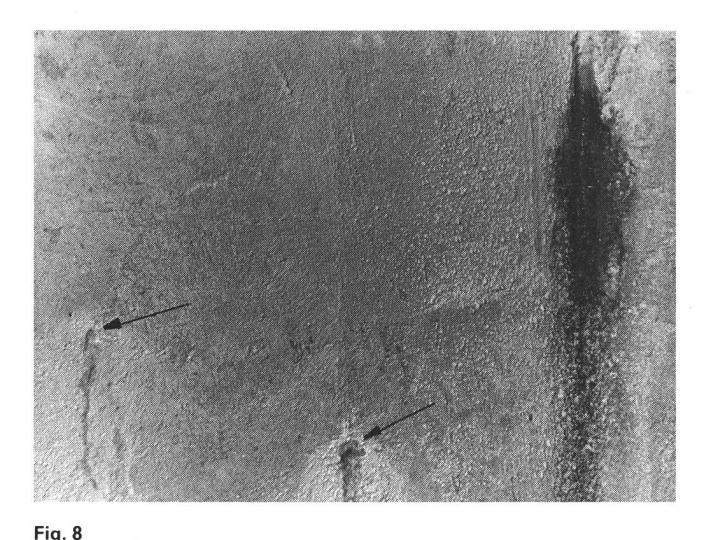
Multiway duct at Egnach

In another chamber, strongly basic water penetrates the concrete at two points on a longitudinal wall - marked by two arrows in the Figure

chamber had been pumped dry the floor was covered once more with water to a depth of 7 cm. This corresponds to a water inflow of about 20 litres per hour. Figure 8 provides proof that water can break through massive concrete walls. Here, water is penetrating at a rate of about 21 per hour at two points in the chamber wall. In addition, water is flowing at the rate of 5 l/h by capillary action between the plastics duct no 5 and the concrete in the same chamber, as is indicated in Figure 9 (arrow). In spite of this, the cable fault in a subscriber cable did not occur in the area of the chamber inlet but instead 30 m inside the duct, where an obstacle had to be avoided by means of a soft polyethylene insert. In this installation, the bare lead sheaths had been protected two years previously against direct contact with water emerging at the vulnerable outlet points by means of polyethylene hose sections slit open and wrapped around the cable sheaths.

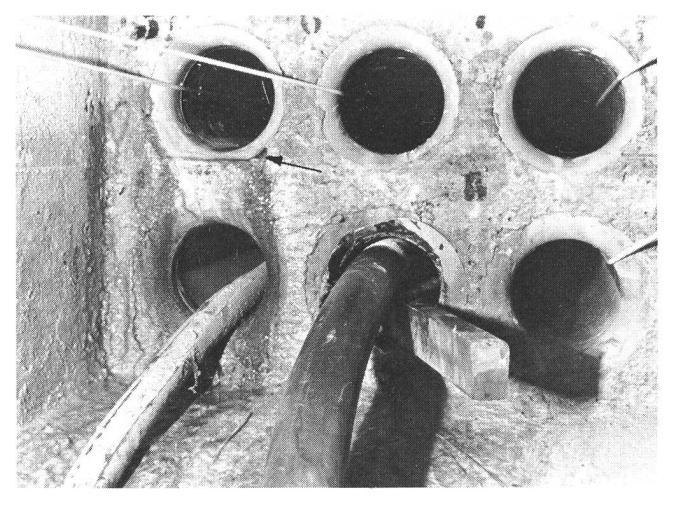
Fig. 9 Multiway duct at Egnach

In the same chamber as that shown in Figure 8 about 5 I of water per hour flow into the chamber at duct no 5 between the plastics tube and concrete packing (arrow)

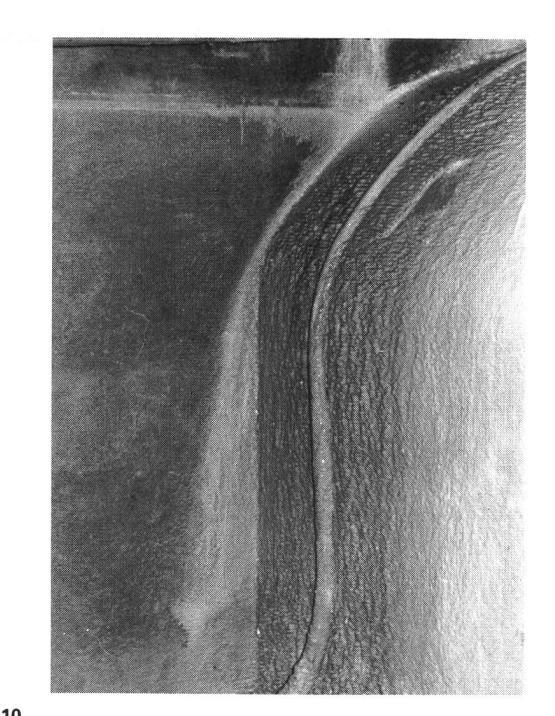
Fig. 10 Multiway duct at Wollerau

Of ten manholes inspected in March 1975, six contained water while three were completely flooded. Jointing chamber 32 was two thirds filled with water and it was observed after the chamber had been pumped out that the water ingress was occurring predominantly via the ventilation pipe. In chamber 29 also, which was filled with water to the level of the lower row of ducts, the water entered mainly through the ventilation pipe. Level marks and lime sediments on the walls and in the upper ducts show that an even higher water level prevailed for a sometime. A particularly gross example of lime deposits produced by water seepage was encountered in chamber 28 where the water had spread and rippled down over the whole width of the concrete inlet funnel and formed centimetre thick lime crusts so that the cable resting on the funnel was virtually petrified as can be seen in *Figure 10*.

In this chamber strongly basic water flows into the chamber distributed over the full width of the concrete inlet funnel so that the precipitating lime crust has virtually petrified the cable resting on the funnel
