Autor(en): **Croci, Giorgio**

Preservation of Newly Built and Historical Buildings

Giorgio CROCI
Prof. of Civil Eng.
University of Rome
Rome, Italy

This paper deals with the preservation of existing buildings. The main problem is the evaluation of the safety level, taking into account the crack patterns, the deterioration of materials, etc. As a result of this analysis, decisions can be taken about the opportunity and the criteria for intervention. The paper illustrates some cases, referring especially to historical buildings in Italy and Spain.

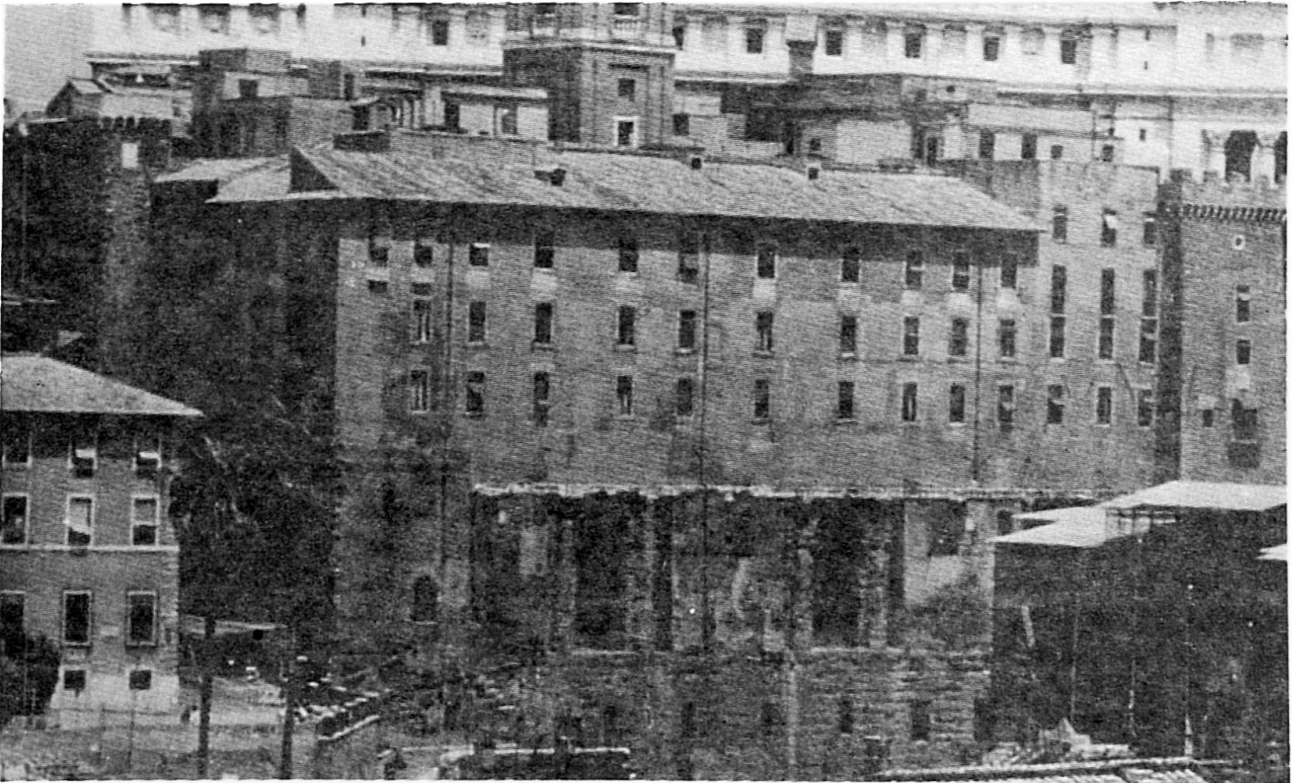
Pic.1: General view of Palazzo Senatorio and Tabularium in Campidoglio from the side of the Roman Forum

The first point to examine in the preservation of a structure is the analysis of the deterioration of the materials. This deterioration in the oldest buildings is linked not only to the chemical and physical phenomena, but also to the countless alterations, that, as in the case of Palazzo Senatorio in Campidoglio, Rome, (fig. 1) have occurred during the centuries (fig. 2), sometime stressed by incorret reinforcements (fig. 3).

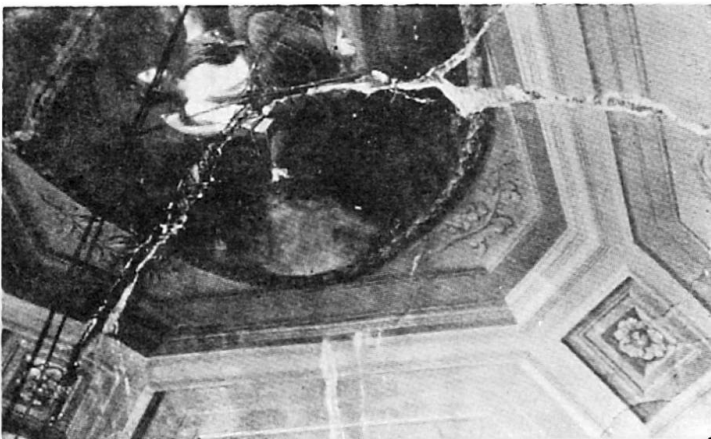
Pic.21: Cracks in the vaults of Ducal Palace of Modena

Soil deformations represent a further group of phenomena that often effect old buildings. The solution is not only in improving the bearing capacity of the foundations (underpinning, ...) or in strengthening the building as a whole. It is often better to use different solutions: in the Ducal Palace of Modena (fig. 20), where important cracks due to soil rettlements effect the walls, floors and vaults (fig. 21), we have proposed to make joints (fig. 22), to allow differential settlements to occur without inducing significant stresses in parts of the Palace.
