Preservation of Newly Built and Historical Buildings

Giorgio CROCI

Prof. of Civil Eng.
University of Rome
Rome, Italy

This paper deals with the preservation of existing buildings. The main problem is the evaluation of the safety level, taking into account the crack patterns, the deterioration of materials, etc. As a result of this analysis, decisions can be taken about the opportunity and the criteria for intervention. The paper illustrates some cases, referring especially to historical buildings in Italy and Spain.

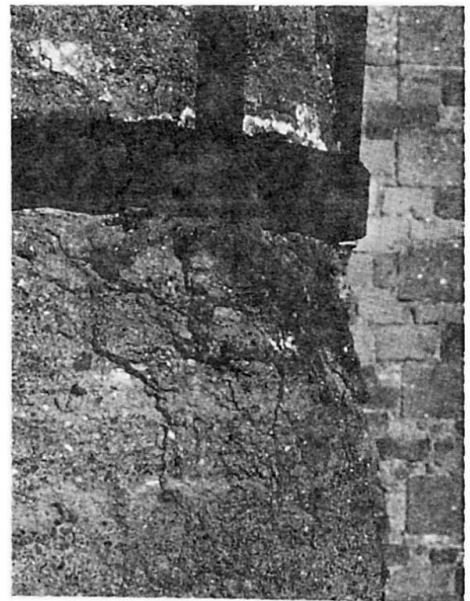
Pic.3: Effect on the columns of Tabularium

The first point to examine in the preservation of a structure is the analysis of the deterioration of the materials. This deterioration in the oldest buildings is linked not only to the chemical and physical phenomena, but also to the countless alterations, that, as in the case of Palazzo Senatorio in Campidoglio, Rome, (fig. 1) have occurred during the centuries (fig. 2), sometime stressed by incorret reinforcements (fig. 3).
