Serviceability and Maintenance

**The James River Bridge.
Rescue Campaign for a 7 Kilometer Crossing**

THOMAS R. KUESEL

Parsons Brinckerhoff Quade & Douglas
New York, N.Y. 10001, USA

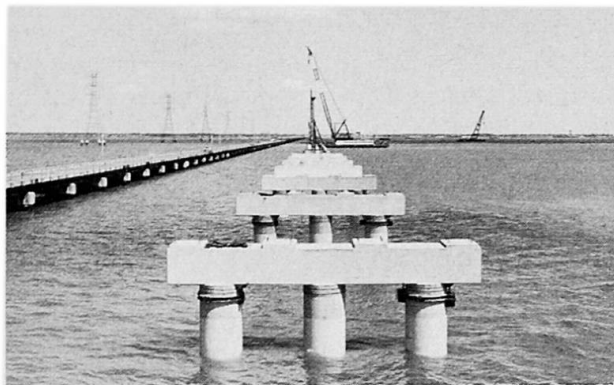
5. Newly installed piles and caps for replacement roadway

For the trestle foundations, precast, prestressed, cylindrical concrete piles were chosen. They have a diameter of 1.4 m and a wall thickness of 13 cm. Cast by a rotary centrifugal process, they have an exceptionally dense and smooth surface for resistance to salt water erosion. Over a 3-m height through the tidal zone they are further protected by an epoxy coating applied at the casting yard. The pile sections were precast in 5.2-m lengths, and joined by 16 prestressing cables to form individual piles up to 52 m long, weighing as much as 60 tons.

Three piles were connected by a precast, reinforced concrete cap to form a pile bent. The piles were filled with sand to furnish resistance against impact by small fishing vessels which abound in the area. A hollow void was left in the tops of the piles after they were cut off to a uniform elevation. The precast caps were fitted with three prongs of reinforcing steel that projected into the pile tops. After the caps were adjusted to grade and levelled, the voids were filled with concrete placed through vertical holes provided through the caps over each pile. The trestle substructure was thus established with a maximum proportion of dense, high quality concrete and a minimum of site labor and materials.
