Artikel: Timber bridge replacement to resist deicing agents

Timber Bridge Replacement to Resist Deicing Agents

J.R. VERNA President Verna Engineering, Inc. Carnegie, PA, USA J.M. SHANNON
Senior Engineer
Verna Engineering, Inc.
Carnegie, PA, USA

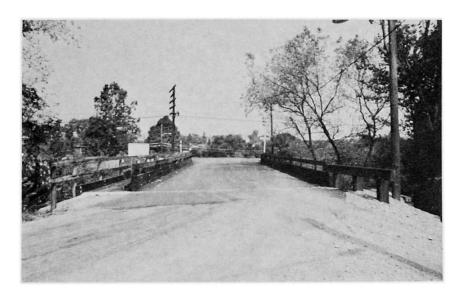
Photograph 2: Case Study 2 - Bridge with glue-laminated timber deck.

The 61 ft (18.6 m) span with two nine-ft (2.7 m) lanes and a four ft (1.2 m) sidewalk was designed to carry coal trucks weighing 60,000 lb (27,215 kg) to a mining site. The rehabilitated structure was to be able to carry 73,280 lb (33,239 kg) trucks in an AASHTO (American Association of State Highway and Transportation Officials) HS-20-44 configuration in two ll-ft (3.3 m) lanes while continuing to support the cantilevered sidewalk, as shown on Photograph 2.
