**Band:** 12 (1984)

**Artikel:** Nail-plates as shear connectors in composite timber and concrete  
structures

**Autor:** Girhammar, Ulf Arne

## **Nail-Plates as Shear Connectors in Composite Timber and Concrete Structures**

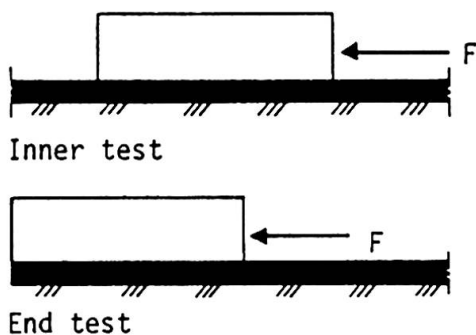
Fig. 4 Two kinds of "push-out" tests

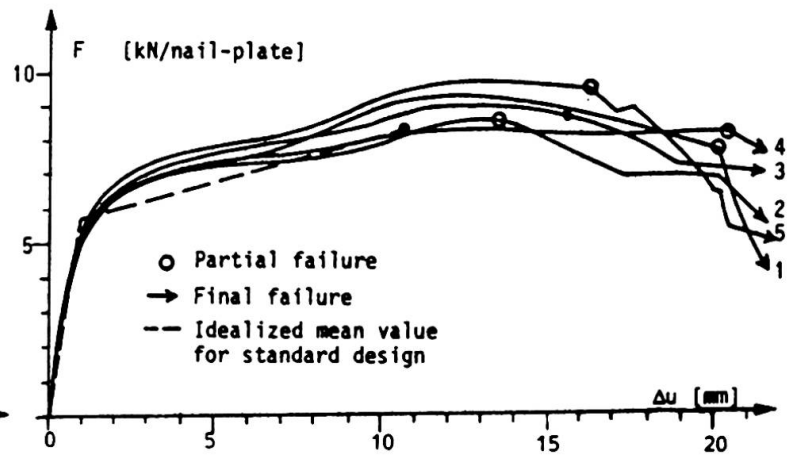
Fig. 15.6 Modified design no. 6

The embedment length of the nail-plates should be retained as it is included in the standard design, cf. fig. 15.5. The nail-plate shear connectors will be fully effective even if they happened to be bent unintentionally during handling and fabrication of the wall element as is clear from fig. 15.6.
