Zeitschrift: IABSE congress report = Rapport du congrès AIPC = IVBH
Kongressbericht

Band: 13 (1988)

Artikel: Stability of a stone arch bridge against flood pressure and its
preservation

Stability of a Stone Arch Bridge against Flood Pressure and its Preservation

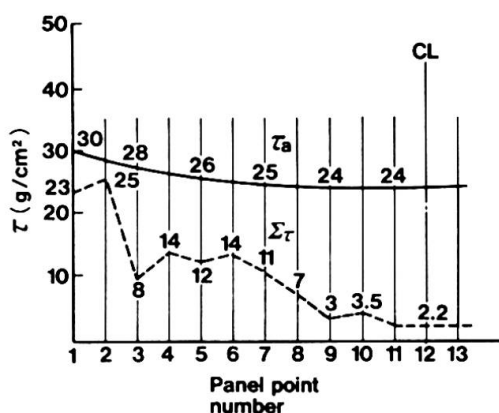
Fig. 3 Results of stability calculation with experimental values

When the resultant stress of τ_1 , τ_2 , and τ_3 becomes larger than τ_a the stability of sealing material between arch stones is lost so that they may start rotating or slipping, and finally the bridge will collapse. Fig.3 shows the calculated results, proving that the stability was maintained in the model arch.

(3) Due to the hydrodynamic forces mentioned above, when the shearing stress caused by torque due to the out-of-plane arch action, the shearing stress due to the in-plane arch action and the shearing stress due to the out-of-plane arch action, exceed the frictional resistance produced by the axial torque of the arch sealing, the sealing between the arch stones will lose the stability, so that they start rotating or slipping and finally the collapse will take place. In the experiment, however, such a collapse did not occur and the arch stones stayed safe.

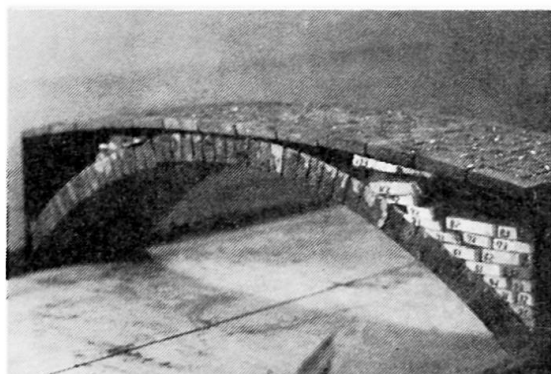
The Fukuro bridge, only using an epoxy adhesive at the joint of the stones of arch spandrel and of pavemant of the road surface, could maintain the stability of the stone arch bridge against flood pressure. Photos. 4 and 5 show the appearance of Fukuro bridge.

Photo 4 Collapse of arch spandrel of downstream side.
