Artikel: Impact resistance on prestressed concrete masts
Autor: Abeles, P.W.
DOI: <https://doi.org/10.5169/seals-15750>

Impact Resistance on Prestressed Concrete Masts¹⁾

P. W. ABELES, London

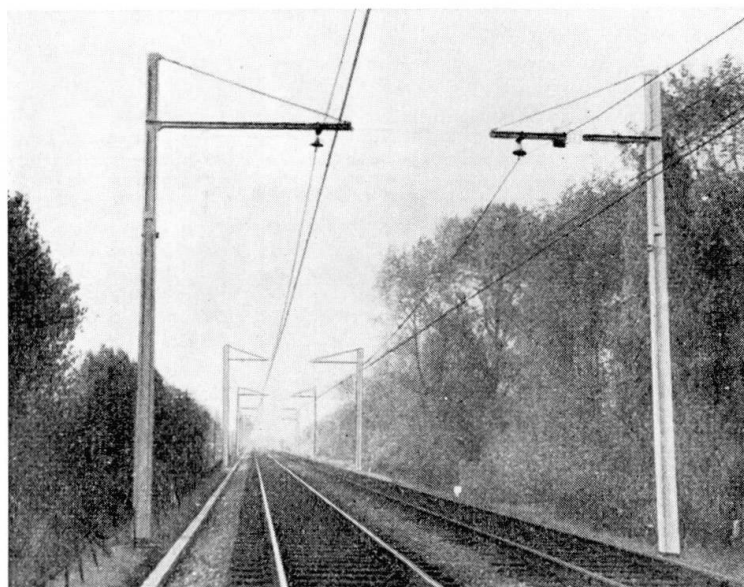
Fig. 1. Prestressed Concrete Cantilever Masts near Southend (England).

From figs. 1—3 it is seen that the prestressed concrete masts differed but little in size from the steel masts. This was achieved by making full use of the tensile resistance of the concrete under working conditions, which is particularly advantageous if loading in opposite directions occurs. Freedom from
