8. Cardiff Arms Park Stand (United Kingdom)

Owner: Welsh Rugby Union, Cardiff Architect: Osborne V Webb & Partners, Cardiff Consultants:

1st Phase: Williamson Partnership, Porthcawl 2nd Phase: James & Nicholas, Port Talbot Quantity Surveyor: Paterson & Seaton & Co. Contractor: Redpath Dorman Long Limited Completion: 1st Phase: 1969 2nd Phase: 1978

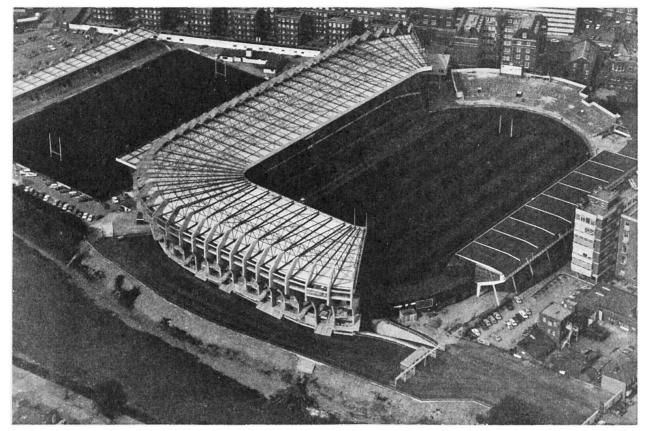
Aerial photograph of the Stadium taken in 1978

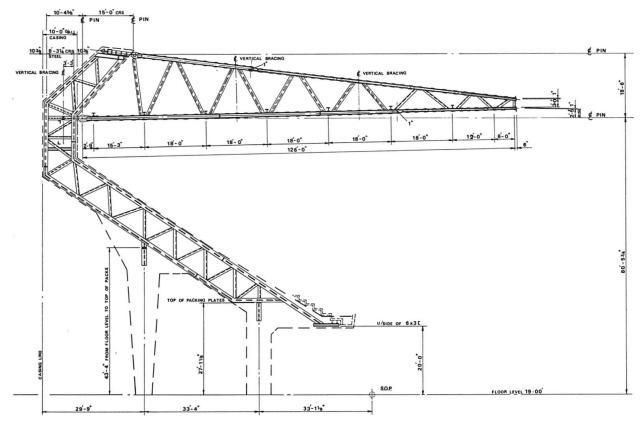
WELSH RUGBY UNION EXTENSION TO WEST END NATIONAL STADIUM

As shown, the works consist of forty-five frames at

- 6.1 m centres, each frame being of:
- a) Two vertical reinforced concrete columns on independent foundations 9.1 m apart. At the top of each concrete column, structural steel stub-columns and plates to receive the Main Raker Beams are fixed at 11.6 m and 8.2 m levels respectively.
- b) Structural steel Main Raker Beams comprising 14×14.5 U.C.s booms and U.B. and U.C. lacings 30.5 m long.
- c) Structural steel Vertical Mast 12.2 m in length monolithic with the Raker Beam.
- d) Cantilever Roof Truss 38.4 m long and 24.4 m above ground level measured to the underside of the Truss.
- e) Horizontal and vertical bracing to the cantilever trusses and associated U.B. ties.
- f) Vertical bracing and longitudinal ties to the Mast Section.
- g) Longitudinal ties to the bottom of the Raker Beam Section.
- h) Gutters and gutter supports.
- i) Glazing supports at high level.
