Artikel: Steel strip reinforced concrete bridge (Denmark)
Autor: Kragerup, Jørgen Birger / Jonsen, Leif
DOI: <https://doi.org/10.5169/seals-20922>

3. Steel Strip Reinforced Concrete Bridge (Denmark)

Owner:	<i>The Danish Road Directorate by County of Frederiksborg</i>
Design and supervision:	<i>Cowiconsult, Consulting Engineers and Planners AS, Copenhagen</i>
Contractors:	<i>Armton A/S, Copenhagen</i>
Works Duration:	<i>May 10 – July 22, 1985</i>
Closed for traffic:	<i>June 6 – July 4, 1985</i>

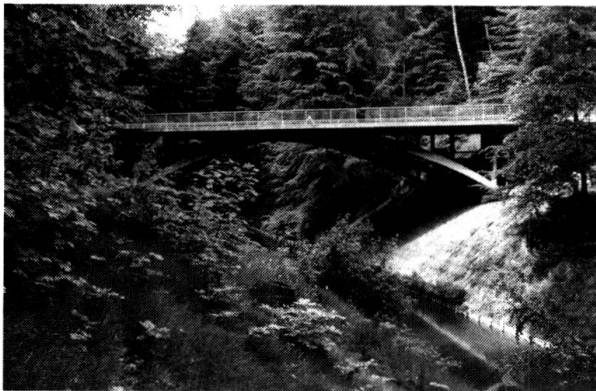
The reinforced concrete bridge in question is an arch bridge 45 m long, 13.5 m wide, built in 1950 and designed by Cowiconsult. Above the 27.5 m span of the arch itself, the bridge deck is divided into sections. At either end of the arch there is a 7 m bay.

Canal Bridge at Frederiksværk.

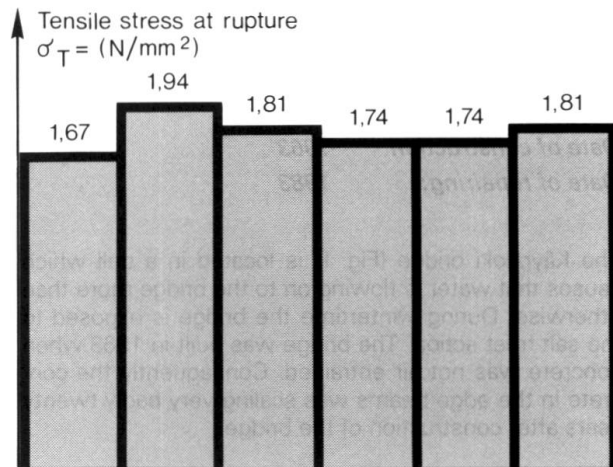
Before the actual work on reinforcing commenced, tests had to be made of the tensile strength of the bridge concrete and the adhesive properties of the bonding agent on the concrete surface. Altogether, tests were made with six plates all of which were tested to breaking point.

All ruptures occurred either in the concrete itself or on the surface between the concrete and the bonding agent. Based on the results, the compressive strength of the concrete was assessed as minimum 25 N/mm².

Adhesion of the bonding measured by tests on 6 test slabs.

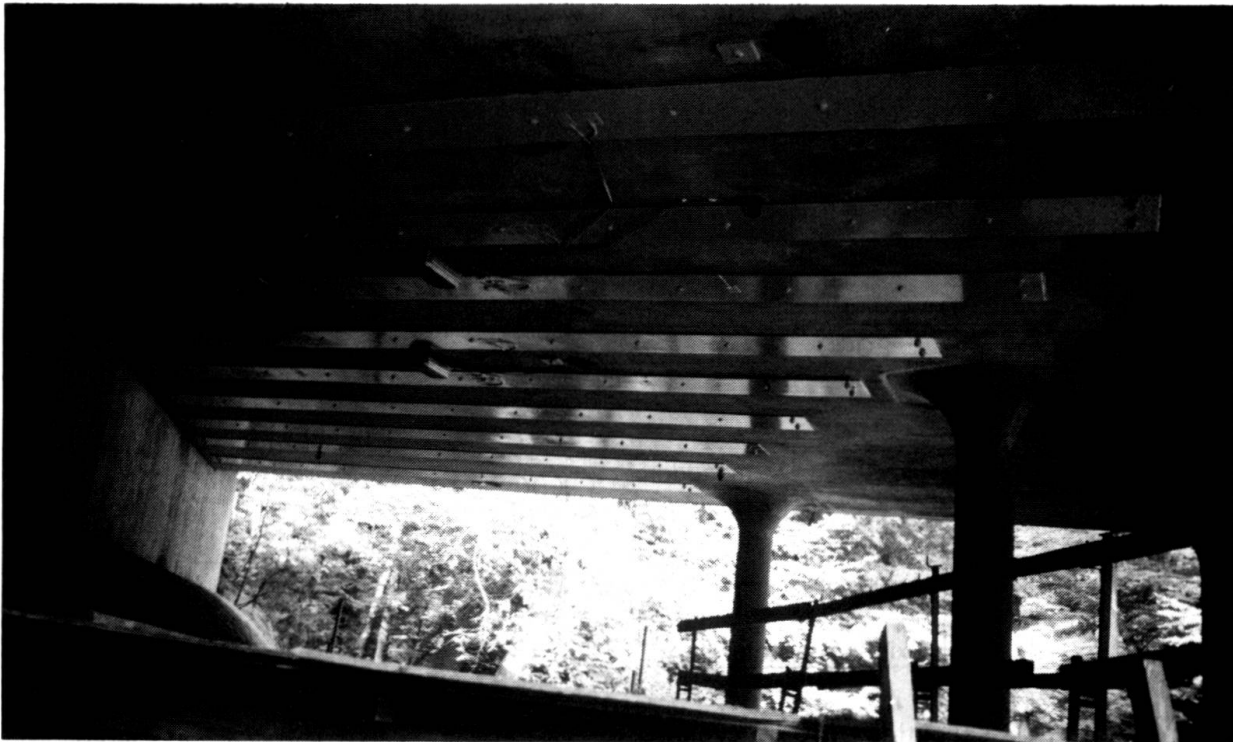
Bridge deck reinforced with bonded steel plates. The strain gauges were used to verify the efficiency of the bonding. The bolts are removed after completion.

In each of the two end bays 9 steel plates (400 × 5850 × 6 mm, st. 37) were bonded to the concrete. When the bridge is subjected to the stipulated maximum load, the permissible tensile strength for the steel will only be 50% utilized. In addition, the shear force to be transferred by the glue joint is only 10% of the permissible force. In other words, reinforcement with plenty of built-in safety.

From measurements taken in connection with a load-bearing test, it was established that the bonding agent fully transferred the shear forces between the concrete and the steel plates. In addition, the distribution of stresses in the steel plates as measured was in keeping with the calculated stress-conditions for cracked and uncracked concrete cross-section.

A load-bearing test carried out one year later produced little divergence in measurements from the year before.
