Zeitschrift: IABSE proceedings = Mémoires AIPC = IVBH Abhandlungen
Band: 8 (1984)
Heft: P-74: Failure of stub-girders due to longitudinal shear

Artikel: Failure of stub-girders due to longitudinal shear
Autor: Gosselin, G.C. / Hosain, M.U.
DOI: <https://doi.org/10.5169/seals-38336>

Failure of Stub-Girders due to Longitudinal Shear

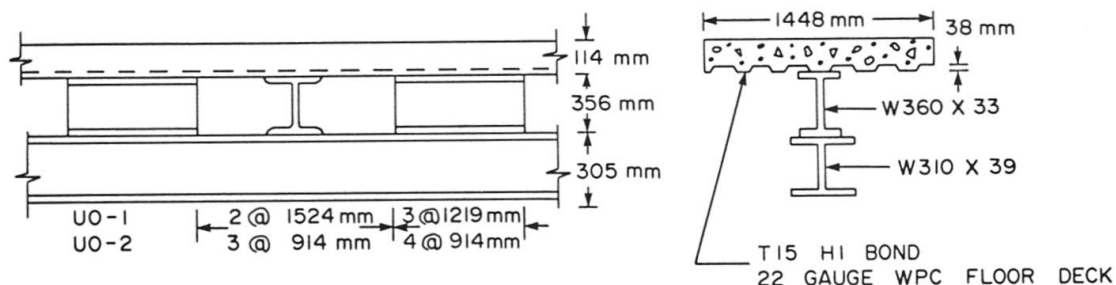
Fig.3 Specimen dimensions

A summary of the geometric properties of the two specimens is given in Fig. 3. The dimensions of the steel beams, the stubs and the concrete slab, which were identical for the two specimens, conformed to those for a stub-girder of 10 to 12 metre span. However, the span of the test beams was intentionally reduced to 7.31 m to induce failure through the stub-concrete connections. While the total length of the stubs was maintained at 3658 mm for both beams, the number of stubs was: three (1219 mm long with 24 studs) for specimen UO-1 and four (914 mm long with 18 studs) for specimen UO-2. Thus specimen UO-1 contained only two interior panels (1524 mm long) whereas three interior panels (914 mm long) were located within specimen UO-2. An 1829 mm long W360 X 33 section was placed at the midlength of each interior panel to simulate a floor beam. It was welded to the primary steel beam and connected to the concrete slab by means of eighteen studs. All headed shear studs were 76 mm long and 13 mm in diameter. For both specimens, the longitudinal reinforcement consisted of eight 13 mm diameter deformed bars whereas the same size bar at 305 mm centre to centre served as the transverse reinforcement. A clear cover of 25 mm was provided between the longitudinal reinforcement and the metal deck.

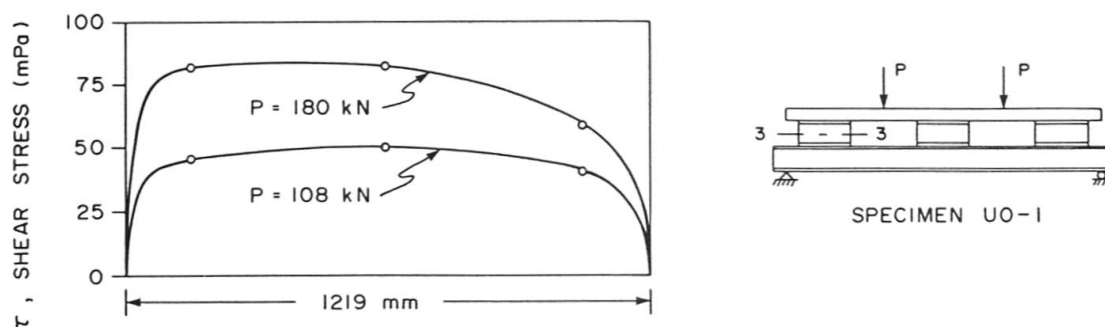
Fig.7 Shear stress distribution across section 3-3

The observed shear stress distribution across one of the end stubs is shown in Fig. 7. The deviation from the basic parabolic shape which occurs at higher loads is believed to be caused by local concrete failure at the tensile (prying) end of the stub. Localized failure could reduce the shear resistance of studs subjected to tension, giving rise to the skewed distribution in Fig. 7. The design equation for headed studs of a conventional composite beam therefore, would not seem to be applicable to the

Using the shear stress distribution across the end stubs at the ultimate load (similar to Fig. 7), the maximum horizontal shear force was calculated for both specimens. This gave an average shear resistance per stud of 26.7 kN for specimen U0-1 and 33.68 kN for specimen U0-2. The maximum capacity that can be developed in shear, based on the CSA standard CAN3-S16.1-M78 [6] for conventional composite design, is 64.2 kN for the high strength concrete used. The difference between the observed and calculated shear resistances is due to several reasons. First, the use of a single row of studs resulted in a wedge action that triggered a somewhat premature concrete splitting along the end stubs. Second, both specimens were subjected to considerable prying. Due to higher prying force induced by the larger open panel in specimen U0-1, the resistance per stud was smaller compared to that of
