**Artikel:** Design and construction of the flood resistant Pongola River Bridge  
**Autor:** Oosthuizen, Andries / Davis, Stuart  
**DOI:** <https://doi.org/10.5169/seals-40367>

## Design and Construction of the Flood Resistant Pongola River Bridge

This paper describes briefly the design and construction of the Pongola River Bridge, Zululand, built to replace an earlier structure destroyed by cyclonic floods. The new bridge has been designed to resist overtopping by similar floods in the future. The loadings assumed to apply during flood conditions are described, as well as the measures taken to ensure that the structure can resist them.

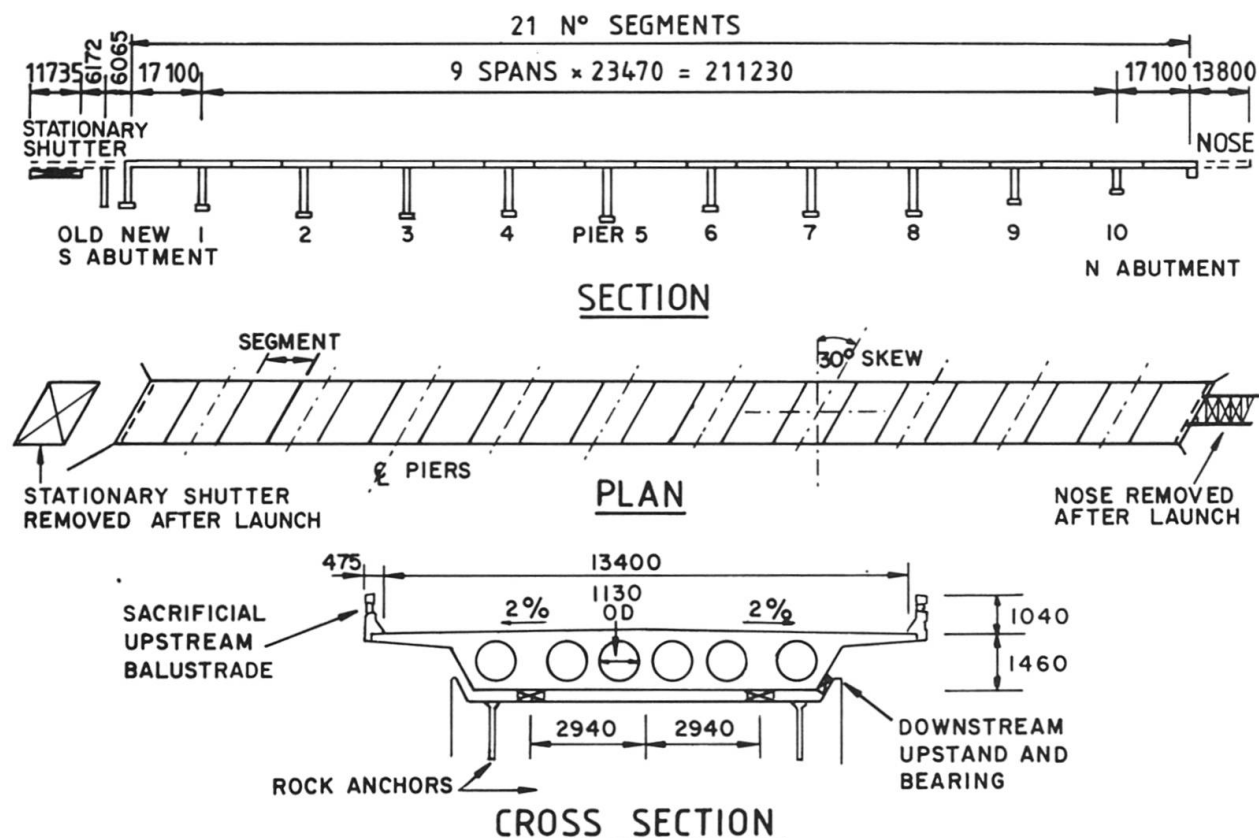
Figure 1: GENERAL ARRANGEMENT

These criteria led to the choice of an 11 span continuous, reinforced concrete, voided slab with cantilevers. A beam and slab configuration like the previous structure was rejected both for hydraulic reasons and because the replacement bridge is wider than the previous one, and this would have meant widening the piers to accommodate the additional beams. Both full and partial prestressing of the slab were investigated but were found to be considerably more costly than the reinforced concrete alternative. Circular voids were chosen in preference to rectangular ones to simplify construction of the shallow, 1,6 m deep slab. The general arrangement of the bridge is shown in Figure 1.

In cross-section, the deck comprised 6 circular voids with, correspondingly, 7 webs. The two bearings were positioned under the webs adjacent to the outermost pair (that is, under webs 2 and 6). In the final condition, loads are transferred to the bearings by the heavy cross-beam located over the bearings, but clearly during the launch this cross-beam was not always present. Without the cross-beam, very high shear forces have to be transmitted transversely across the top and bottom flanges of the circular voids adjacent to the bearings. This effect was minimised by departing from the usual uniform void spacing and increasing the width of the two webs positioned on the line of the bearings, as shown in Figure 1.

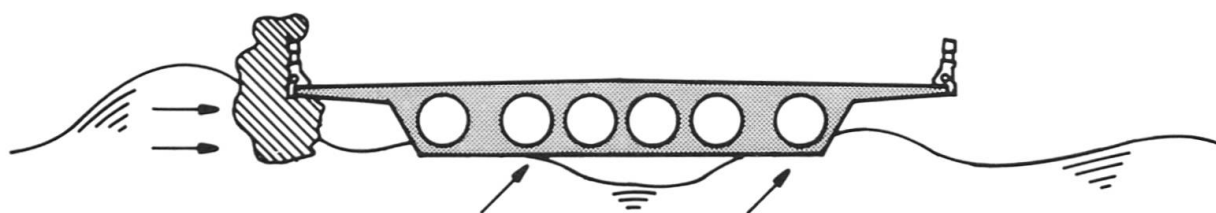
- Combination 1 : This occurs as the water reaches the soffit of the deck, and is shown in Figure 2(a). The deck still has its full self weight, that is, hydrostatic buoyancy forces are not applied. Debris is assumed to collect on the upstream edge of the deck to a height of 1,5 m above road level, but not below soffit level, since this would reduce wave action.

(a) Stage 1: Hydrodynamic forces on accumulated debris and wave action on deck.

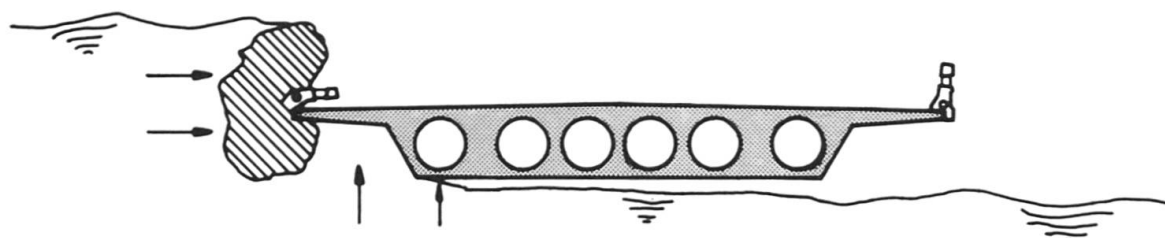
- Combination 2 : This covers possible hydrostatic effects as the water dams up behind the deck and accumulated debris just prior to overtopping. See figure 2(b). The deck still has its full self weight, but is subjected to hydrostatic uplift on the upstream side of the soffit from the 2 m head of water created by the debris. This is a severe loading which is extremely unlikely to occur over more than a small proportion of the length of the deck at one time.

(b) Stage 2: Horizontal and uplift hydrostatic forces — deck & debris acting as dam.

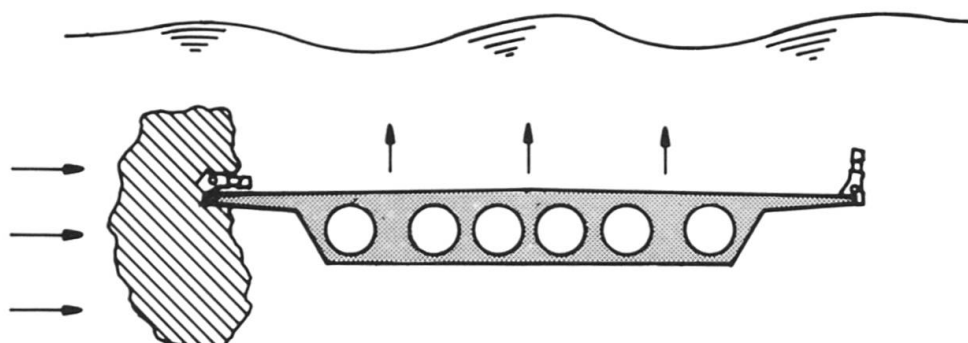
**Figure 2 : LOADINGS CONSIDERED IN DESIGN OF BRIDGE AGAINST OVERTOPPING FLOODS.**

- Combination 3 : This is the fully submerged condition. The deck is subjected to full hydrodynamic loading from the flow acting on a 5 m depth of debris, positioned centrally on the upstream edge of the deck. The deck has its submerged self weight, which includes hydrostatic buoyancy forces.

(c) Stage 3: Hydrodynamic forces on fully submerged deck and accumulated debris.

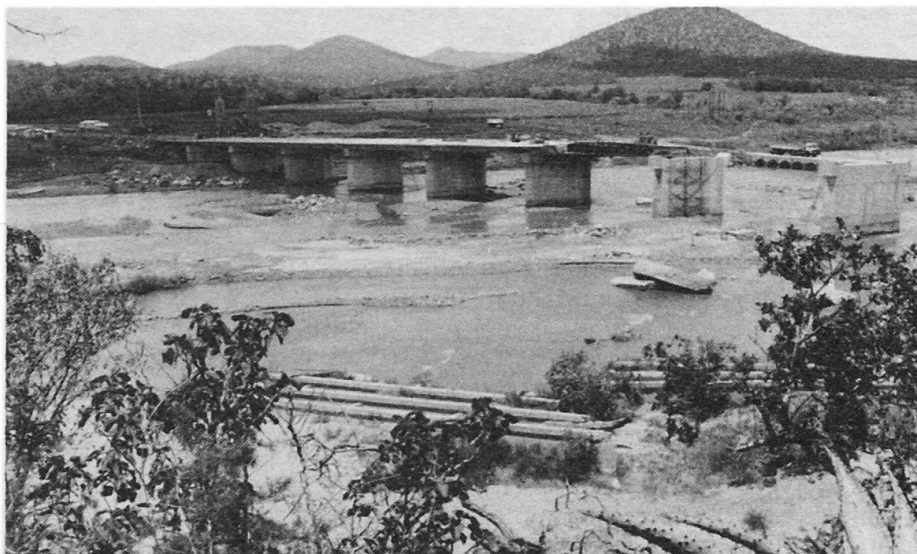
Fig. 3 : Bridge during construction, with remains of earlier structure in the foreground.

The deck was then constructed by incremental launching from the South bank. The lack of prestress and overall simplicity of the deck cross-section allowed for the unusually short cycle time for the preparation, casting and launching of each segment of 5 days. Segments were launched after about 62 hours, once a concrete strength of 15 MPa had been obtained. This is considerably less than the usual strength requirement for an incrementally launched deck. With the 5 day cycle, the bridge deck was constructed at a rate equivalent to 33 m<sup>2</sup> of deck per day.

The bridge is shown under construction in Figure 3.
