Fatigue Crack Locations in Orthotropic Steel Decks

J. R. CUNINGHAME

C. BEALES

SUMMARY

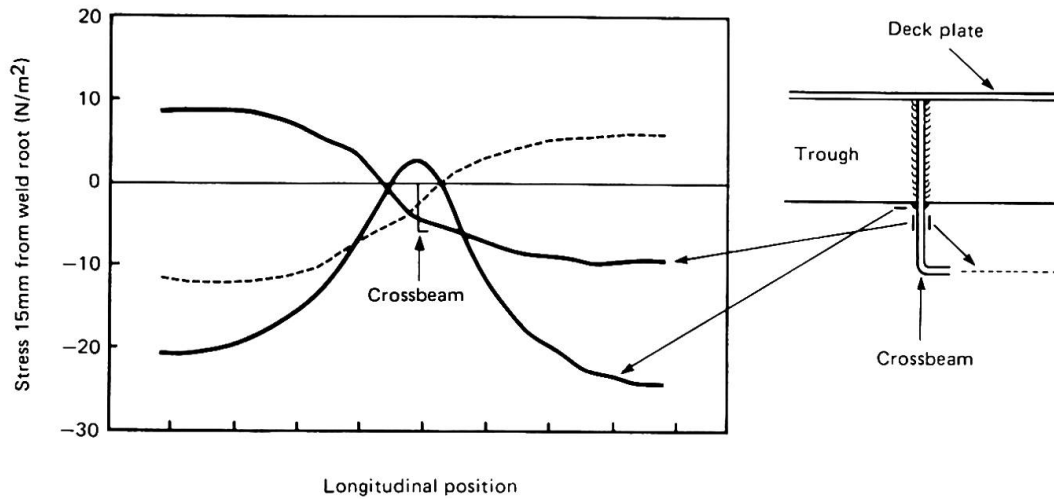
Fig.1 Stress influence lines for trough to crossbeam joint

Fatigue tests were carried out on a deck panel by loading alternately at two positions over the trough on either side of the crossbeam, coinciding with the stress peaks on the influence line. Small (1500 x 600mm) specimens were also tested.

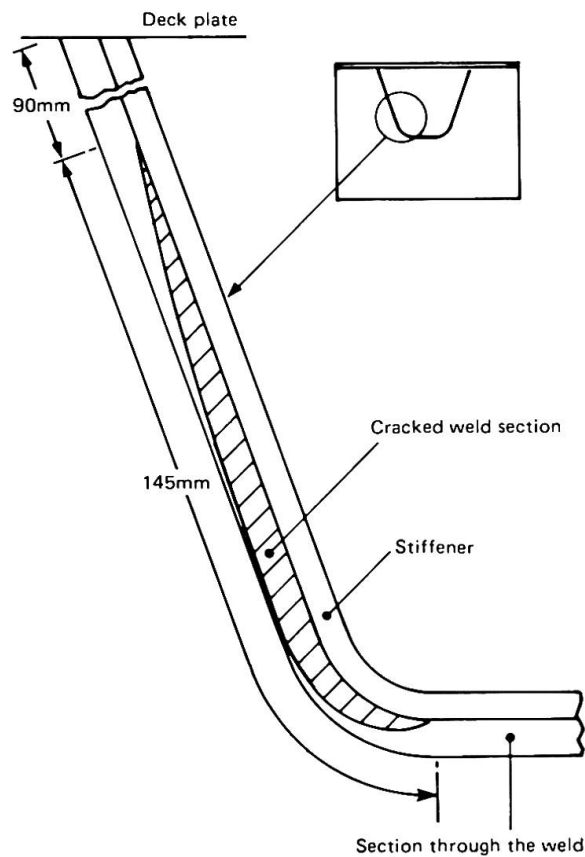
Fig.2 Crack location in trough to crossbeam weld

Most cracks, both in the fatigue tests and on the bridge, started at the weld root on the web of the trough in a region of tensile residual stress, and grew through the weld throat with the fracture surface parallel to the crossbeam. Fig 2 shows a crack just before it reached the weld surface and became visible.

The stress distribution around the trough to crossbeam joint is complex and the stress in the weld depends on the geometry and fit up of the trough to the crossbeam. Since the applied stress in the trough adjacent to the weld is entirely compressive, the rate of fatigue crack growth depends on the weld stress cycle which, in turn, depends on the residual stress.

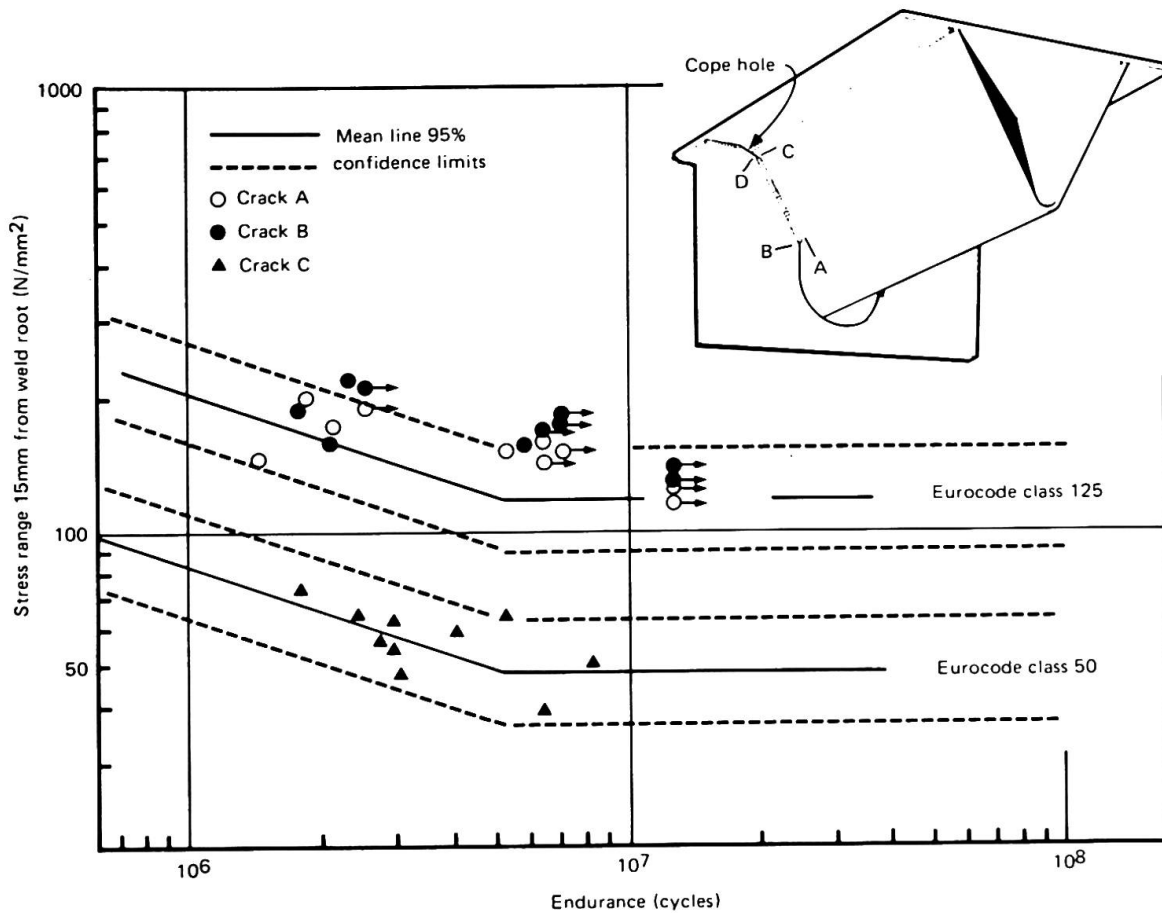
Fig.3 Crack locations and test results for trough to crossbeam joint

In two of the designs, the trough to crossbeam weld stops short of the deck plate and a cope hole is left in the crossbeam, to bridge the trough to deck plate weld. This avoids three welds meeting at a point. However, when these joints were fatigue tested cracks occurred in the trough and crossbeam at the upper end of the trough to crossbeam weld, ie at the edge of the cope hole.

The crack locations and test results are shown in figure 3. Cracks also occurred at the lower end of the weld but at much longer endurances. The fatigue strength of the cope hole detail is consistent with BS 5400 class G or Eurocode class 50 [10]. The estimated life under design traffic loading is less than 5 years. Without the cope hole detail, the fatigue strength (for cracking at the weld toe at the lower end of the weld) is much higher than expected and is consistent with BS 5400 class C, or Eurocode class 125. The design life of the joint is then greater than the 120 years required by the UK design standard.

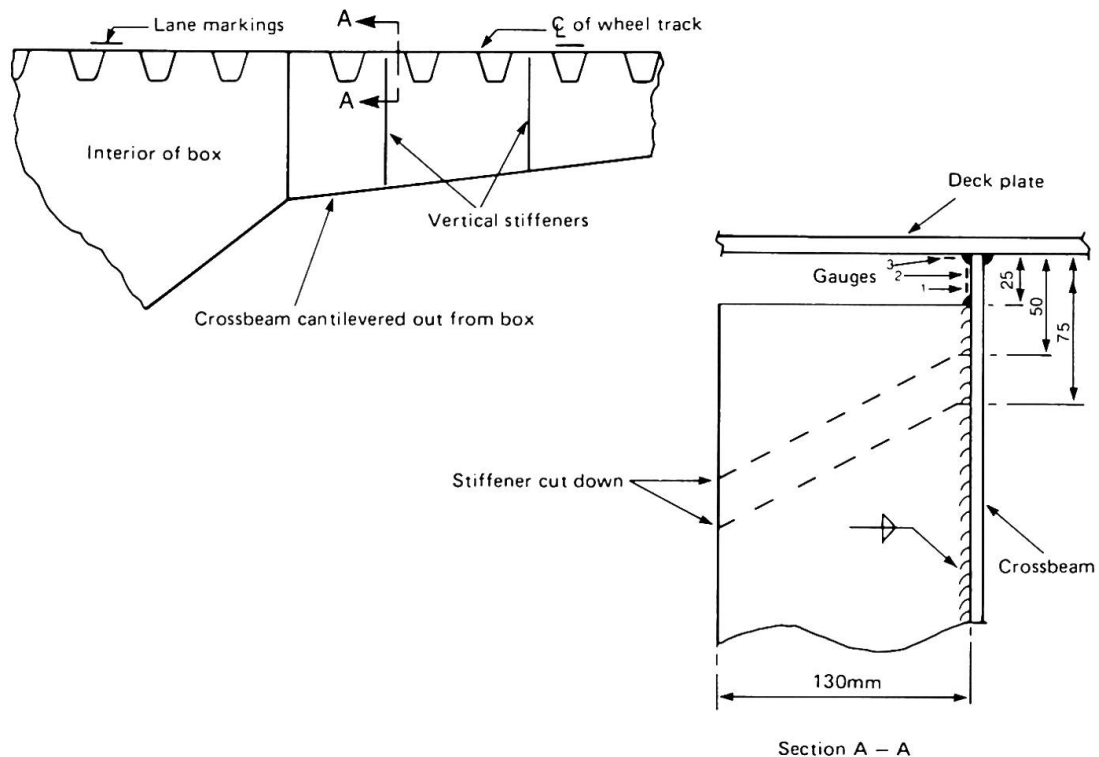
Fig.5 Crossbeam stiffener

The webs of these beams are stiffened by two vertical stiffeners, figure 5 shows the arrangement. In this case a nominal 25mm gap was left between the top of the stiffener and the deck plate. A survey showed that the actual gap varied between 15mm and 40mm.

Loading tests were carried out with the surfacing removed using the same, two axle, test vehicle. Strains were measured on the crossbeam web at the top of a stiffener and at the crossbeam to deck plate weld directly above, see figure 5.

The stress data was used to estimate the fatigue life of the joint by the same methods as described above. The highest stress occurred at the end of the stiffener to crossbeam weld between the top of the stiffener and the deck plate (gauge position 1, see figure 5).

have been found in this joint although the bridge is older and more heavily trafficked. Part of the reason for this is the effect of the transverse position of the traffic relative to the joint, see figure 5. With the present position of traffic lanes on the bridge, the joint is 450mm from the centre of the vehicle wheel track. It is calculated that this will increase the life to 12 years.

Some improvement was thought necessary, so tests were carried out on stiffeners modified in a similar way to those described above, ie by increasing the gap between the top of the stiffener and the deck plate, see figure 5. This time it was not possible to remove the surfacing so dynamic tests were carried out on the surfaced deck, with the same vehicle as in the static tests.

It will be seen that for this joint there is no benefit from increasing the gap at the top of the stiffener, in fact stress ranges are increased by about 50%. However, all the stresses were considerably reduced by the surfacing.

It was concluded that there was no advantage in modifying this joint by cutting down the stiffener. However, fatigue cracking is unlikely to occur provided the surfacing remains effective (the effect of surfacing is discussed further in section 8).
