Experiences with Orthotropic Steel Deck and Cable Stayed Bridges

Dietrich E. LEBEK

Federal Road Research Institute
Köln, Fed. Rep. of Germany

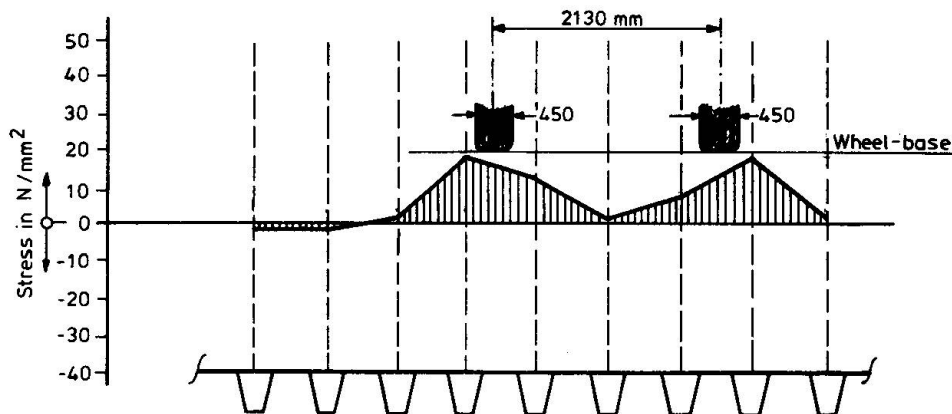
Fig. 1 Transverse Load Distribution

Orthotropic plates, even those with torsionally stiff stiffeners, have a poor transverse load distribution. Results of strain gauge measurements on the bottom flange of stiffeners of a "standard" orthotropic plate are shown in Fig. 1 [1]. Studies made under traffic in motion show that about seventy to eighty per cent of all wheels of commercial vehicles passed within about ± 300 mm of the centre line of the "ideal" wheel track. These two facts combined indicate that orthotropic plates have heavily loaded and less heavily loaded stiffeners.

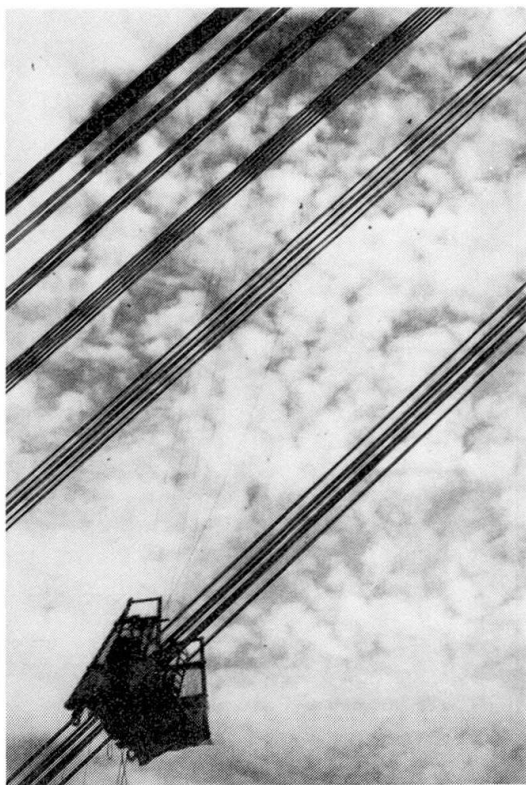
Fig. 10 Inspection of Cables

The development of an appropriate procedure and sequence for the inspection of all parts of a cable is important. In the past, the importance of a thorough and complete inspection of cables was often not acknowledged to the required extent by all designers of cable stayed bridges. Even an appropriate access to cable anchorages and cable sockets has not always been provided for in the design. Access to the free cable length between bridge deck and tower must also be possible and would normally require a special type of traveller. Fig. 10 shows a possible solution to this problem.

The general principal inspection will entail examination of the cable anchorages, cable sockets and condition of corrosion protection. An examination of the free cable length from the bridge deck, high quality binoculars will normally suffice, is strongly recommended. The interval between general principal inspections should not exceed three years.

The major principal inspection will be more intensive and require close examination of all parts. Free access to all parts is absolutely necessary. Special attention should be paid to possible wire breakage, cracks in sockets and anchorages
