**Zeitschrift:** IABSE reports = Rapports AIPC = IVBH Berichte  
**Band:** 46 (1983)

**Artikel:** Corrosion deterioration of reinforcement in concrete structures  
**Autor:** Rasheeduzzafar / Dakhil, Fahd H. / Ahmad, Fouad A.  
**DOI:** <https://doi.org/10.5169/seals-35845>

## Corrosion Deterioration of Reinforcement in Concrete Structures

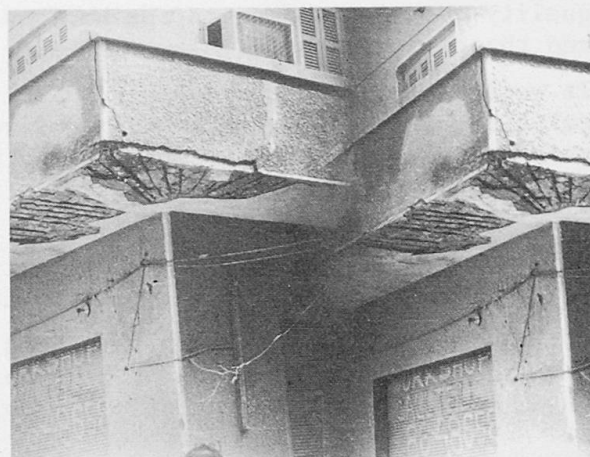
Figs. 5 and 6 show two structures which were condition surveyed and where concrete spalling has occurred as a direct outcome of visible heavy rebar corrosion. In each of these figures two pictures appear of the same structure on one photographic slide. Photogrammetric technique has been used for measuring the area of spalling and the results are shown in Table 2.

Structure No.	Total area under observation (m <sup>2</sup> )	Area showing cracking and initiation of Spalling (m <sup>2</sup> )	Spalled Area (m <sup>2</sup> )
1	4.65	1.19 (26%)	1.77 (38%)
2	4	0.13 (3%)	1.35 (34%)

Fig. 6 Structure 2 showing concrete spalling due to rebar corrosion
