Zeitschrift: IABSE reports = Rapports AIPC = IVBH Berichte
Band: 46 (1983)

Artikel: A method to assess the reliability of actual buildings
Autor: Zaupa, Francesco / Modena, Claudio / Odorizzi, Stefano
DOI: <https://doi.org/10.5169/seals-35858>

A Method to Assess the Reliability of Actual Buildings

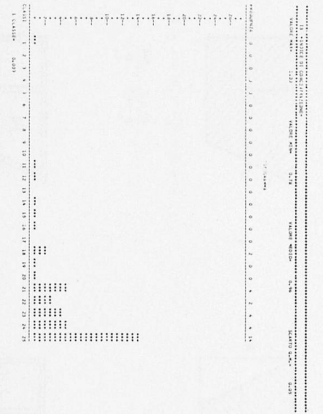
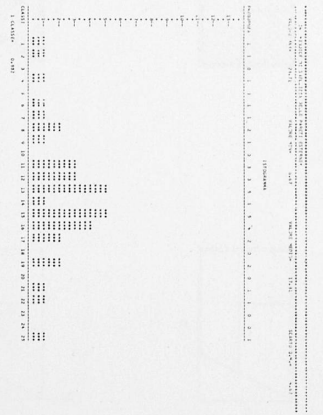
The reliability of the obtained results can be firstly judged by comparison of figures 5a,b, and figures 4a,b, where the statistical distribution of the global safety indexes obtained from the two formulations of the safety function proposed in [1] are plotted, for a slightly reduced sample.

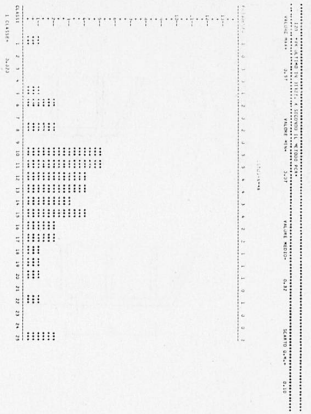
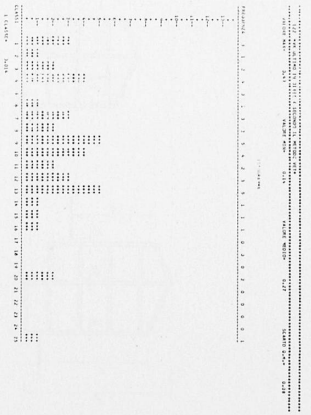
The statistical distributions of VK are shown in figure 5a(POR method) and 5b(VET method), for seismic forces acting in one of the principal directions of the buildings.
