Strengthening of Wooden Ceiling Constructions

Josef POSTULKA
Civil Eng.
Inst. for Culture-building Design
Bratislava, CSSR

The loading capacity and the stiffness of wooden ceiling constructions in historical buildings is usually not sufficient for modern demands. A method for strengthening of such wooden ceilings is recommended by coupling the wooden beams with an additional reinforced-concrete slab over them. After this strengthening the loading capacity and the stiffness increases cca 4x.

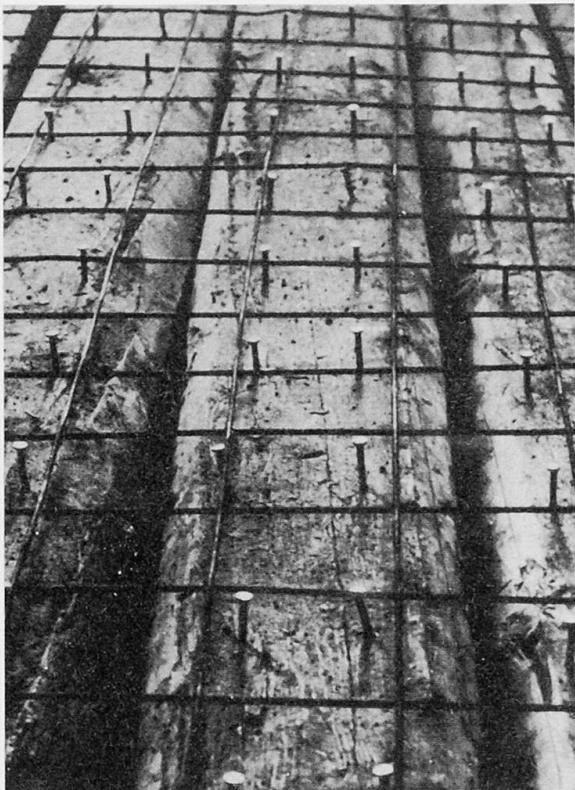
In figure 3 are the wooden beams tightly together, and in figure 4 there is the same ceiling under strengthening operation. The surface of the old wooden ceiling gets coupling elements such as steel nails driven in distances fixed by statical analysis. The nails stick out of the surface cca 40 mm.

Fig. 4. The strengthening of a wooden ceiling under construction

The nails are driven in by an electric percussion drill with a special inserted tool head in order to let the nails stick out of the surface with 40 mm. Fig. 4. Over the nails we lay down the wire net and the concrete slab can be made.

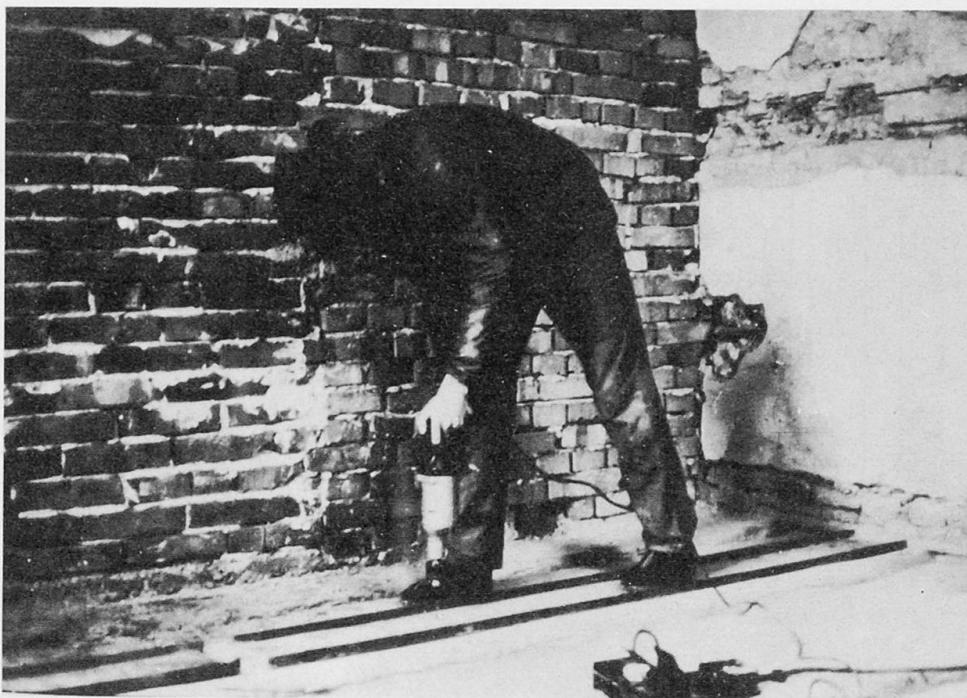
For the rough drilling we use a drilling template made of a thin perforated steel sheet. Fig. 6. The perforation of the template is made in distances ordered by the statical analysis.

Fig. 6. Rough drilling with a drilling template

After cleaning of the ceiling surface and after the chemical protection of wood by penetration it is necessary to rough drill the holes for the nails in the upper surface of the wooden ceiling. The depth of the holes has to be more than a half length of the nails driven in.
