Session 2: Inspection and monitoring

Zeitschrift: **IABSE reports = Rapports AIPC = IVBH Berichte**

SESSION 2

Inspection and Monitoring

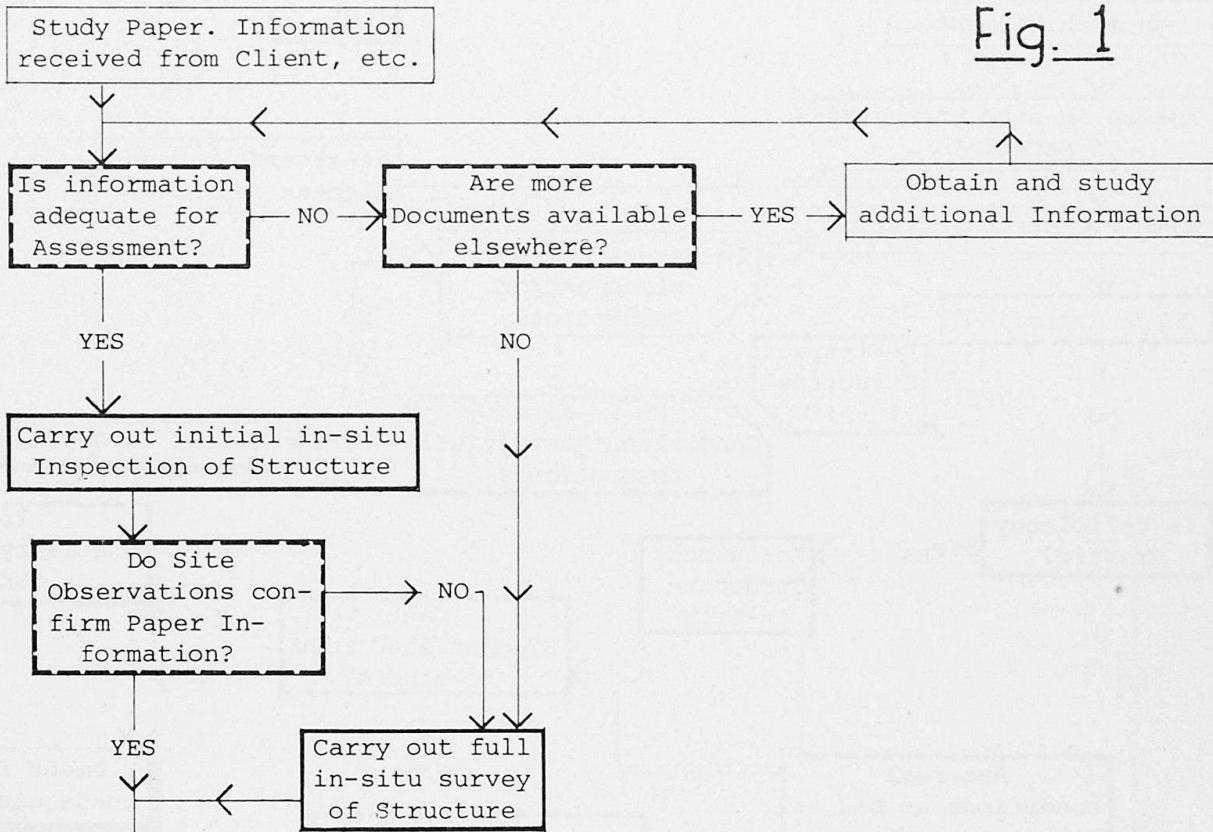
Fig. 1 illustrates the initial gathering of information. The first loop emphasises the need to obtain as much documentary evidence as possible: some effort at this stage may save a considerable amount of calculations and physical testing later. The other important operations are the site inspections: a) to make sure that the paper information is relevant to the actual building (and has not been superseded by a subsequent design alteration, lost in the meantime); b) to give the appraising engineer a first hand visual impression on how the structure performs in its present condition; this can be a very useful check on the validity of later calculations.

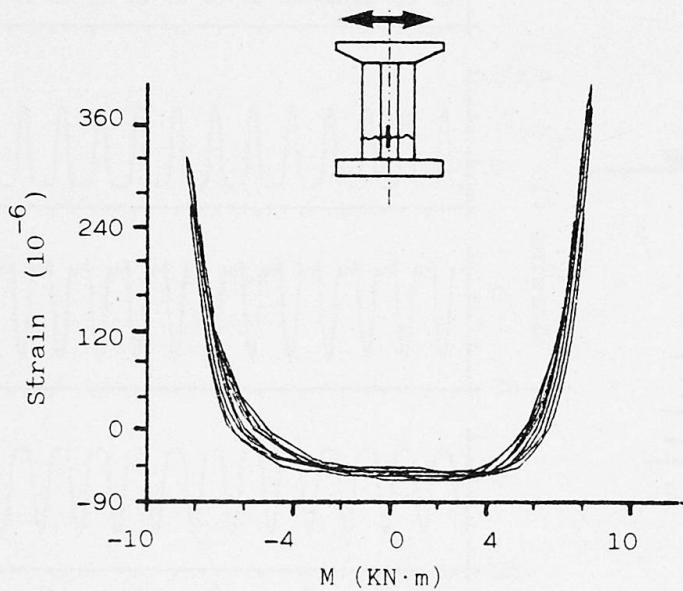
Fig. 9 Pier B: strains measured versus overturning moment across a crack on the "neutral axis" of the shaft.

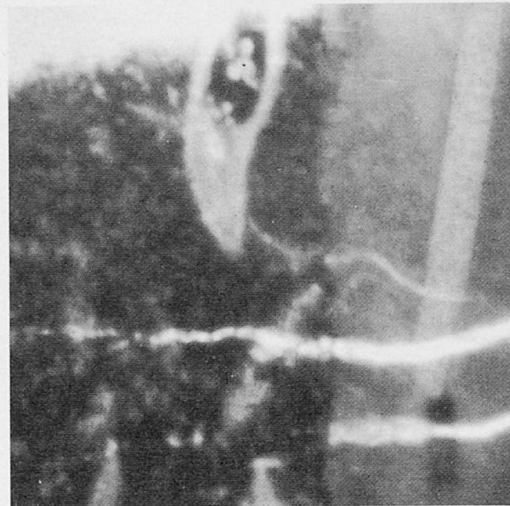
Fig. 12. Fluorescence. 65x.
Surface parallel cracks in a clay containing limestone used as building stone.
