Experimental and Theoretical Investigations of Existing Railway Bridges

Friedrich MANG

Oemer BUCAK

This paper describes an investigation of a complete bridge structure of the «museum railway» in the community of Blumberg as well as two bridge structures of the «Deutsche Bundesbahn». Results of component tests are compared with data taken from the literature as well as other results of similar investigations.

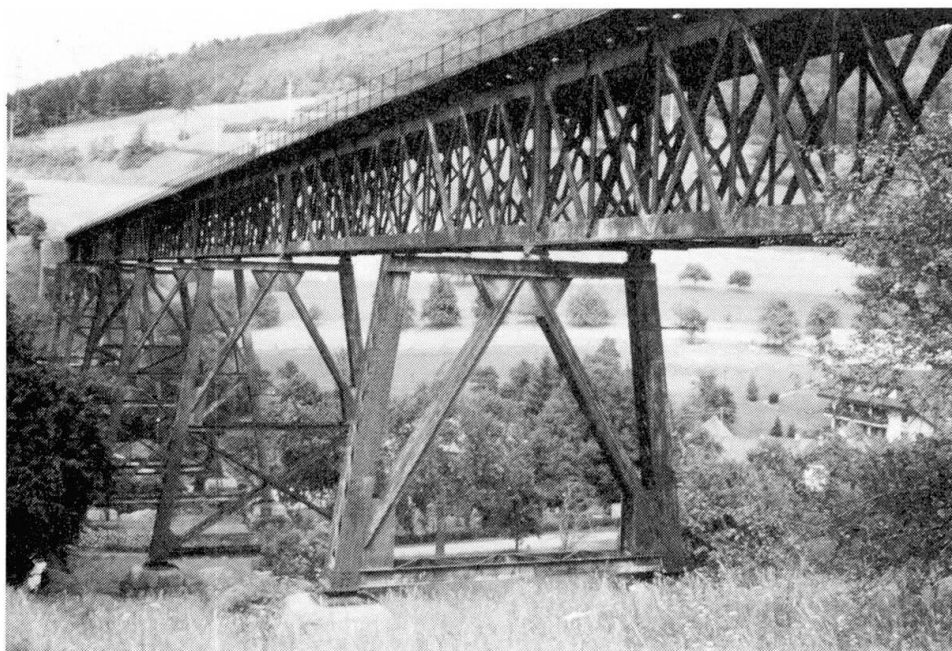
Fig. 2 Bridge of the "Museumsbahn"

At the "Versuchsanstalt für Stahl, Holz und Steine" tests were carried out on a whole bridge built in 1887 which had been chosen from different bridge systems of the "Museumsbahn" (Fig. 2).
