Zeitschrift: IABSE reports = Rapports AIPC = IVBH Berichte
Band: 62 (1991)

Artikel: Full-scale shear tests on two bridges
Autor: Plos, Mario / Gylltoft, Kent / Cederwall, Krister
DOI: <https://doi.org/10.5169/seals-47696>

Full-Scale Shear Tests on two Bridges

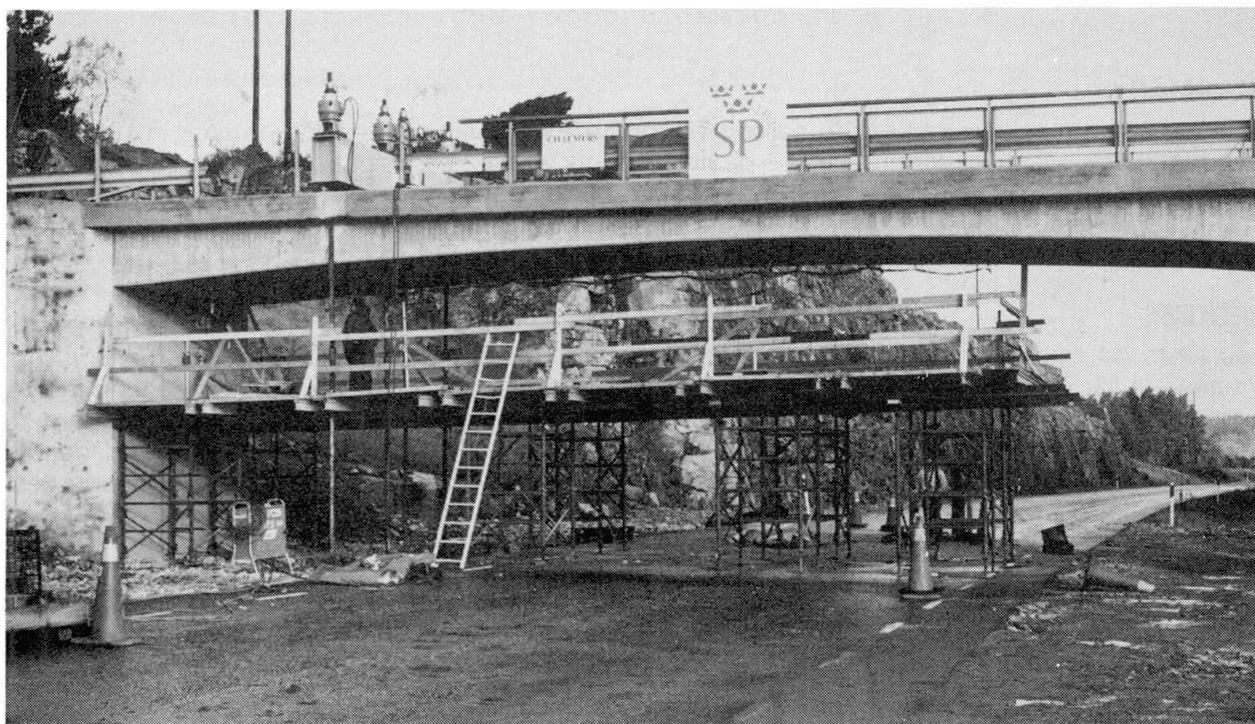
Fig. 1 Non-prestressed bridge during test preparation.

Full scale shear tests were performed on two concrete portal frame bridges. One of the bridges was a non-prestressed slab frame bridge with a free span of 21 m (fig 1 and 2).

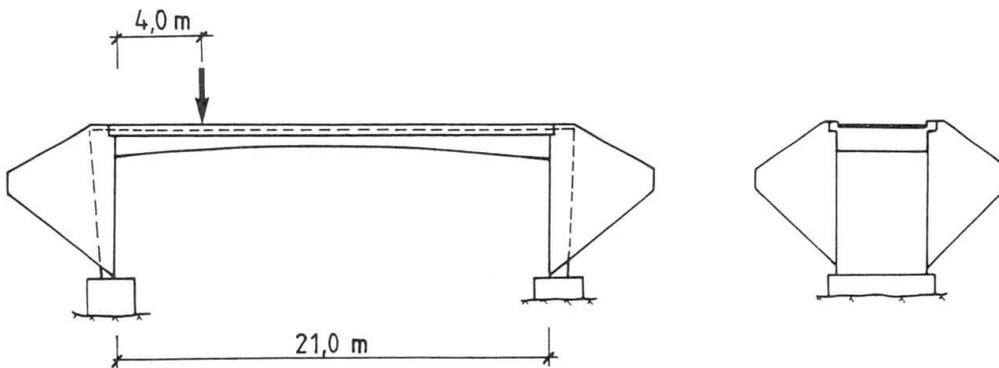
Fig. 2 Non-prestressed bridge

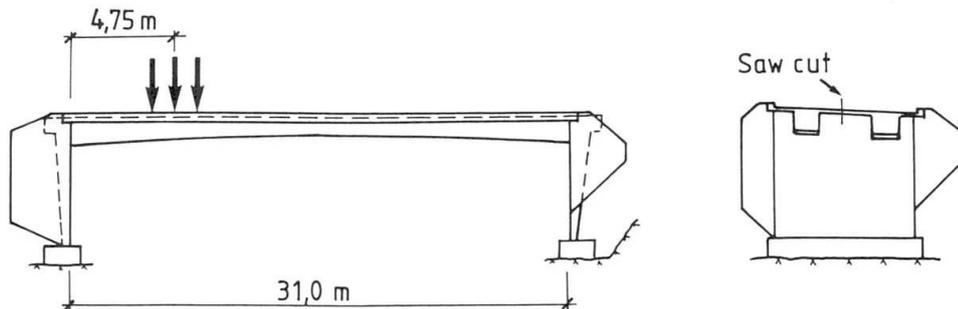
Fig. 3 Prestressed bridge

The other bridge was prestressed and had a free span of 31 m (fig 3 and 4). The span consisted of two post-tensioned beams connected by a bridge deck slab. The beams and the slab were connected with the front walls at the supports, forming a frame.

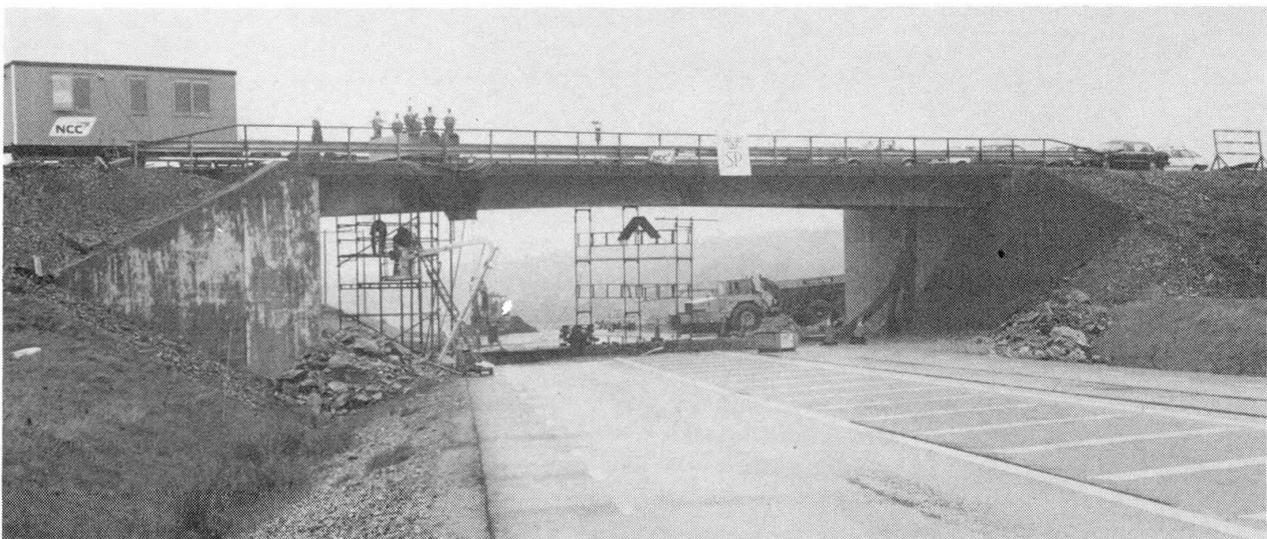
Fig. 4 View of the prestressed bridge

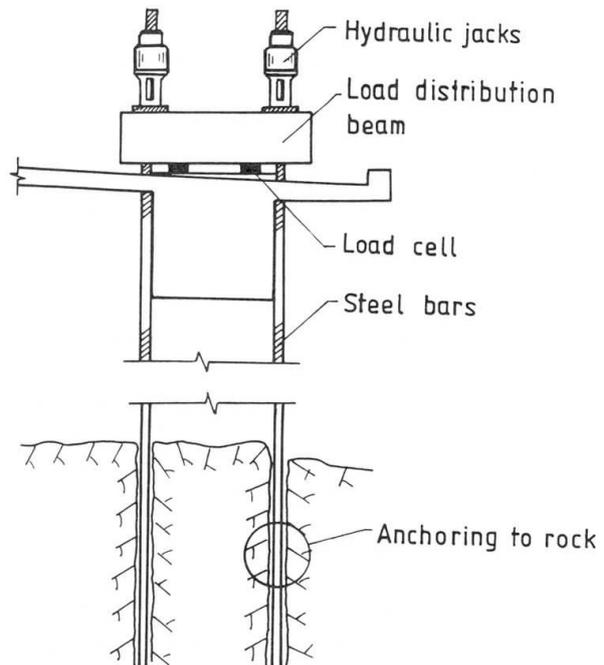
Fig. 5 Loading arrangement

The loads were applied through steel bars anchored to the rock under the bridges and transferred to the bridges by hydraulic jacks (fig 5). Loads, deflections and strains were measured during the tests, and crack growth was registered. The concrete strength was tested on cylinders drilled out of the bridges.

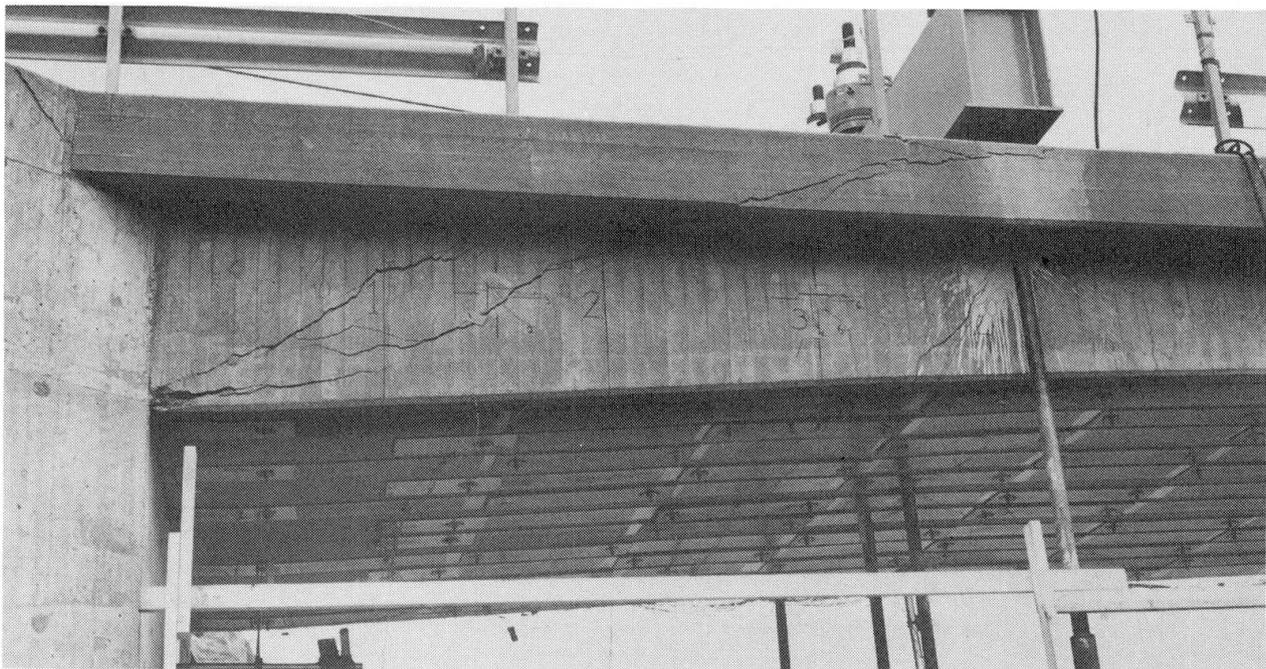
Fig. 6 Shear failure in the non-prestressed bridge

The non-prestressed bridge was loaded 4,00 m from one of the supports and failed at a load of 4,5 MN due to a sudden diagonal shear crack (fig 6). The bridge was substantially cracked due to bending, and some shear-bending cracks were observed close to the loading section before the failure occurred.

In the non-prestressed bridge a typical shear failure occurred. The moment and shear distribution of this bridge are under evaluation, but preliminary results indicate good agreement between the capacity according to the model in the code and test results.

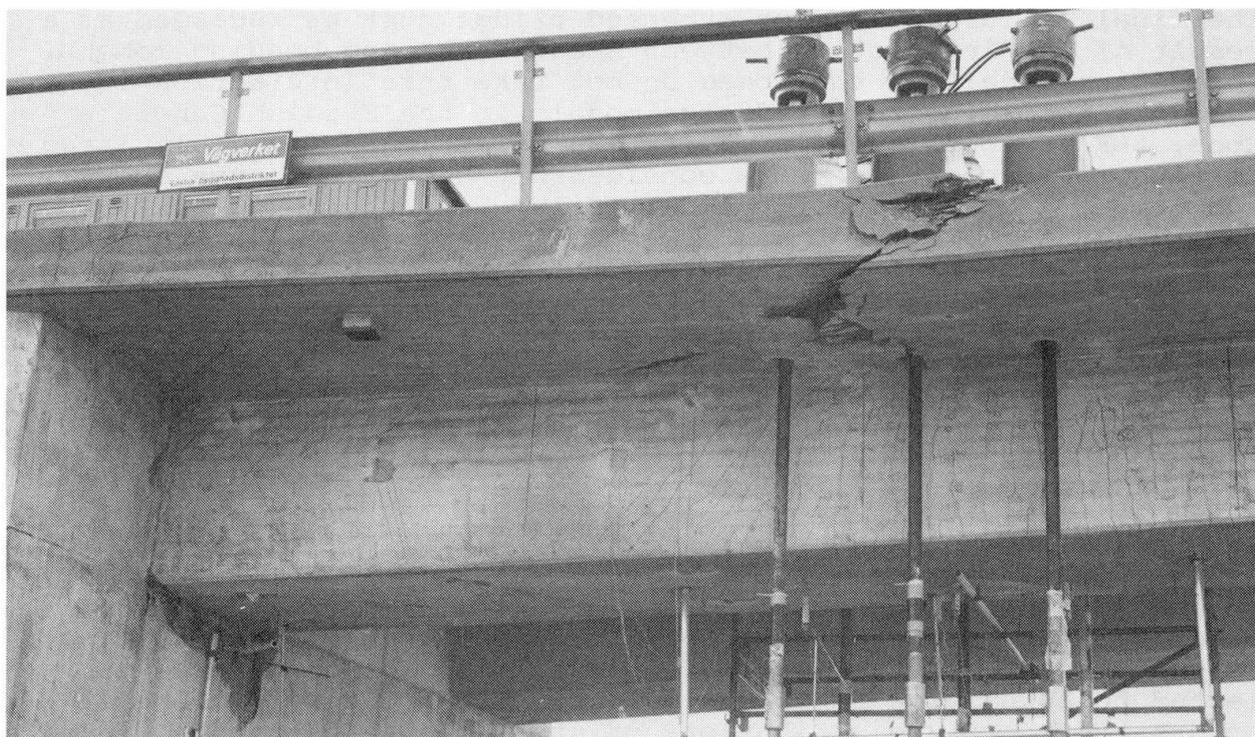
Fig. 7 Failure in the prestressed bridge. Cracking, support failure and concrete compression failure at the top of the loading section can be seen.

The failure of the pre-stressed bridge was more complicated. Before the test this bridge was cut longitudinally between the two main beams and one of the beams was loaded about 4,75 m from one of the supports. After extensive cracking due to bending, together with a few shear-bending cracks, the support closest to the load unexpectedly failed at a load of 8,5 MN. The support failure led to a redistribution of the moment, with increasing moment in the loading section.

When the support failed, the load decreased to 6,0 MN. Further loading with the jacks led to large deformations and several inclined cracks in the shear span. The final failure occurred at a load of 6,3 MN, when the concrete at the upper edge of the loading section crushed due to compression (fig 7).

The final failure in the prestressed bridge must be regarded as a result of the interaction between shear force and bending moment. The design models in the codes do not take this interaction into account. According to the design models in the Swedish Concrete Code, BBK 79, both shear capacity and moment capacity, calculated as separate capacities, were considerably higher than the shear and moment in the bridge at final failure.
