# Full-scale shear tests on two bridges

Zeitschrift: **IABSE reports = Rapports AIPC = IVBH Berichte**

Band (Jahr): **62 (1991)**

## Full-Scale Shear Tests on two Bridges

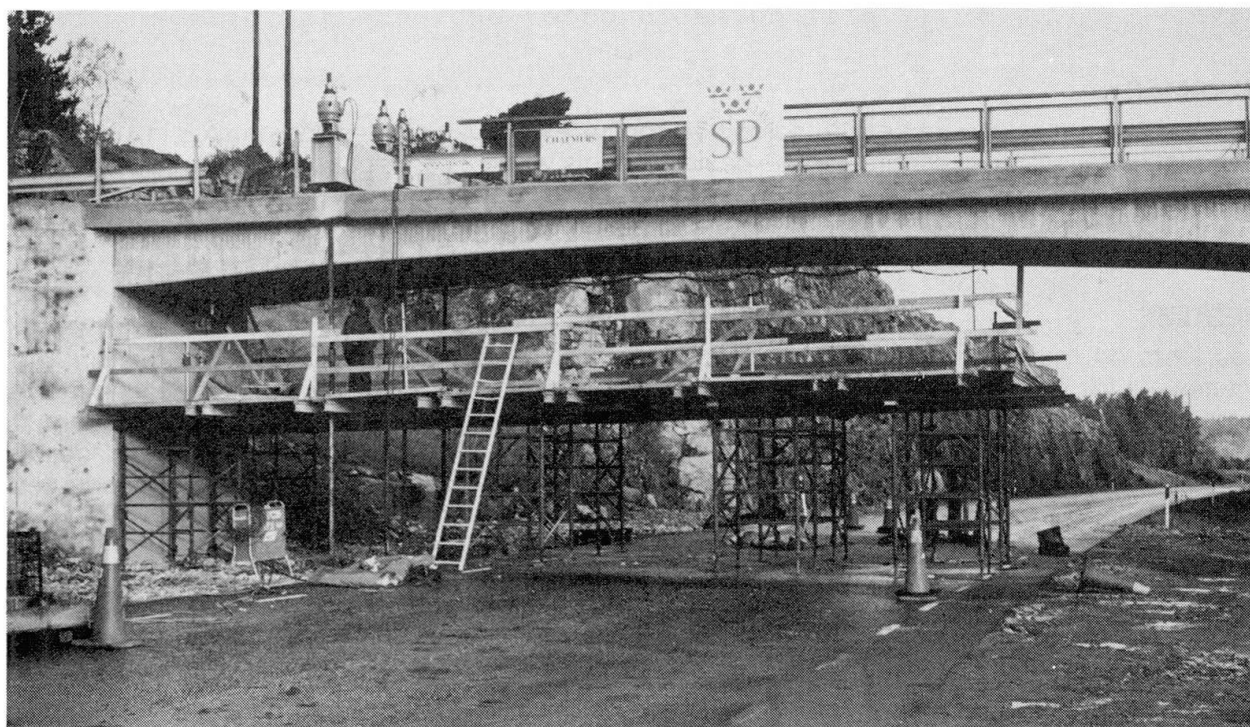
Fig. 1 Non-prestressed bridge during test preparation.

Full scale shear tests were performed on two concrete portal frame bridges. One of the bridges was a non-prestressed slab frame bridge with a free span of 21 m (fig 1 and 2).

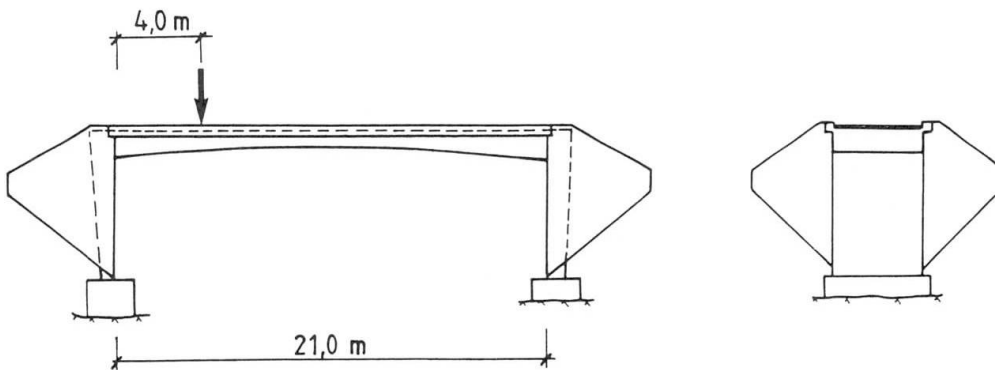
Fig. 2 Non-prestressed bridge

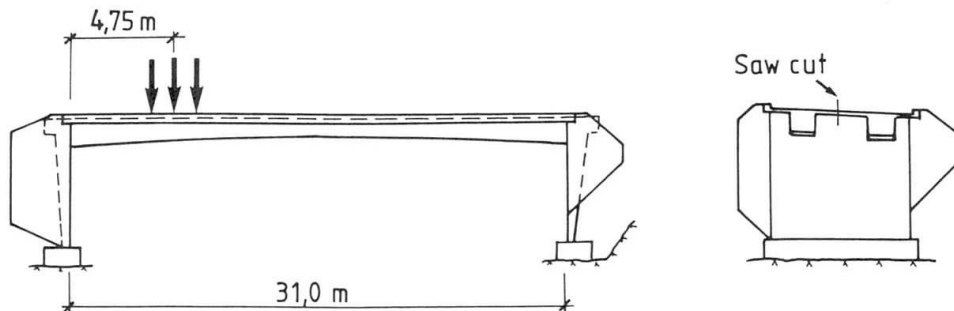
Fig. 3 Prestressed bridge

The other bridge was prestressed and had a free span of 31 m (fig 3 and 4). The span consisted of two post-tensioned beams connected by a bridge deck slab. The beams and the slab were connected with the front walls at the supports, forming a frame.

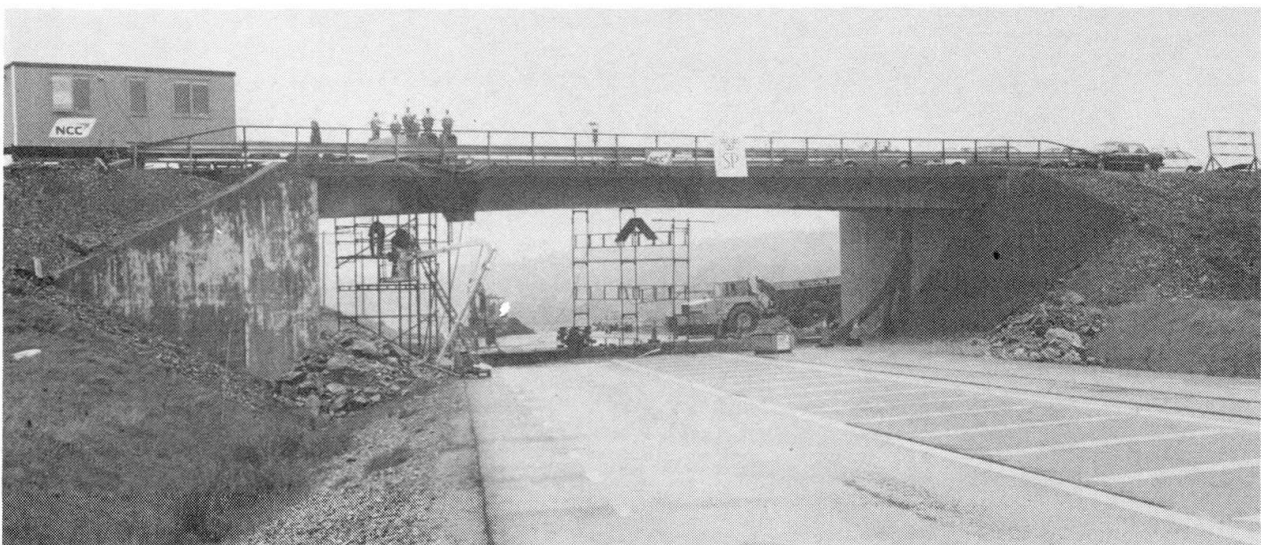
Fig. 4 View of the prestressed bridge

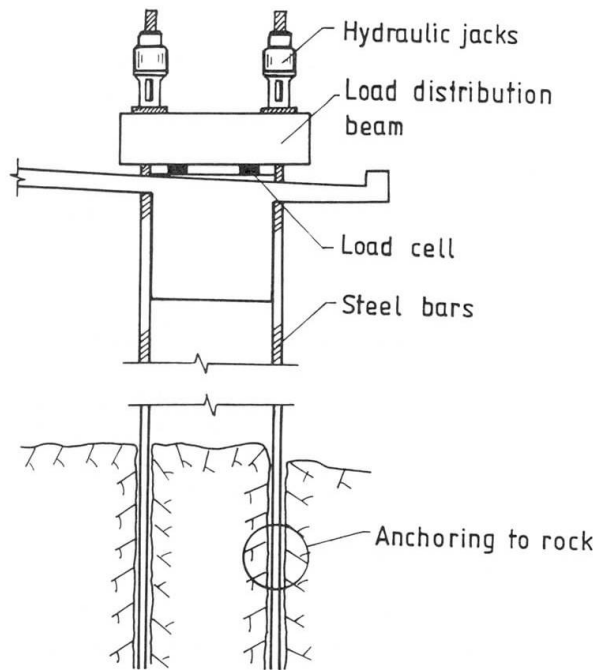
Fig. 5 Loading arrangement

The loads were applied through steel bars anchored to the rock under the bridges and transferred to the bridges by hydraulic jacks (fig 5). Loads, deflections and strains were measured during the tests, and crack growth was registered. The concrete strength was tested on cylinders drilled out of the bridges.

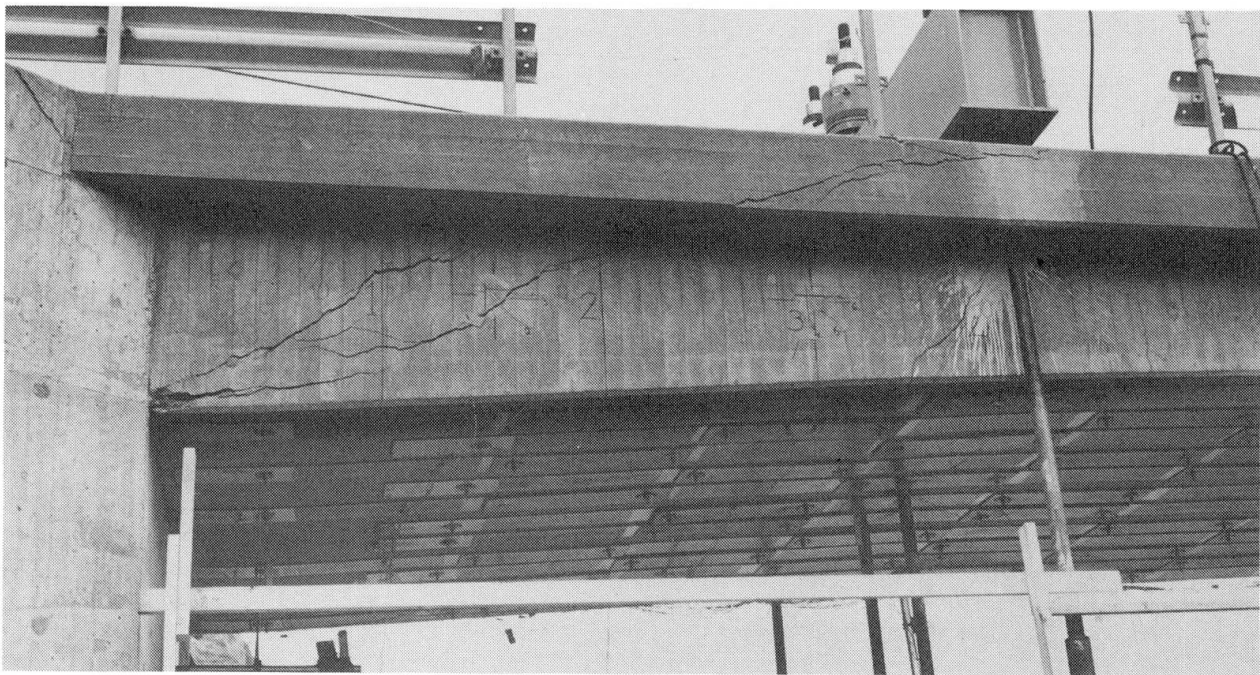
The non-prestressed bridge was loaded 4,00 m from one of the supports and failed at a load of 4,5 MN due to a sudden diagonal shear crack (fig 6). The bridge was substantially cracked due to bending, and some shear-bending cracks were observed close to the loading section before the failure occurred.

Fig. 6 Shear failure in the non-prestressed bridge

In the non-prestressed bridge a typical shear failure occurred. The moment and shear distribution of this bridge are under evaluation, but preliminary results indicate good agreement between the capacity according to the model in the code and test results.

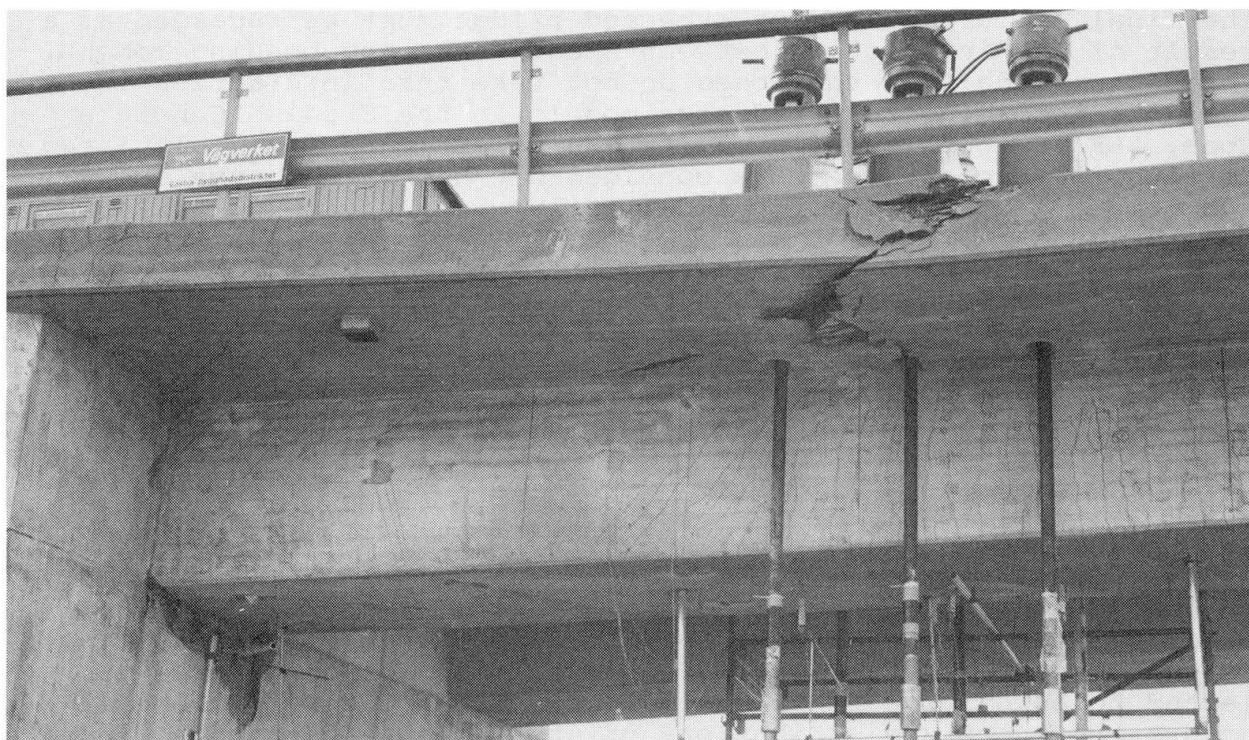
The failure of the pre-stressed bridge was more complicated. Before the test this bridge was cut longitudinally between the two main beams and one of the beams was loaded about 4,75 m from one of the supports. After extensive cracking due to bending, together with a few shear-bending cracks, the support closest to the load unexpectedly failed at a load of 8,5 MN. The support failure led to a redistribution of the moment, with increasing moment in the loading section.

When the support failed, the load decreased to 6,0 MN. Further loading with the jacks led to large deformations and several inclined cracks in the shear span. The final failure occurred at a load of 6,3 MN, when the concrete at the upper edge of the loading section crushed due to compression (fig 7).

**Fig. 7** Failure in the prestressed bridge. Cracking, support failure and concrete compression failure at the top of the loading section can be seen.

The final failure in the prestressed bridge must be regarded as a result of the interaction between shear force and bending moment. The design models in the codes do not take this interaction into account. According to the design models in the Swedish Concrete Code, BBK 79, both shear capacity and moment capacity, calculated as separate capacities, were considerably higher than the shear and moment in the bridge at final failure.

It should however be observed that the final failure was achieved at a load level lower than the maximal. The difference between calculated shear capacity and shear force in the bridge was much smaller at maximum load level than at the final failure. The moment in the loading section, however, increased considerably from maximum load level until final failure occurred. The effect of moment must therefore have a decisive influence on the failure.
