Performance Assessment of Cap-Column Joints Under Seismic Loading

Frieder SEIBLE

M. J. Nigel PRIESTLEY

An overview of joint damage in beam-column joints of multi-level bridge bents during the 1989 Loma Prieta earthquake, is presented. Assessment criteria for evaluating seismic performance characteristics and retrofitting schemes for existing concrete bridge structures, are developed. The application of analytical concrete models of various complexities in support of structural concrete design is demonstrated.

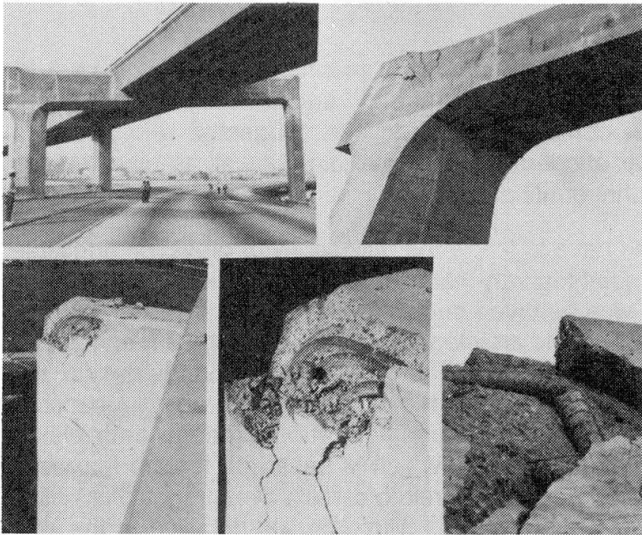
A single-deck outrigger bent (bent #38) with only a 0.92 m (3 ft) outrigger cap beam extension past the superstructure on I-980 featured heavy joint damage as shown in Fig. 1c,d,e. Built in 1985, the column was well confined with an interlocking spiral, see Fig. 3, however, this spiral did not continue into the joint region

A capacity check on the cap beam and column capacities showed that the cap beam capacity is critical for positive moment due to the insufficient anchorage length of 1.8 m (72 in.) for the $D = 57 \text{ mm}$ (#18) bars which, based on ACI 318-89, require a basic development length of 3.0 m (117 in.) which is likely to be on the conservative side. In the other loading direction (negative moment in the joint), the column capacity is critical. Joint shear force levels derived from simple stress models, Fig. 4, show joint shear stress levels of $0.37\sqrt{f'_c} \text{ MPa}$ ($4.3\sqrt{f'_c} \text{ psi}$) and $0.5\sqrt{f'_c} \text{ MPa}$ ($6.0\sqrt{f'_c} \text{ psi}$), under positive and negative moment loading, respectively, which are both above an assumed level of $0.33\sqrt{f'_c} \text{ MPa}$ ($4.0\sqrt{f'_c} \text{ psi}$), where diagonal tension cracking in the joint can be expected. Since the shear capacity of the 5 gauge wire spirals does not add significant joint shear capacity, the formation of any flexural hinge mechanism in adjacent members was inhibited. This explains the encountered diagonal joint crack patterns during the Loma Prieta earthquake, see Fig. 1c,d,e.

In addition to the diagonal crack patterns, large areas of cover concrete spalling along the outer cap corner as well as a ruptured $D = 57 \text{ mm}$ (#18) reinforcement bar which was bent on a 45 cm ($1'-6''$) radius were observed, see Fig. 1d,e.

Fig. 1 Outrigger bent joint damage

The first phenomenon of cover concrete spalling can be explained with the fully reversed cyclic loading. Under negative moment, flexural cracks open on the cap surface as shown in Fig. 3 and under subsequent positive moment loading, the entire compression force has to be transferred through the negative moment reinforcement until the cracks can close. These high compression forces in the negative moment reinforcement transferred to the concrete by bond, have a tendency to spall off the concrete cover between flexural cracks developed in the previous tensile excursions. The second phenomenon, the ruptured reinforcing bar, see Fig. 1d, points to a potentially critical problem which needs further investigation. Common ultimate strain levels in $D = 57 \text{ mm}$ (#18) $f_y = 414 \text{ MPa}$ (Grade 60) bars are in a range from 7 to 15%. Introducing a $R = 45 \text{ cm}$ (18 in.) radius bent into a $D = 57 \text{ mm}$ (#18 or $\phi = 2.25 \text{ in.}$) bar causes strain levels of $D/(2R) = 225/(2 \times 18) = 6.25\%$, which is close to the ultimate strain range. The very low strain reserves and possible strain aging effects which raise the notch ductile temperature at which steel will fail in a brittle mode can cause sudden failure in these bent bars at very low additional strain levels.

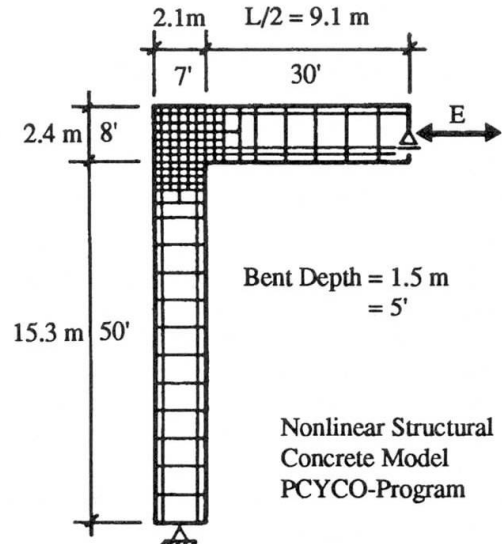
In addition to the simple stress models of the knee bent joint, detailed nonlinear finite element simulations, see Fig. 2, based on extended compression field principles were performed to determine analytically failure modes and joint deformation contributions to the overall bent deformations. Reinforcement development of straight bars was modeled by assuming a reduced yield level in the anchor zone decreasing linearly from the full yield at the ACI 318-89 basic development location to zero at the bar end. Subsequently derived yield patterns in bar anchorage regions therefore are indicative of bond failure or slip. Superimposed to the dead load case, the half bent, Fig. 2, was subjected to lateral force, and force-deformation envelopes with major event indicators, depicted for positive moment loading in Fig. 5, were obtained. Associated crack, slip/yield and first crushing patterns, see Fig. 5, indicate the failure mechanisms in the joint region. The heavy yield in the joint center, both horizontally and vertically, indicates the deficiency of both vertical and horizontal joint shear reinforcement, particularly under negative moment on the joint. Also, the crushing of the concrete in the outer joint region under the bent negative moment reinforcement under loading to the left or negative moment indicates the high compressive stress state and associated transverse prying forces in this region and the need for sufficient transverse confinement reinforcement, as outlined by Schlaich et al. [2], for strut and tie models for negative moment knee joints.

Fig. 2 Analytical bent model

Since joints should be detailed based on capacity considerations such that the major inelastic action occurs in the cap or column, and since they should remain effectively elastic for small seismic disturbances (Paulay et al. [4]), the nonlinear finite element analysis was repeated with a linear elastic joint for a direct comparison of deformation limit states. As can be seen from Fig. 5, while joint deformations did not contribute significantly to the initial overall structural deformations, the failure mode in the positive moment direction shows improved ductile behavior when the failure mechanism is shifted from joint distress to flexural cap beam hinging. It should be noted that the cap beam capacity still may be artificially low due to the reduced yield strength in the bottom $D = 57 \text{ mm}$ (#18) reinforcing bars based on a reduced development length according to ACI 318-89. Negative moment loading behavior is also improved by forcing the yield mechanism clearly into the column (not shown). Since the bent joint failure is the critical link in the overall behavior, repair/retrofit of these joints is a logical next step.

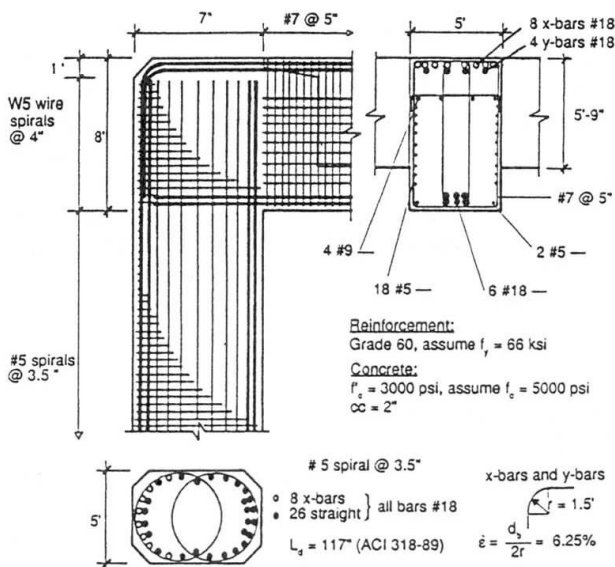
where it was replaced by a 5 gauge wire spiral with $D = 5 \text{ mm}$ at 10 cm ($\phi 0.2 \text{ in. @ } 4 \text{ in.}$). Also, the cap beam reinforcement, aside from the top and bottom bars, see Fig. 3, did not extend into the joint region.

Fig. 3 I-980, #38, Reinforcement details

Detailing for repair or retrofit of the damaged knee joint on I-980, bent #38, can be derived using either strut and tie models as outlined in Fig. 3 with additional considerations as outlined in [2] for transverse splitting under negative moment and tie back for fully reversed cyclic loading, or directly from the force states derived from the compression field analysis, see Fig. 5. A possible repair measure consists of providing an additional 23 cm (9 in.) concrete jacket around the existing joint with horizontal and vertical distributed joint reinforcement and a diagonal corner tie back based on force and reinforcement quantities derived in Fig. 4. The damaged joint concrete can either be removed and the joint rebuilt completely or the damaged joint can be epoxy injected subsequent to removal of loose concrete, roughening of the interface, and adequate doweling bonding of the added structural concrete jacket.

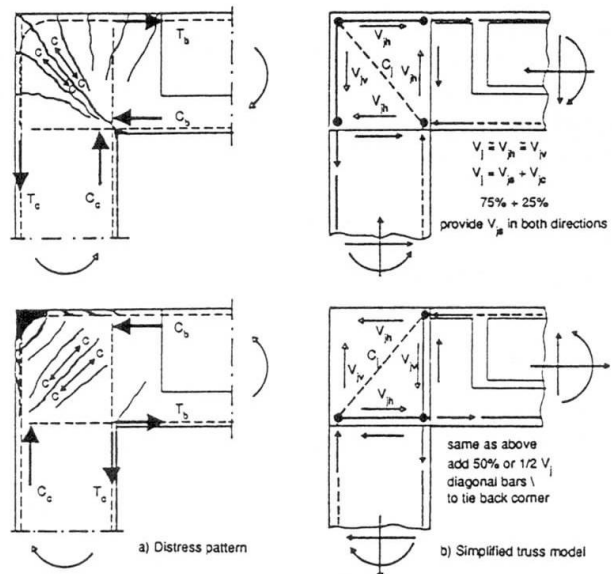
Fig. 4 Joint behavior models

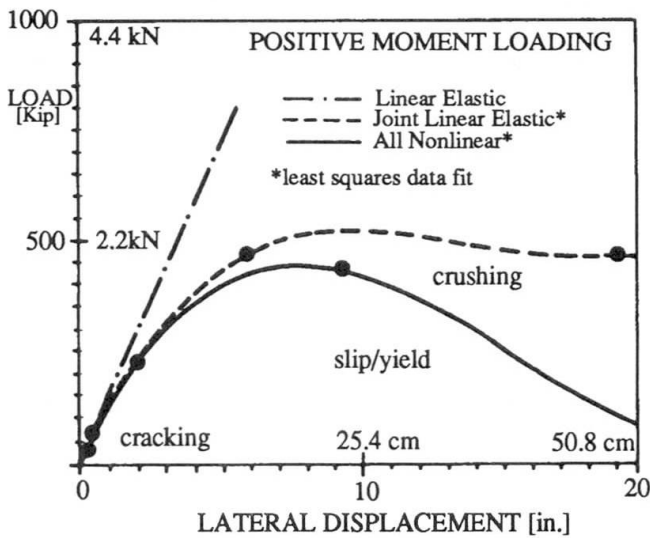
Fig. 5 Positive moment limit states

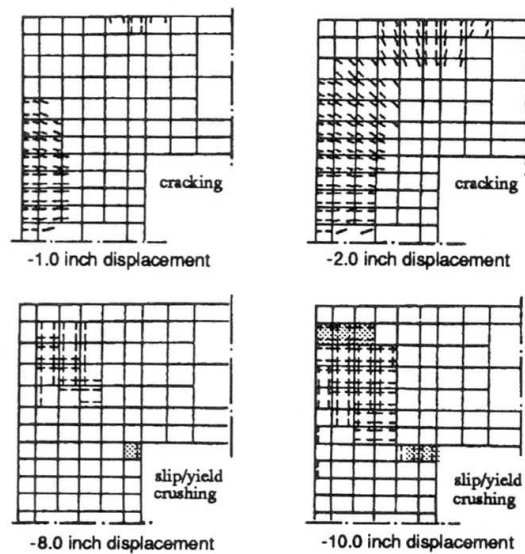
Fig. 6 Negative moment distress patterns
