Testing the Steeple of the Peter and Paul Cathedral in Saint Petersburg

Jossif RACHA

Civil Eng.
Institute of Steel Structures
Saint Petersburg, Russia

The steel steeple with a cross of 60 m in height (from el. + 60.0 to el. 120.0) was erected in 1857 in place of a wooden one destroyed by fire. When examining the cathedral structures in 1991, cracks were found in the masonry at an el of 40.0 m in a place where the steeple anchoring beams had been built in.

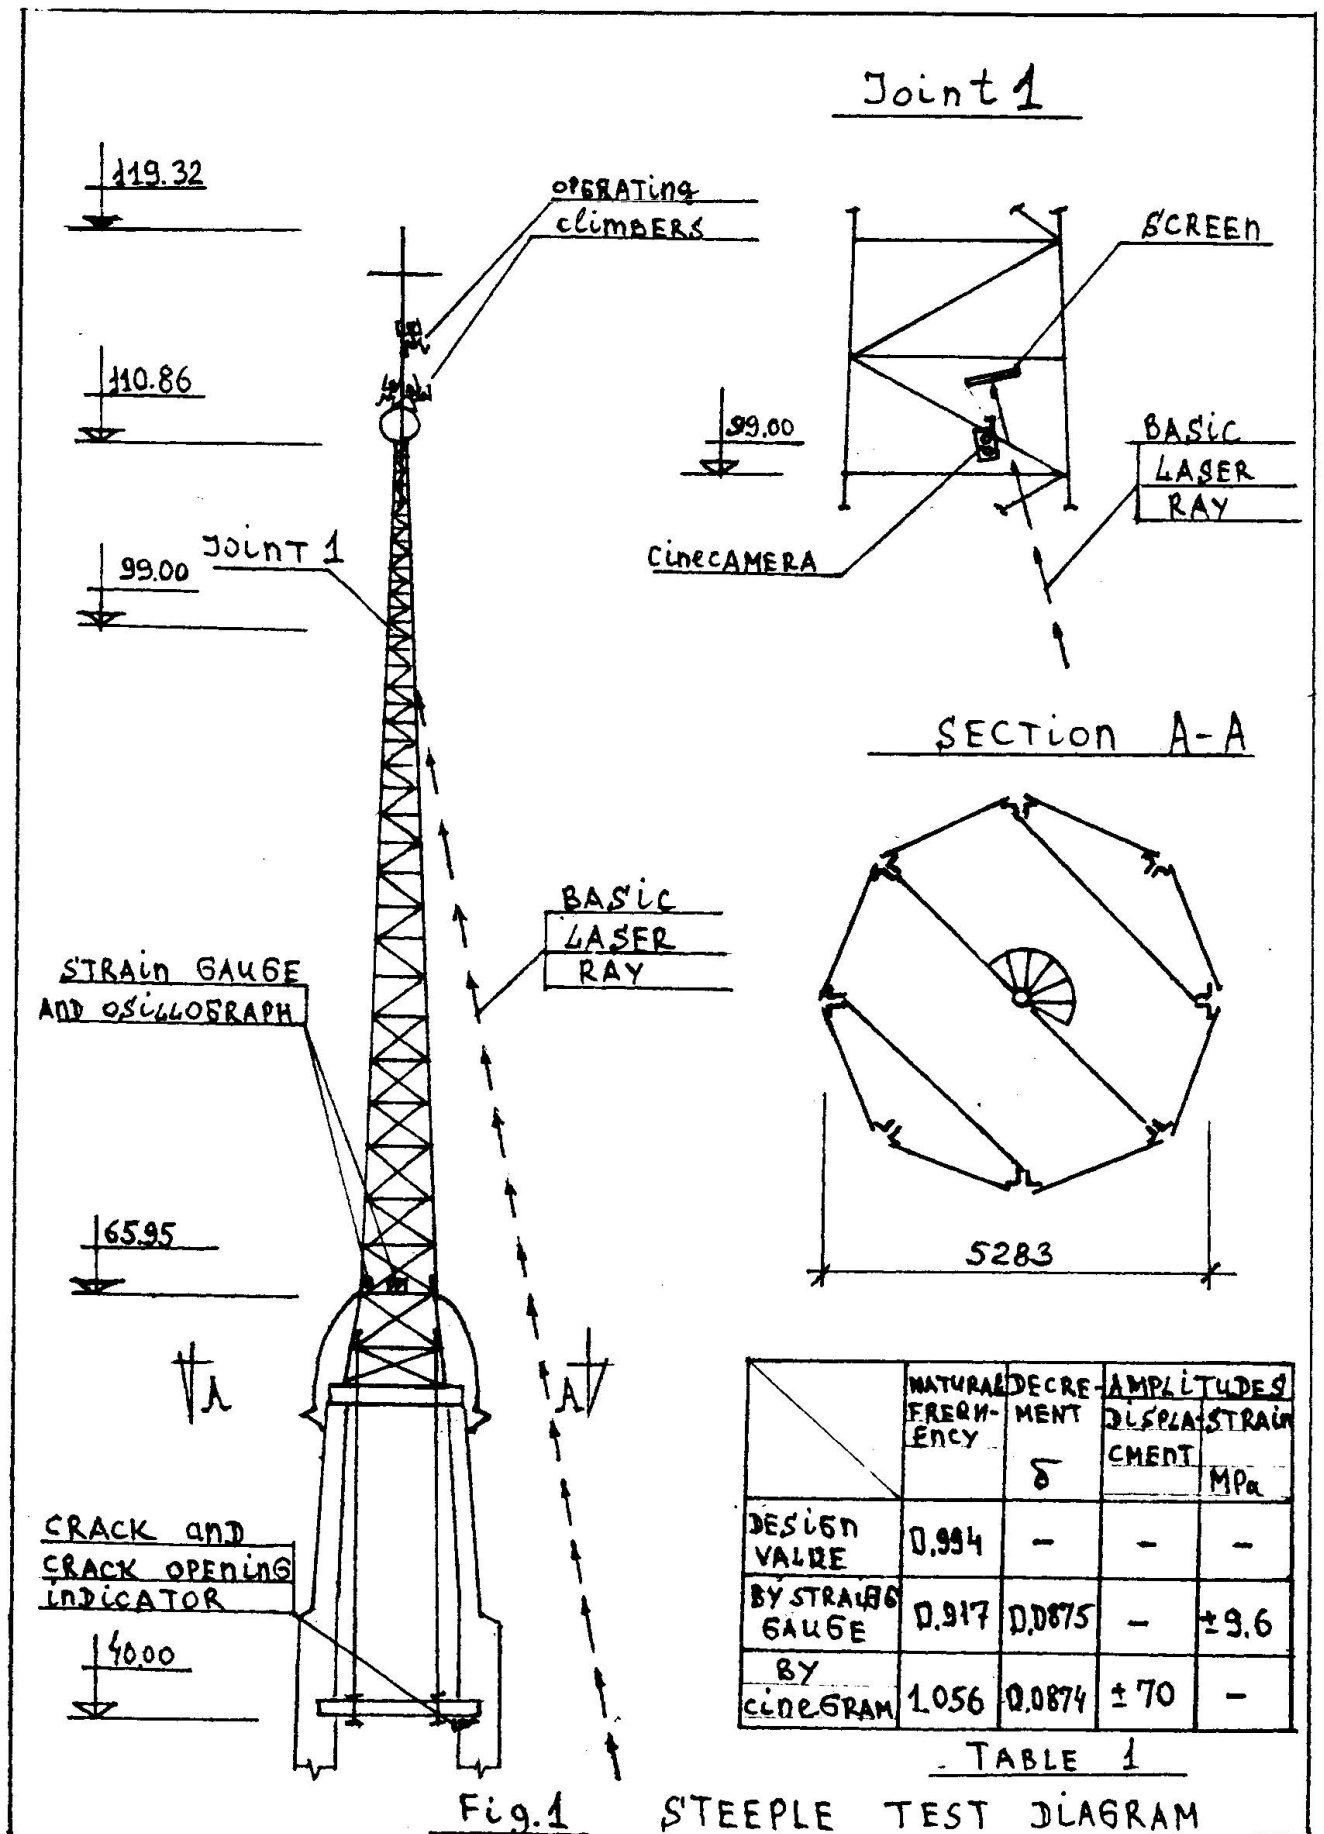
In the cracked area at an elevation of 40.0 m, vertical displacement was recorded of the steel supporting beam relative to the brick masonry with an amplitude of ± 0.01 mm at a maximum amplitude of the steeple 70 mm at an el. of + 115.0.

The diagram of the tests is shown in Fig. 1. The results are presented in Table 1.
