# Damage and repair of St. Charles Basilica in Rome

## Damage and Repair of the St. Charles Basilica in Rome

### SUMMARY

The paper reports on studies of damage and solutions proposed for the restoration of the dome of the St. Charles Basilica in Rome. The study is based on the results of an indepth program of investigation on the soil conditions, the building materials and the analysis of the behaviour during this period. The data has been recorded by a computer connected to a monitoring system. The assessment of the safety levels was performed with the support of mathematical models, by studying historical information and a permanent analysis and comparison of theoretical results with reality.

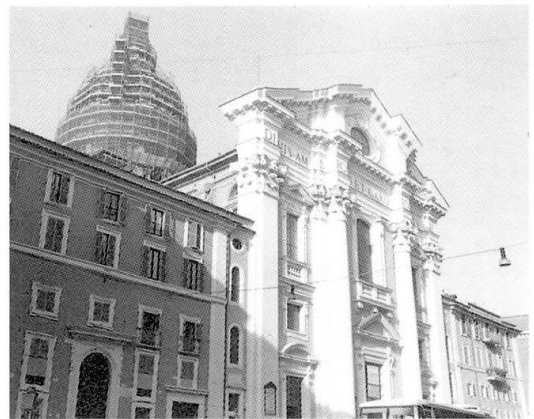
Fig. 1

The construction of the church began in 1612, after Pope Paul V canonised St. Charles Borromeo. It was finished in 1684 with the completion of the façade (fig. 1).

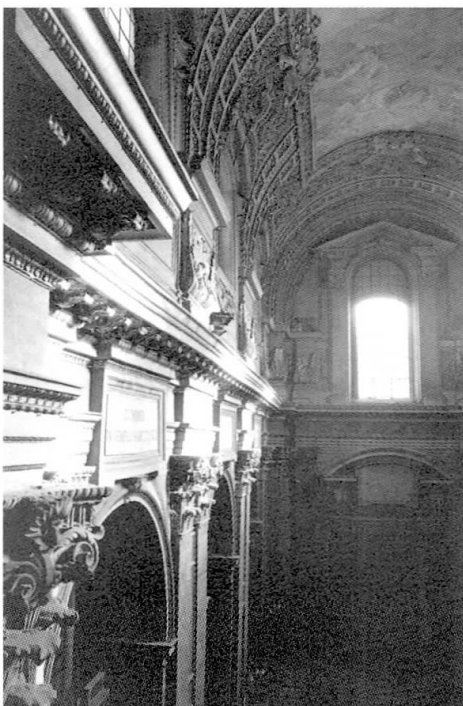
Fig. 2

At the death of Onorio the project continued under the guidance of his son, Mario Longhi, with successive interruptions due to lack of funding, the most important being the interruption which occurred from 1625 to 1642, during which the central vault was absent; this probably lead to large deformations of the columns in the central nave that are now out of plumb by about 10cm (fig. 2).

Longitudinal cracks are present along the lateral nave in the keys of the vaults, these are associated with a pronounced deformation of the columns along the central nave and a macroscopic deformation of the cornice (fig. 2).

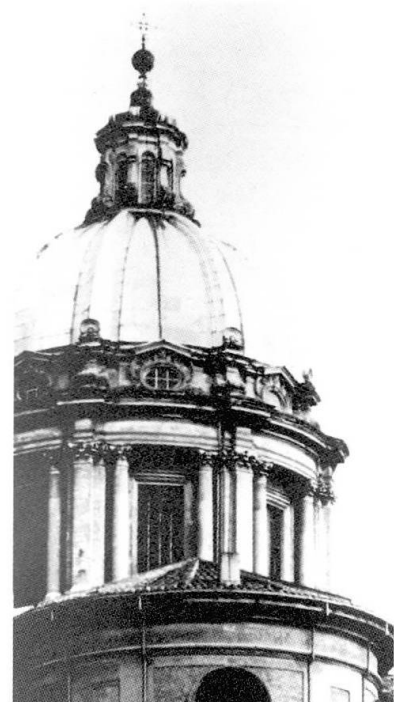
Fig. 3

The drum and dome were built in 1668 and 1669 under the direction of Pietro Berrettini (known as "il Cortona") (fig. 3). By the time Rome was affected by the strong earthquake, which caused damage and failures in the Colosseum, in 1703, the building was completed.

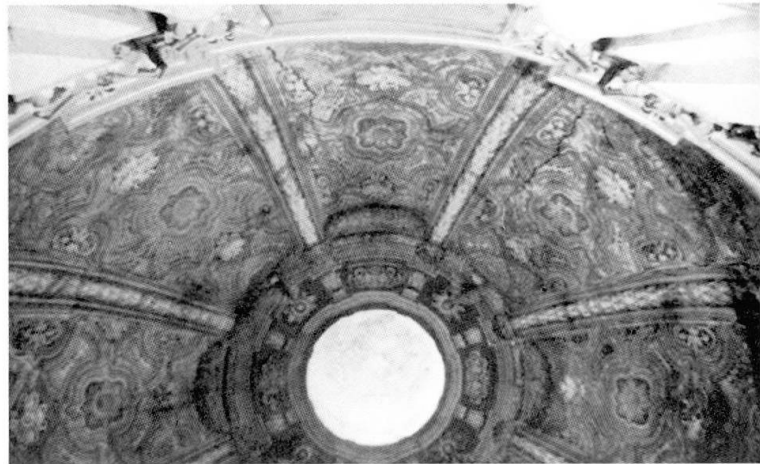
Fig. 4

The church has suffered from large scale cracking present in the dome, the vaults of the lateral naves and the vaults of the preambulatory (in general they are diagonal and symmetrical about the longitudinal axis of the church), some cracks are also present in the walls, the crypt, the paving and in the floor above. The cracks in the dome are rather serious, being of the amplitude of a few centimeters (fig. 4); they follow the meridian curves and are concentrated around the ribs, where the architectural requirement of emphasizing the ribs lead to a reduction of the dome section immediately next to them, they continue along the drum and also affect the fan arches connected to the drum.

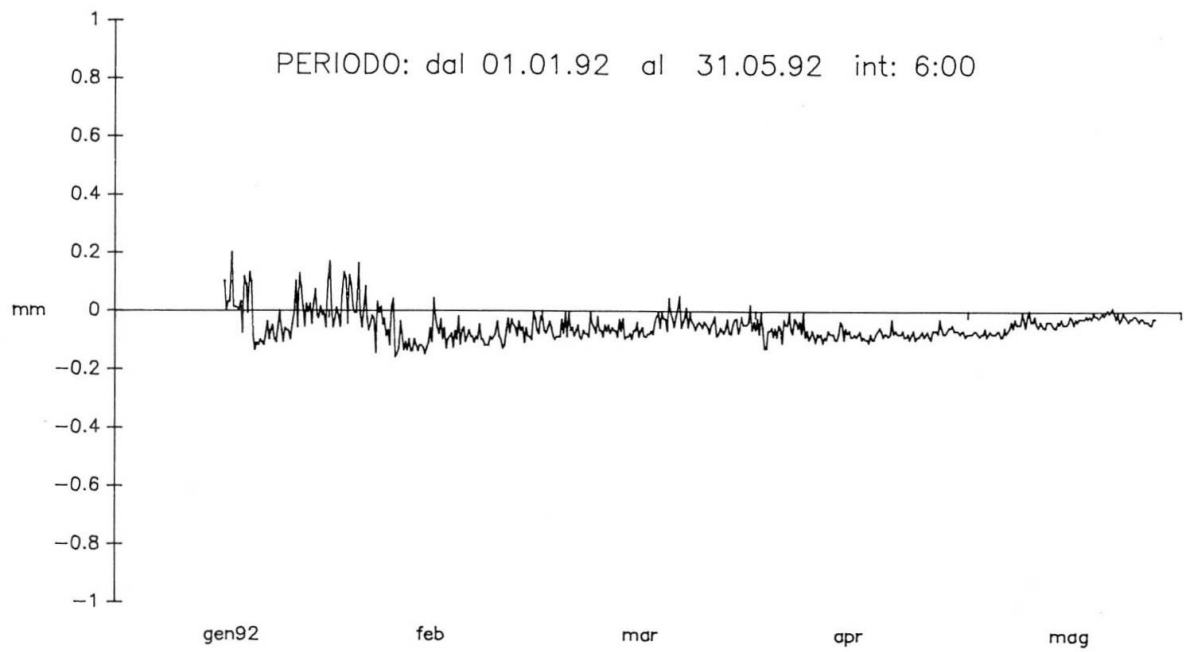
Fig. 6

During the control period, which took place, with interruptions, for over three years, no sign of evolutionary phenomena linked to the cracking was observed; however the longitudinal cracks showed a high sensibility to both the daily and seasonal temperature cycles, probably caused by the fact that these cracks represent a hinge which

runs along the centre of the basilica and along which the thermal deformations take place (fig. 6).

## S.CARLO-MIS.DI DEFORMAZIONE CH.20 (CV.12) – CRIPTA
