Autor(en): **Page, John**

Zeitschrift: **IABSE reports = Rapports AIPC = IVBH Berichte**

Band (Jahr): **70 (1993)**

Repair and Strengthening of Arch Bridges

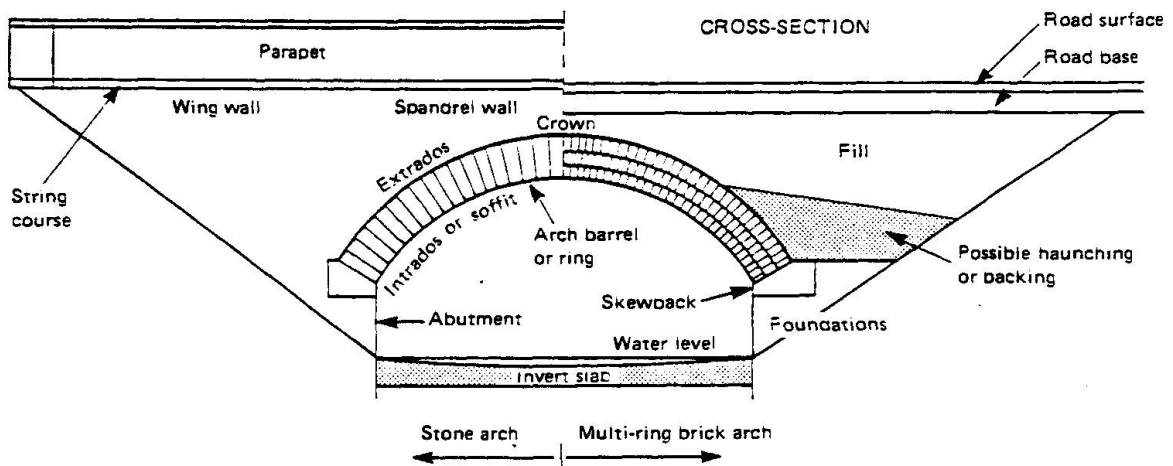
Many of them have deteriorated due to the effects of weathering and traffic: some of the traffic they are now required to carry is much heavier than was envisaged when they were built. There are a variety of commonly used repair and strengthening methods used to maintain their function or to increase their load carrying capacity. This paper discusses the common types of deterioration and the effectiveness and cost of some repair and strengthening methods. Typical construction of masonry arch bridges is shown in figure 1.

Fig 1 Typical masonry arch bridge construction

An invert slab (see figure 1) is a slab of concrete or masonry placed between the abutment walls or piers with its top surface at or below river bed level. It helps to prevent scour. If incorrectly installed however, there is a risk of scour beneath the slab, particularly at its downstream end, and this was found in one of the cases studied.

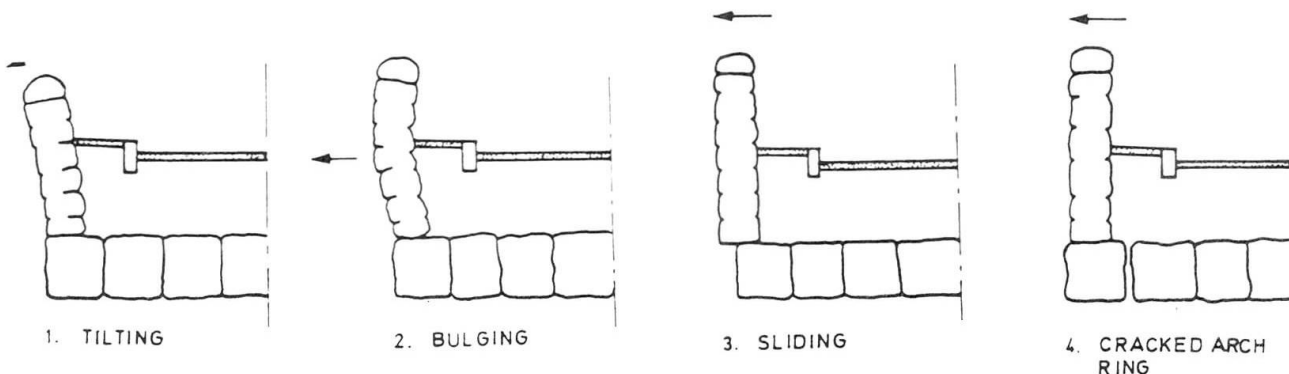
Spandrel walls probably represent the biggest single problem with masonry arch bridges. They suffer from the normal problems associated with exposed masonry such as weathering and loss of pointing. They are also frequently affected by dead and live load lateral forces generated through the fill or as a result of vehicle impact on the parapet or by freezing of the fill. The effect may be (see figure 3) outward rotation, sliding on the arch ring, cracking of the arch ring, or bulging.

Fig 3 Spandrel wall failures
