Artikel: Strengthening of a 400 year old Ottoman Minaret
Autor: Penelis, George / Papayianni, Ioanna / Stylianidis, Kosmas
DOI: <https://doi.org/10.5169/seals-53355>

Strengthening of a 400 Year Old Ottoman Minaret

The Minaret of Rotunda in Thessaloniki was built in 1590. The structure has a total height of 36m and is made of stone and brick masonry. The monument has been damaged by several strong earthquakes. During the earthquake of June 1978 the damage increased dangerously. This paper presents the procedure followed for the assessment of the bearing capacity of the structure, including in situ measurements, laboratory tests and geotechnical-seismological studies of the area. Finally, alternative strengthening solutions are analyzed and evaluated.

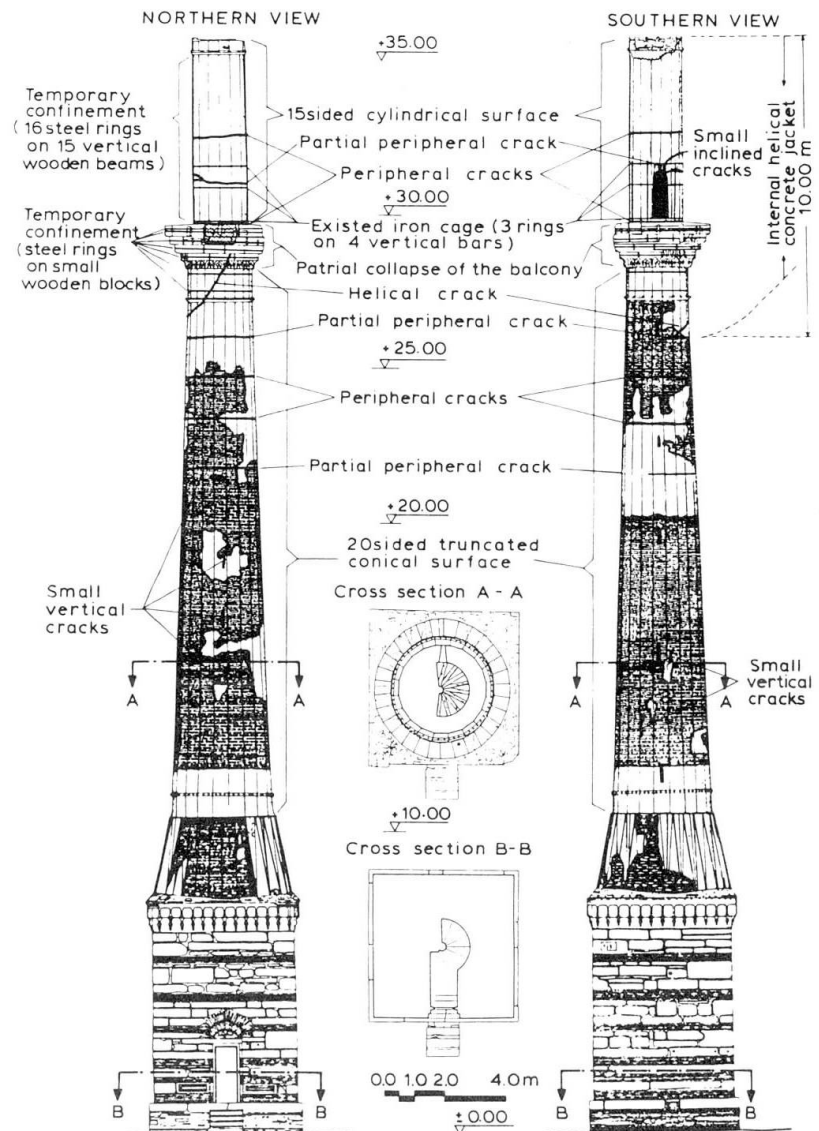
Fig.2 Northern and Southern elevations of the Minaret. Cracking pattern, external emergency interventions

As it can be easily seen in Fig.2, the base of the Minaret is unplastered. The plaster covering has been collapsed at the major part of the trunk, while at the rest of the surface, as well as at the upper cylindrical trunk, it is heavily cracked. Limited superficial deterioration of masonry, especially at the northern face of the trunk has been detected and confirmed by the hammer tests. The wooden beams at the highest steps of the staircase have been heavily corroded due to rain water passing through the open top, as the wooden acute conical roof of the Minaret fall down, probably during an earthquake, at the beginning of the

present century. Successive horizontal peripheral cracks have been ascertained at the upper two fifths of the Minaret and have been drawn in Fig.2. There is one helical crack starting from the highest loophole, following the ascending steps and cutting the balcony. All the cracks, being under vertical compression, are just visible (see Fig.1b). During the earthquake of June 20,1978 (epicenter 30km from Thessaloniki, magnitude 6.5 grades in Richter scale) a part of the balcony collapsed and the upper half of the cylindrical trunk was slightly translocated (see Fig.1d,2). It must be pointed out that, despite of the damages, no permanent horizontal drift of the structure has been ascertained and no foundation problem has been detected.

Emergency works were undertaken just after the 1978 earthquake including general external scaffolding (see Fig.1a) and temporary external confinement by steel rings and wooden beams as well as internal helical concrete jacket at the upper 10m of the Minaret (see Fig.1d,2).

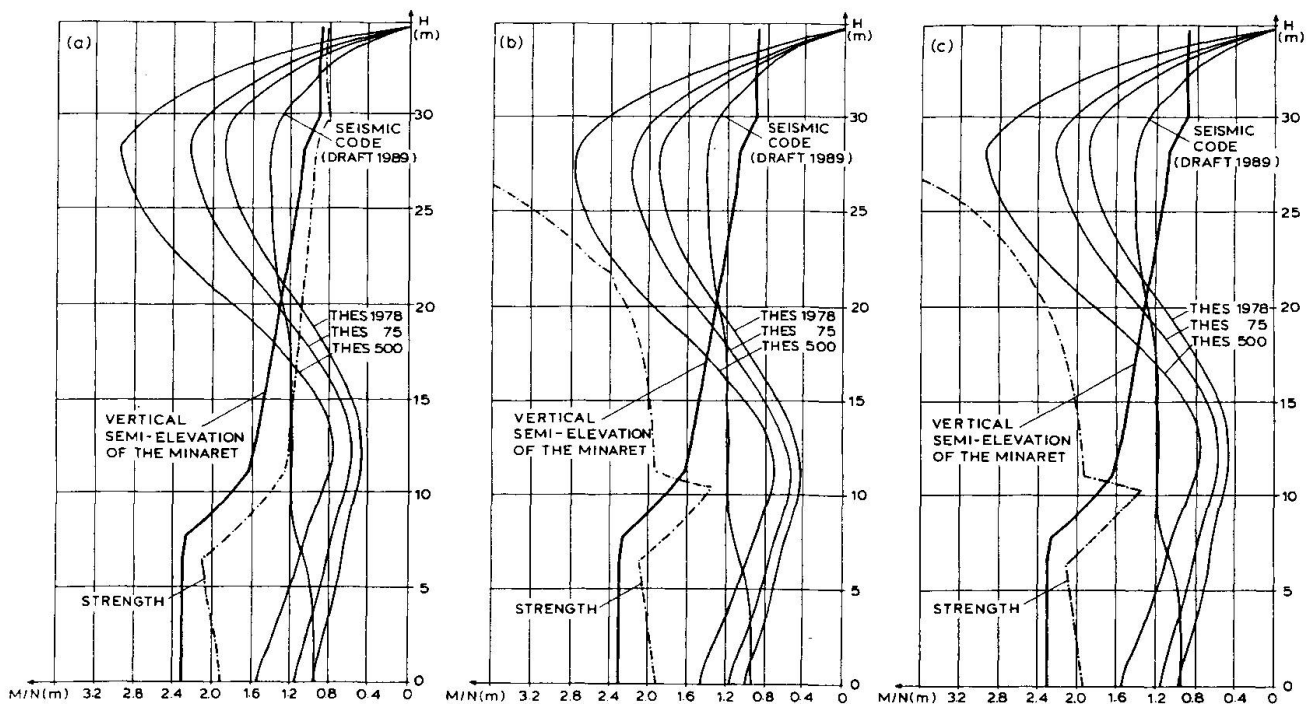
Fig.5 Eccentricity curves under seismic spectra and strength eccentricity curve: (a) Virginal state, (b) Concrete jacket, (c) External steel strips

The structure at its virginal state was analyzed under the four design spectrums of Fig.4. The corresponding results are presented in Fig.5a by means of eccentricities of the dead load axial forces due to seismic bending moments ($e = M/N$). It must be pointed out that these diagrams are more informative than the conventional bending moments and axial forces diagrams since they include their combined action on the structure. From Fig.5a it is obvious that over the height of about 17m, where the eccentricity curves surround the semi-elevation of the structure, the masonry, having an almost zero tensile strength, is inadequate to carry the pair of (N, M) since the axial forces act outside of the cross section.

In order to determine more precisely the region of the structure which needs to be strengthened, the strength curve shown in Fig.5a was determined with the aid of a specific computer program which can calculate the ultimate bending moment, under a given axial force, of a polygonal section composed of various materials (masonry, concrete, steel) and given stress-strain relations of the materials (see Fig.3). It can be seen that under the height of 14m, the structure is adequate to carry out the combination of dead and seismic loads. In order to secure a reasonable safety factor, slightly greater than one, it was decided that the region to be strengthened extends from 12m height to the top of the structure.

of the structure. In Fig.5b, the eccentricities of the axial forces due to seismic bending moments under the design spectrums of Fig.4 are shown. It is obvious that, in comparison to the relative curves of Fig.5a, the differences are small. The calculation of the ultimate bending moment of the cross sections under the acting axial force was based on the specific computer program mentioned in chapter 3.2. From the strength curve, shown in Fig.5b, it can be concluded that the strengthening proposal is adequate.

After some pilot calculations, the use of ten, grade S400, austenitic stainless steel strips having an effective cross section of 50x5mm was adopted (see Fig.6b). Because of the relatively small increase in stiffness and the practically zero increase in mass due to steel strips, the response of the structure, under seismic loads was assumed to be equal to the one of the virginal state. Using the same computer program, the strength curve shown in Fig.5c was calculated and it can be seen that it is almost identical with that of Fig.5b, which means that the selected strengthening proposals are equivalent in strength.
