# Strengthening of a 400 year old Ottoman Minaret

Zeitschrift: **IABSE reports = Rapports AIPC = IVBH Berichte**

Band (Jahr): **70 (1993)**

## **Strengthening of a 400 Year Old Ottoman Minaret**

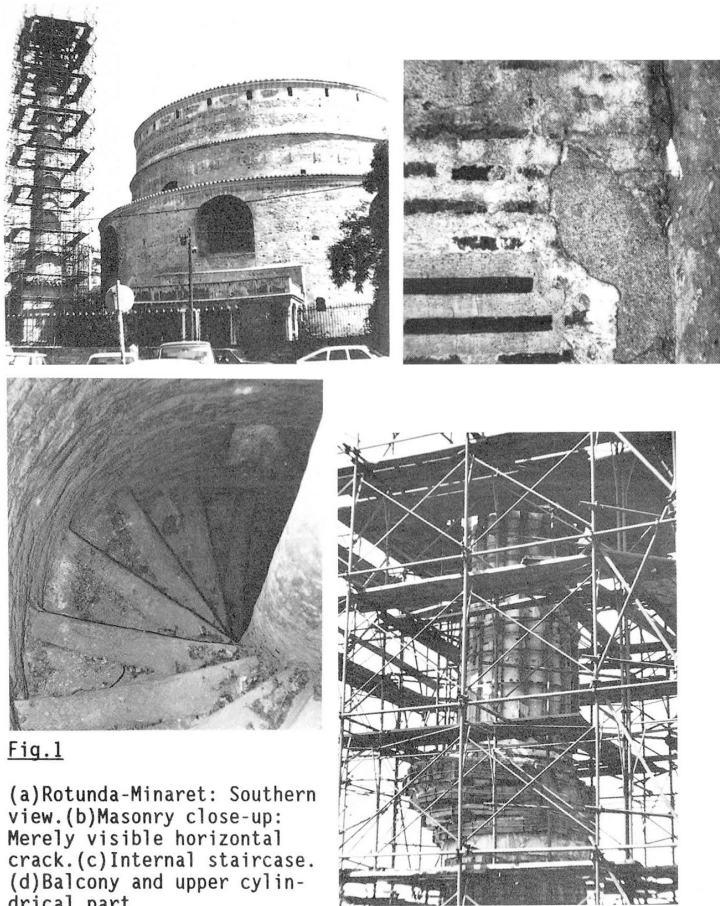
**Fig.1**

(a) Rotunda-Minaret: Southern view. (b) Masonry close-up: Merely visible horizontal crack. (c) Internal staircase. (d) Balcony and upper cylindrical part

The Minaret is located at a distance of 3.50m western of Rotunda (see Fig.1a). It consists of a 4.50x4.50m square cross-sectioned base, 7.50m in height and is founded on a thick stiff red clay layer approximately 6.00m below the ground level. The base is supporting the trunk of the Minaret consisting of two successive twenty-sided truncated conical parts of 22.00m total height crowned by the muezzin's balcony and the highest fifteen-sided cylindrical part 6.00m in height (see Fig.2). The external diameter of the trunk decreases gradually from 3.25m to 2.10m and finally to 1.75m at the highest cylindrical part. The narrow entrance (0.85x1.95m) is located at the northern face of the base. The internal helical staircase with gradually decreasing diameter ( $D=1.80-1.45m$ ) leads up to the balcony at a height of 29.50m. The small muezzin's doorway (0.50x1.50m) is located at the southern face of the cylindrical trunk penetrated till the top by the narrow staircase ( $D=1.35m$ ). Five narrow loopholes are located along the height of the southern side of the trunk.

The base of the Minaret is consisted of successive stone and brick masonry layers while the masonry of the trunk is pure brickwork built by flattened bricks (30x40x4cm) with thick mortar joints (4cm), (see Fig.1b). The balcony consists also of brickwork supported by successive horizontal wooden beams tangentially projecting from the cylindrical trunk. The staircase is masoned together with the surrounding trunk. At the edge of every step a wooden beam is located diametrically and is embedded in the masonry of the trunk, while along the axis of the staircase a masonry column ( $D=0.25m$ ) is constructed (see Fig.1c).

Emergency works were undertaken just after the 1978 earthquake including general external scaffolding (see Fig.1a) and temporary external confinement by steel rings and wooden beams as well as internal helical concrete jacket at the upper 10m of the Minaret (see Fig.1d,2).

Non destructive tests in combination with a limited number of laboratory destructive tests were applied to make an estimation of mechanical characteristics of bricks, mortar and masonry. To this direction a new series of hammer and ultrasonic tests on bricks and mortar, beyond those performed by the 9th Ephorate, was carried out. Three masonry "triplets" were extracted from the base and the trunk of the Minaret (see Fig. 1b) and were used for the laboratory tests. The results are shown in Table 1.

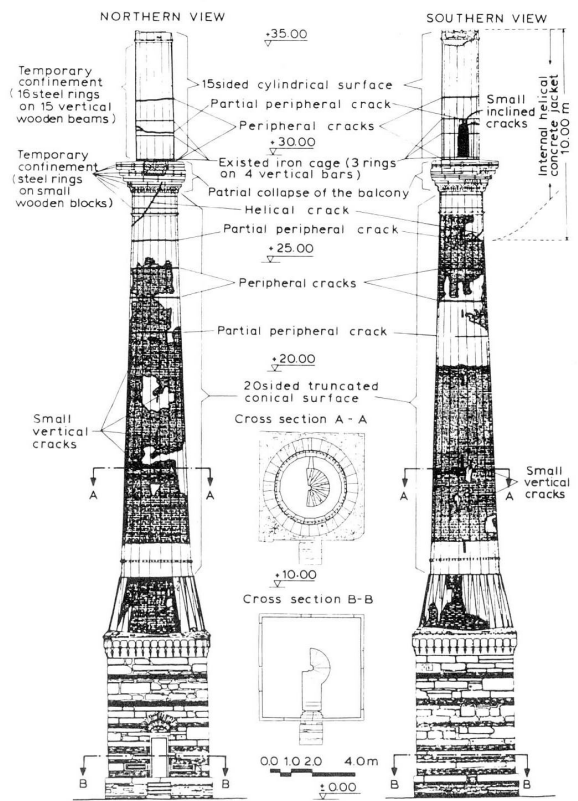
**Fig.2** Northern and Southern elevations of the Minaret. Cracking pattern, external emergency interventions

As it can be easily seen in Fig.2, the base of the Minaret is unplastered. The plaster covering has been collapsed at the major part of the trunk, while at the rest of the surface, as well as at the upper cylindrical trunk, it is heavily cracked. Limited superficial deterioration of masonry, especially at the northern face of the trunk has been detected and confirmed by the hammer tests. The wooden beams at the highest steps of the staircase have been heavily corroded due to rain water passing through the open top, as the wooden acute conical roof of the Minaret fall down, probably during an earthquake, at the beginning of the

present century. Successive horizontal peripheral cracks have been ascertained at the upper two fifths of the Minaret and have been drawn in Fig.2. There is one helical crack starting from the highest loophole, following the ascending steps and cutting the balcony. All the cracks, being under vertical compression, are just visible (see Fig.1b). During the earthquake of June 20,1978 (epicenter 30km from Thessaloniki, magnitude 6.5 grades in Richter scale) a part of the balcony collapsed and the upper half of the cylindrical trunk was slightly translocated (see Fig.1d,2). It must be pointed out that, despite of the damages, no permanent horizontal drift of the structure has been ascertained and no foundation problem has been detected.

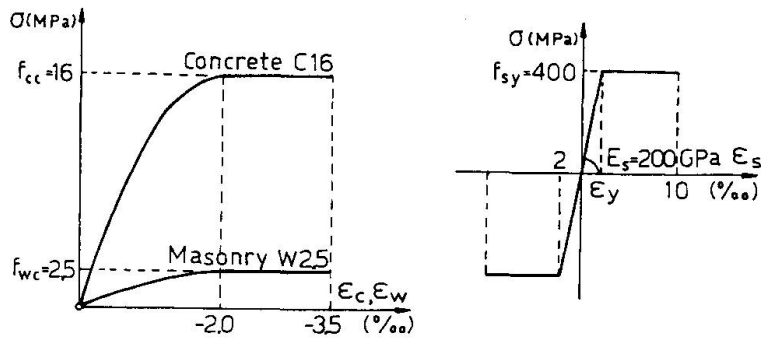
**Fig. 3** Idealized stress-strain curves for masonry and intervention materials (Concrete, Steel)

Significant difference in the composition of mortars between the highest cylindrical part and the rest of the Minaret below the balcony has been found out, although the compressive strengths of the mortars were almost equal. Consequently, either the Minaret had been erected in two phases, or the part over the balcony had probably been collapsed and rebuilt. In Fig.3 the idealized masonry stress-strain curve adopted for the analyses and the stress-strain curves of concrete and steel for the strengthening interventions are shown.

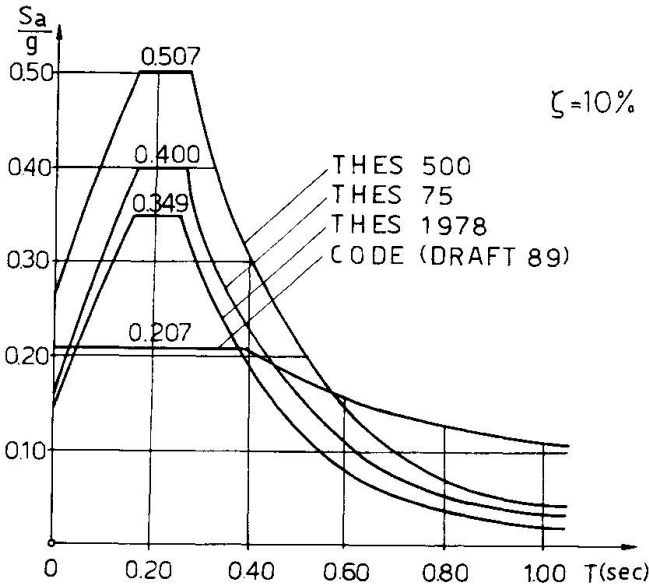
**Fig. 4** Design seismic acceleration spectrums

To determine the soil shear modulus ( $G$ ) throughout the foundation depth, two bore holes were drilled very close to the Minaret and the Cross Hole technic was carried out. Resonant Column Tests on foundation red clay samples were also performed. Based on the obtained values of  $G$ , the deformational characteristics of appropriate soil springs, necessary for a reliable analytical model, were estimated. The analytical procedure was performed using four elastic acceleration response spectrums. Three of them were based on the seismic excitation of 1978 at the region of Thessaloniki. The motion at bedrock of this earthquake was multiplied by the factors 1.000, 1.267, 1.756 and then, using the SHAKE program [2], the ground motions at the site of Minaret were determined. The first motion (THES 1978,  $a_{max}=0.172g$ ) corresponds to the earthquake of 1978 since the other two correspond to similar earthquakes for return periods of 75 (THES 75,  $a_{max}=0.218g$ ) and 500 years (THES 500,  $a_{max}=0.302$ ). For the estimation of the latter maximum ground accelerations a statistical evaluation of the strong ground motions at the territory from 1500 till 1990 was performed. The adoption of such a long return period (500 years) was necessary because of the monumental character of the structure and the need of a long-life intervention. The fourth response spectrum corresponds to the new Greek Seismic Code (draft 1989). These response spectrums, after being appropriately smoothed and normalised, were multiplied by the foundation factor  $\theta=0.8$  and were divided by the behaviour factor  $q=1.5$  to take design spectrums (see Fig.4).

The structure at its virginal state was analyzed under the four design spectrums of Fig.4. The corresponding results are presented in Fig.5a by means of eccentricities of the dead load axial forces due to seismic bending moments ( $e=M/N$ ). It must be pointed out that these diagrams are more informative than the conventional bending moments and axial forces diagrams since they include their combined action on the structure. From Fig.5a it is obvious that over the height of about 17m, where the eccentricity curves surround the semi-elevation of the structure, the masonry, having an almost zero tensile strength, is inadequate to carry the pair of  $(N,M)$  since the axial forces act outside of the cross section.

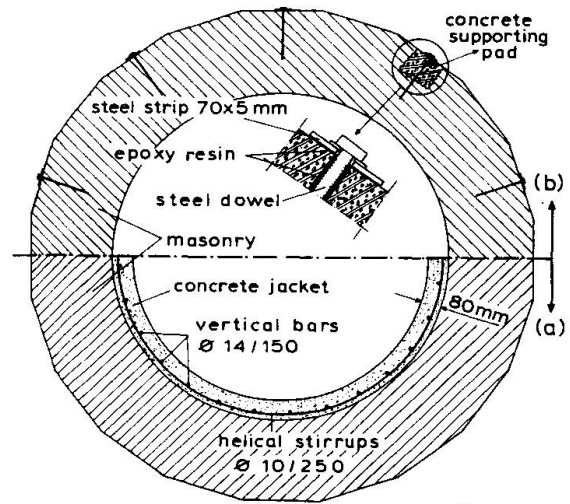
**Fig. 6** Semisections of Minaret trunk: (a) Internal concrete jacket, (b) External steel strips

After some pilot calculations, the use of ten, grade S400, austenitic stainless steel strips having an effective cross section of 50x5mm was adopted (see Fig.6b). Because of the relatively small increase in stiffness and the practically zero increase in mass due to steel strips, the response of the structure, under seismic loads was assumed to be equal to the one of the virginal state. Using the same computer program, the strength curve shown in Fig.5c was calculated and it can be seen that it is almost identical with that of Fig.5b, which means that the selected strengthening proposals are equivalent in strength.

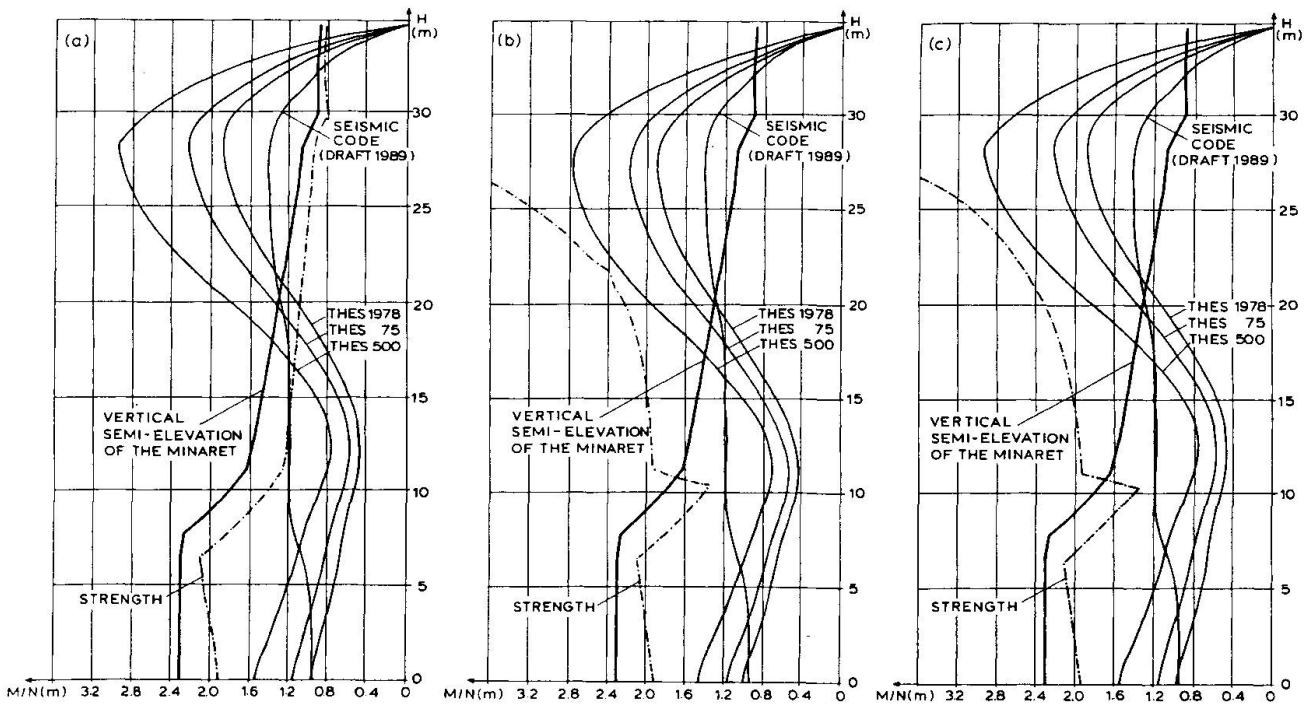
**Fig. 5** Eccentricity curves under seismic spectrums and strength eccentricity curve: (a) Virginal state, (b) Concrete jacket, (c) External steel strips

In order to determine more precisely the region of the structure which needs to be strengthened, the strength curve shown in Fig.5a was determined with the aid of a specific computer program which can calculate the ultimate bending moment, under a given axial force, of a polygonal section composed of various materials (masonry, concrete, steel) and given stress-strain relations of the materials (see Fig.3). It can be seen that under the height of 14m, the structure is adequate to carry out the combination of dead and seismic loads. In order to secure a reasonable safety factor, slightly greater than one, it was decided that the region to be strengthened extends from 12m height to the top of the structure.

of the structure. In Fig.5b, the eccentricities of the axial forces due to seismic bending moments under the design spectrums of Fig.4 are shown. It is obvious that, in comparison to the relative curves of Fig.5a, the differences are small. The calculation of the ultimate bending moment of the cross sections under the acting axial force was based on the specific computer program mentioned in chapter 3.2. From the strength curve, shown in Fig.5b, it can be concluded that the strengthening proposal is adequate.
