**Zeitschrift:** IABSE reports = Rapports AIPC = IVBH Berichte  
**Band:** 70 (1993)

**Artikel:** Case studies of structural preservation in Taiwan  
**Autor:** Lee, Horng-Ji / Jiang, Du-Hsin / Lai, Cheng-Hsiung  
**DOI:** <https://doi.org/10.5169/seals-53360>

## Case Studies of Structural Preservation in Taiwan

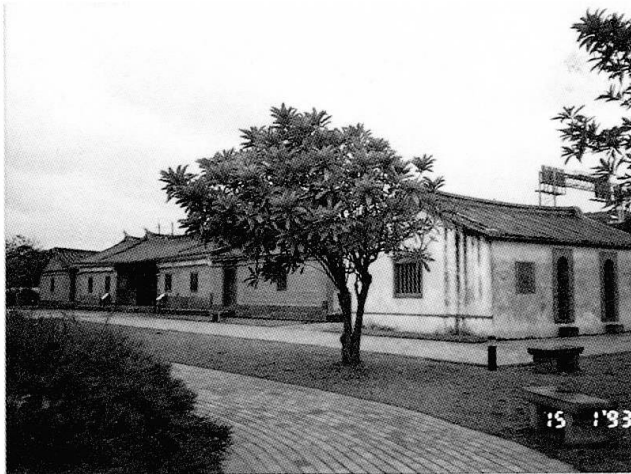
Fig. 1 Old homestead  
(Fu Kien style)

In this paper we take some examples of the removing and reconstruction of the homestead, most of them are wooden structures used for Chinese immigrant clan to Taiwan or the aboriginal cottages, for case study (Fig.1,2). The way of study are thus:

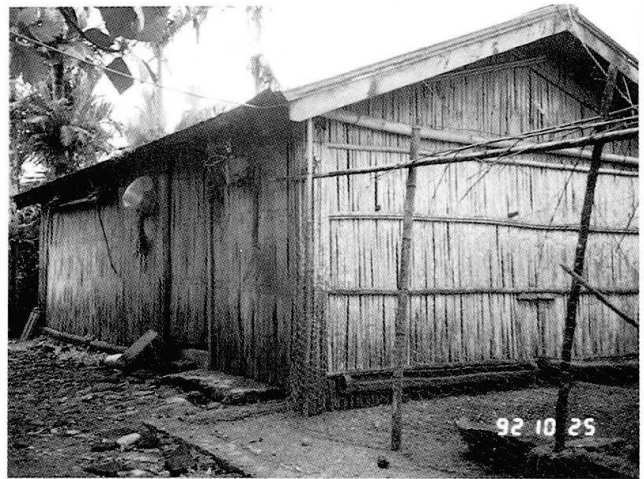
Fig. 2 Bamboo house of an  
aboriginal

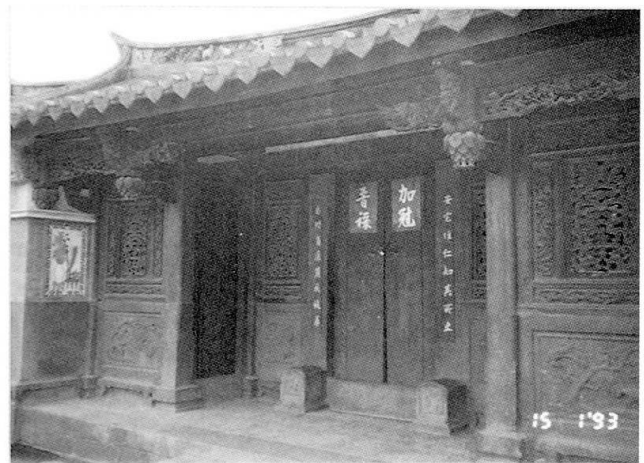
- B. The stone carving part: The stone materials are all connected by using hidden dovetail keys, and the stone materials and the wood materials are also connected by the use of tenons and mortises. The same is true of the doorposts, wainscots, stone thresholds, and pillar bases. With ordinary houses, the stone hinges and the doorpost pedestals are two separate parts, but in the Homestead they are carved as an integrate piece. The same skill is applied to the stone hinges at the bottom. The stone steps, stone wall bases and the friezes are all well proportioned in their dimensions. The igneous stone used in paving the inner court, the open drain, and the front court, though not carved very exquisitely, are well selected, and their sizes are all very accurated. Owing to their old age, the stone slates are no longer very even; but the crevices were adjusted by using copper coins as tools, and ground leveling was secured by melting lead underneath. These all show the great care taken in its construction (Fig.4).

Fig. 4 The stone carving part
