**Zeitschrift:** IABSE reports = Rapports AIPC = IVBH Berichte  
**Band:** 76 (1997)

**Artikel:** Stress measurement and repair of a fatigue cracked box girder bridge  
**Autor:** Yamada, Kentaro / Ojio, Tatsuya / Kainuma, Shigenobu  
**DOI:** <https://doi.org/10.5169/seals-57469>

## **Stress Measurement and Repair of a Fatigue Cracked Box Girder Bridge**

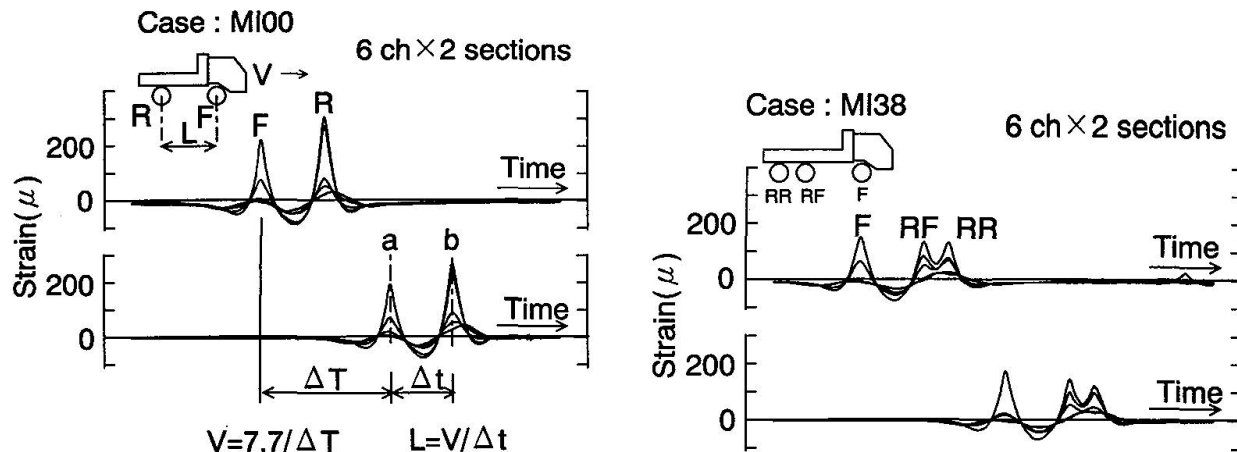
- FEM analysis** : The finite element analysis was carried out for the orthotropic steel deck of interest to determine influence surfaces for all locations of strain gages, that were placed at the mid-span of the longitudinal ribs.
- Effect of tire loading** : Wheels with single tire and double tires with an unit weight were placed at different positions to calculate stress waves of the longitudinal ribs. Loading areas of the tires were determined according to JRA Specifications. Through such analysis it was determined to use six strain gages at two sections, A and B, near the supports, which were 7.7 m apart, as shown in Figure 2.
- Strain measurements** : Strain histories were recorded dynamically using Digital Data Recorder, and the data was transferred to a personal computer for further analyses. Typical strain recordings for 2-axle truck and 3-axle truck are shown in Figure 3.

Fig. 3 Strain histories due to running of test trucks

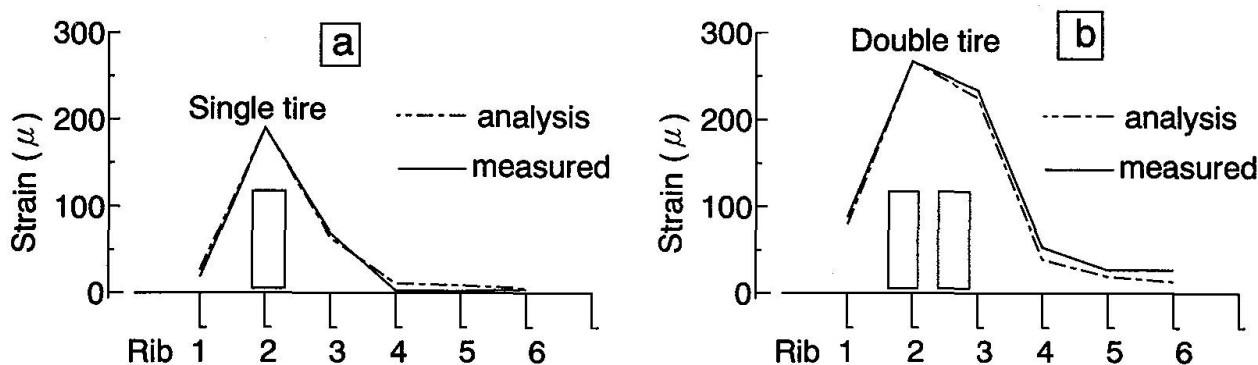
d) **Tire types and their positions** : From six strain recordings peak strains corresponding to wheels passing on the mid-span of the ribs were determined first. Then, three largest strain recordings were picked up, and tire position was determined. Single or double tires was also clarified from the shape of the strain waves, as shown in Figure 4.

Fig. 4 Stress distribution of six ribs at a and b

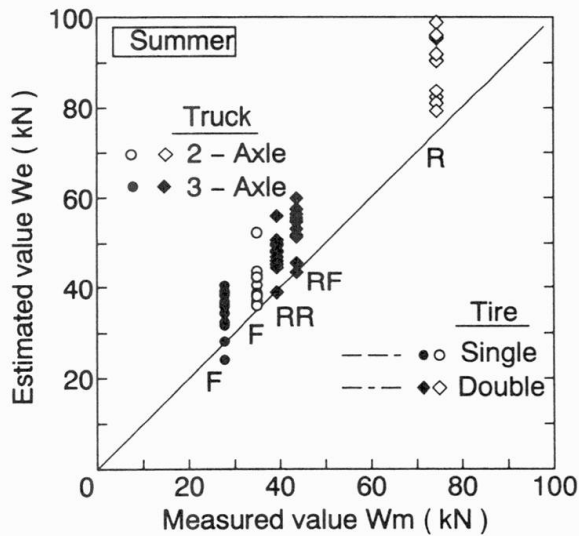
From the recorded strains the wheel loads were estimated. The estimated wheel loads,  $W_e$ , are plotted against actual wheel loads,  $W_a$ , measured statically at a weigh station in Figure 6. It was found that  $W_e$  for the front and rear wheels were about 20 percent higher in average than  $W_a$ . The scatter of the estimated wheel loads was also observed owing to the scatter in the measured strain recording, which probably came from the vibration of the truck during the passage over the test sections.

Fig. 6 Comparison of measured and estimated wheel loads of test trucks
