Stress measurement and repair of a fatigue cracked box girder bridge

Zeitschrift: **IABSE reports = Rapports AIPC = IVBH Berichte**

Stress Measurement and Repair of a Fatigue Cracked Box Girder Bridge

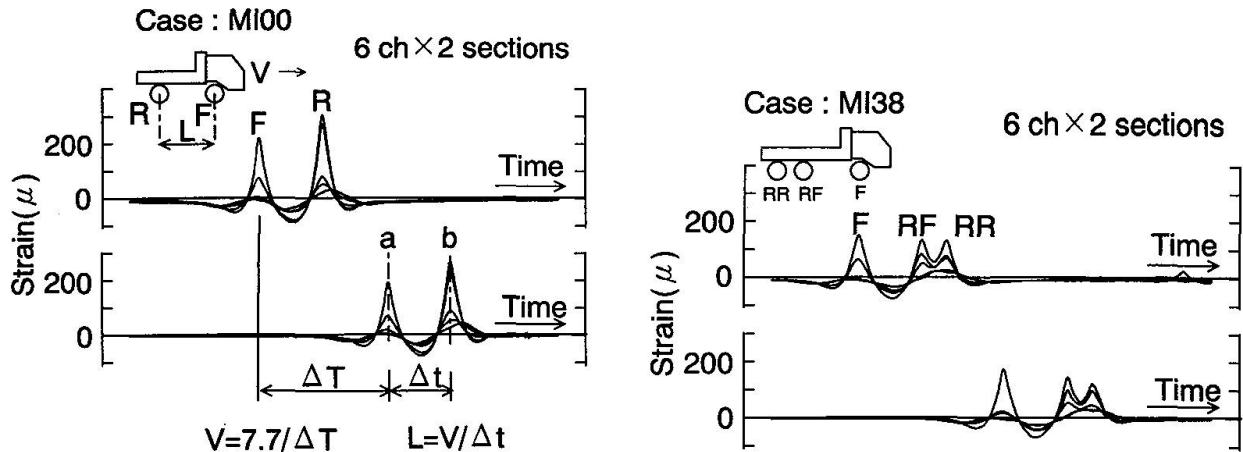
Fig. 3 Strain histories due to running of test trucks

- FEM analysis** : The finite element analysis was carried out for the orthotropic steel deck of interest to determine influence surfaces for all locations of strain gages, that were placed at the mid-span of the longitudinal ribs.
- Effect of tire loading** : Wheels with single tire and double tires with an unit weight were placed at different positions to calculate stress waves of the longitudinal ribs. Loading areas of the tires were determined according to JRA Specifications. Through such analysis it was determined to use six strain gages at two sections, A and B, near the supports, which were 7.7 m apart, as shown in Figure 2.
- Strain measurements** : Strain histories were recorded dynamically using Digital Data Recorder, and the data was transferred to a personal computer for further analyses. Typical strain recordings for 2-axle truck and 3-axle truck are shown in Figure 3.

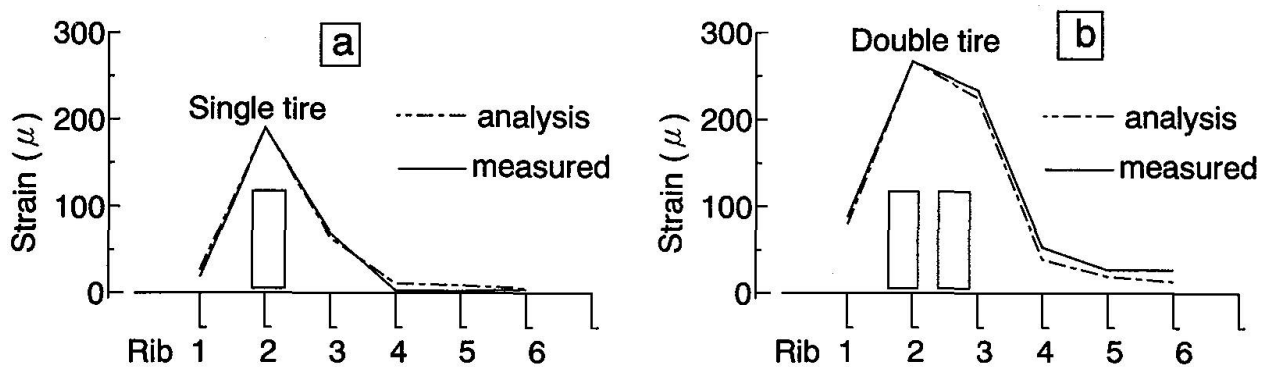
Fig. 4 Stress distribution of six ribs at a and b

d) **Tire types and their positions** : From six strain recordings peak strains corresponding to wheels passing on the mid-span of the ribs were determined first. Then, three largest strain recordings were picked up, and tire position was determined. Single or double tires was also clarified from the shape of the strain waves, as shown in Figure 4.

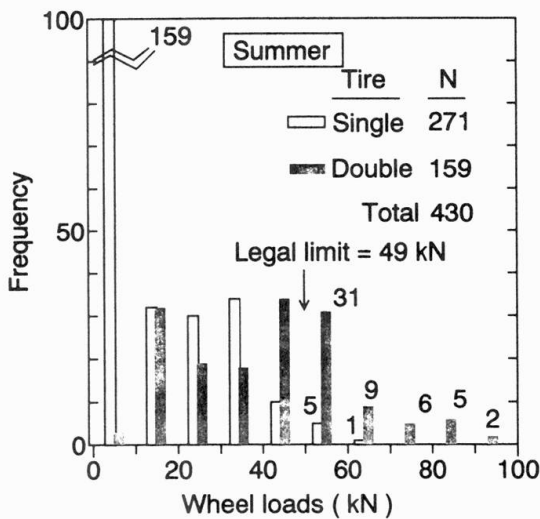
Fig. 7 Frequency of estimated wheel load position

The wheel loads of the passing trucks of various types were also estimated. The result is plotted in Figure 7. The wheel loads of these trucks were not known, but the estimated wheel loads for the front wheel (single tire) are ranging from 4.9 kN to 64 kN. The maximum wheel loads showed scatter from 4.9 kN to 98 kN. The legal limit of the wheel loads was 49 kN in Japan. From the measured strain the wheel positions were also determined through the analysis and plotted in Figure 8. For 312 wheel loads heavier than 4.9kN the wheel positions were between the ribs 1 and 5, which were 1.2 m apart. The majority of the wheels passed between the ribs 2 and 3.

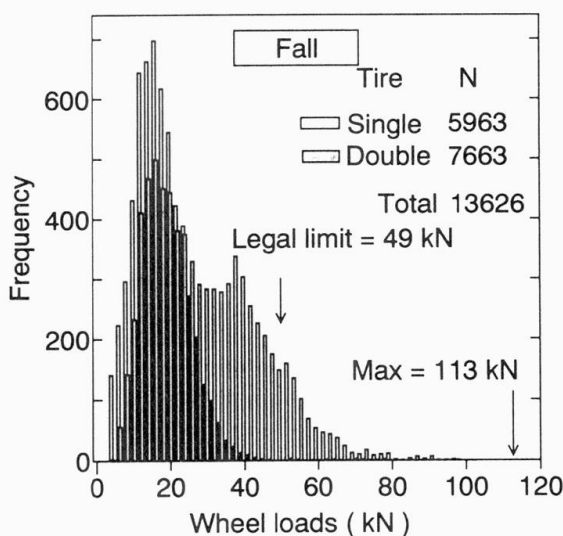
Fig. 10 Frequency of estimated wheel load

The estimated wheel loads, W_e , are summarized in Figure 10. Note that these wheel loads are for the trucks in which one of the strain recordings exceeded the trigger level of 50 micro-strain. The maximum wheel load observed during the 12-hr measurement was 113 kN. The frequency distribution of wheels with double tires shows two peaks, one around 39 kN, and the other at about 15 kN. The latter seemed the wheel loads when the truck were not loaded.

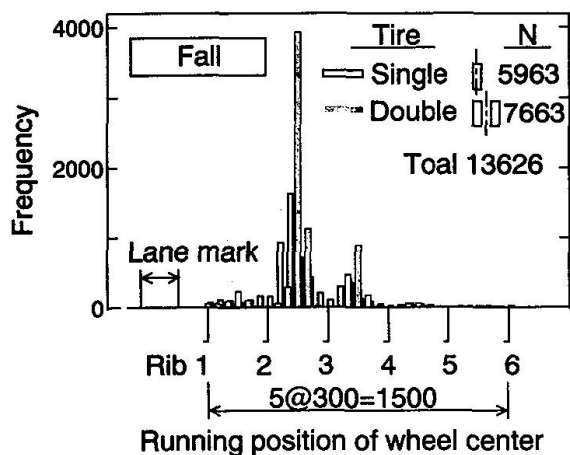
Fig. 11 Frequency of estimated wheel position

The running position of all wheels are plotted in Figure 11. The majority of the wheels passed between ribs 2 and 3, and some passed between ribs 3 and 4. In these areas ruts were observed, and the trucks seemed to run along such ruts.

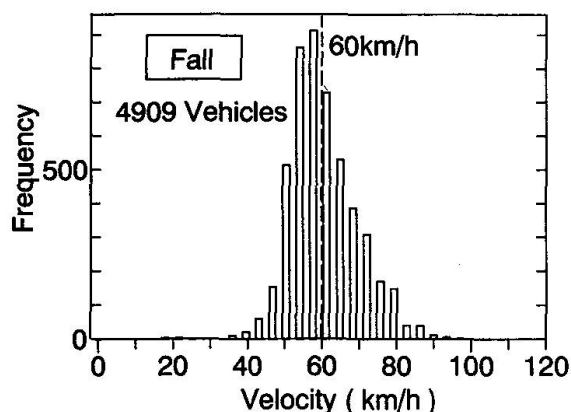
Fig.12 Frequency of vehicle velocity

The velocity of each truck in service was also computed. The distribution of the velocity is plotted in Figure 12. The average speed was about 57 km/h. Approximately 50 percent of the trucks ran with speeds over 60 km/h, while speed limit of this road was 60 km/h.

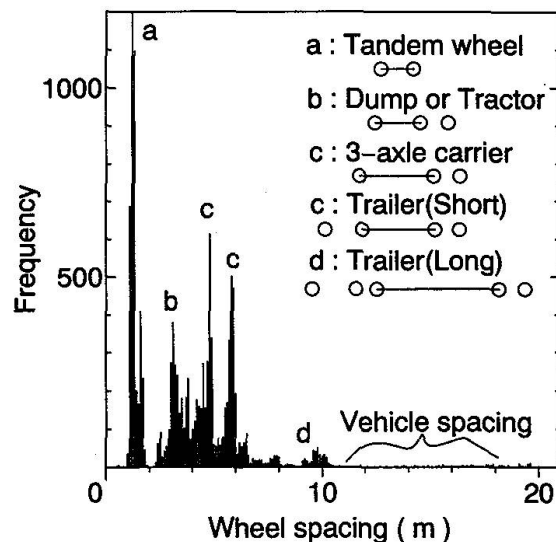
Fig.13 Frequency of estimated wheel spacing

Once the speed of each truck was known, one can compute the wheel spacing. The distribution of the computed wheel spacing is shown in Figure 13. There are several groups of wheel spacing. Compared with the configuration of the trucks currently used in Japan, the wheel spacing seems to correspond to (a) tandem wheels (about 1.3 m), (b) main spacing of dump trucks or tractors, (c) main spacing of 3-axle trucks or short trailer trucks, and (d) main spacing of long trailer trucks.
