# Full scale laboratory fatigue tests on riveted steel bridges

Autor(en): **Helmerich, Rosemarie / Brandes, Klaus / Herter, Jürgen**

Zeitschrift: **IABSE reports = Rapports AIPC = IVBH Berichte**

Band (Jahr): **76 (1997)**

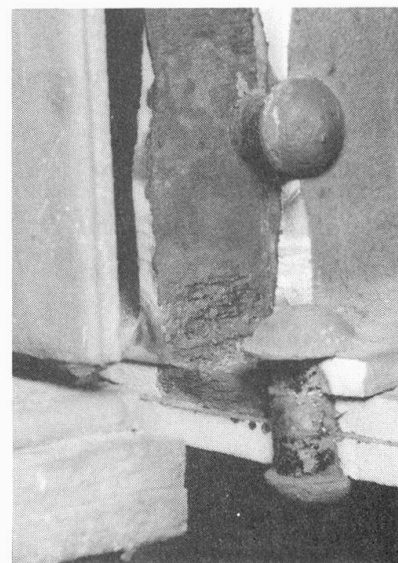
**Fig. 5** Crack in the tension flange

The bridge crossing the Teltow canal "Knesebeck-bridge", had presumably been damaged during World War II. Almost every bridge crossing the canal had been blasted during the last days of the war. We found old corroded failures in the cross section of cover plates and untypical cracking behaviour in the region of constant moments. In the tension flange of the second plate girder the crack was growing from an old corroded failure, as shown in Figure 5. The third web plate girder seemed to have been exchanged. In material tests we found higher tensile strength, appropriate to Fe 360, in girder Kn 3. By means of strain measurement or deflection measurement it was possible to detect crack growth.

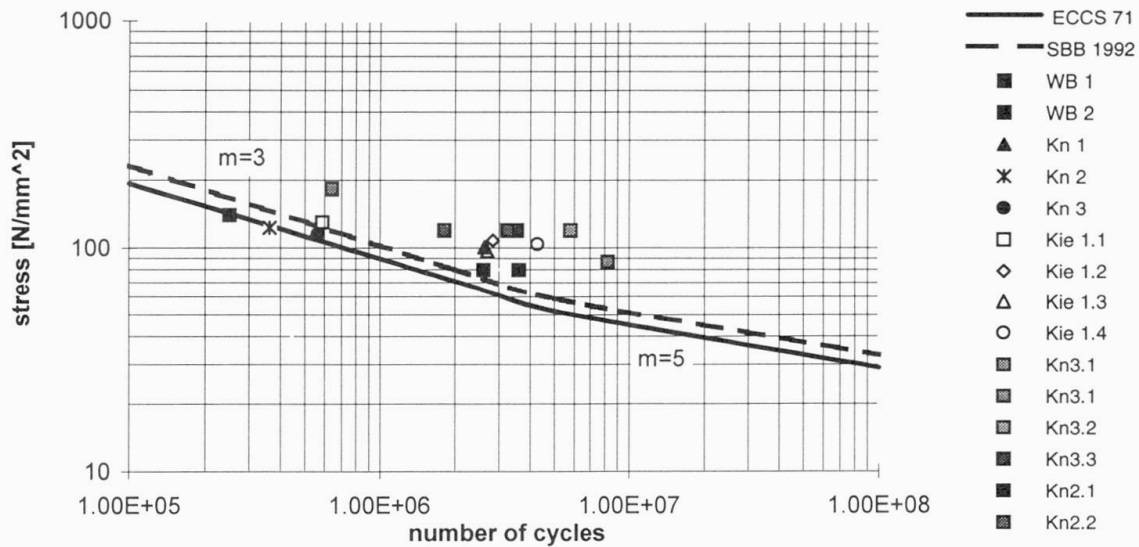
**Fig. 8** Results of full scale tests in S-N-curve

The girders from the second series were cut into smaller specimens (lengths of about 1m) and the fatigue tests were continued with the same load range as in the main tests. These results are included in Fig. 8. During the third test series (wrought iron), we continued the test on a cracked element at the stress level which was measured under traffic load.

All results fall in a S-N diagram above the ECCS category 71 with constant slope  $m = 5$ .

In two tests the crack occurred in the plate under an additional plate at the first row of rivets. Crack growth was indicated by decreasing strains in the tension flange. All tests are summarized in the S-N-diagram in Figure 8.
