Session 6: Repair and rehabilitation methods of historical buildings

Zeitschrift: **IABSE reports = Rapports AIPC = IVBH Berichte**

Band (Jahr): **77 (1998)**

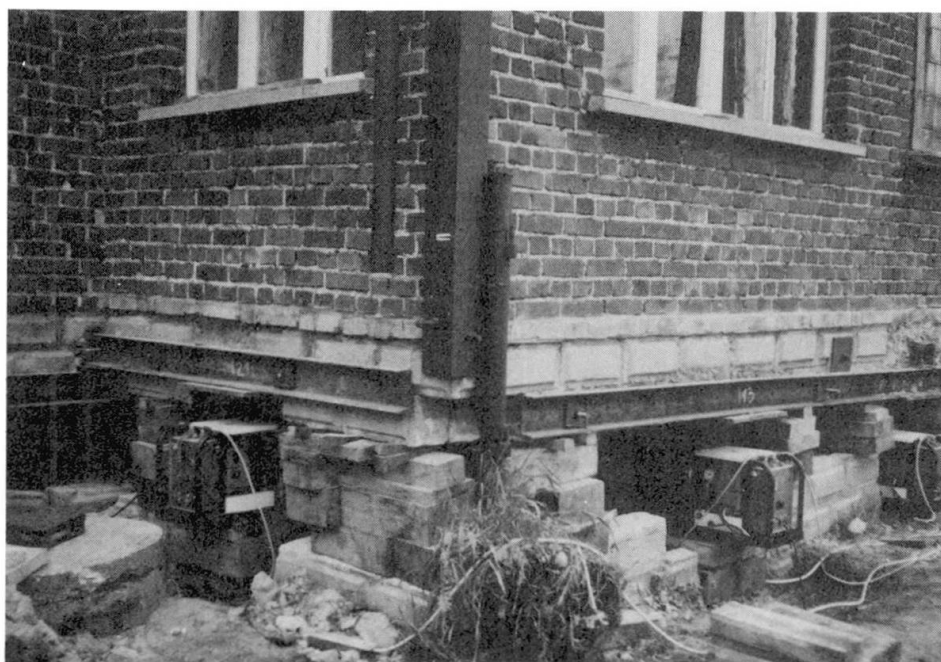
Fig.2 Built in jacks in cellar storey

is two channel bars running on both sides of the torn walls. Fig.2 shows built in jacks in cellar storey.

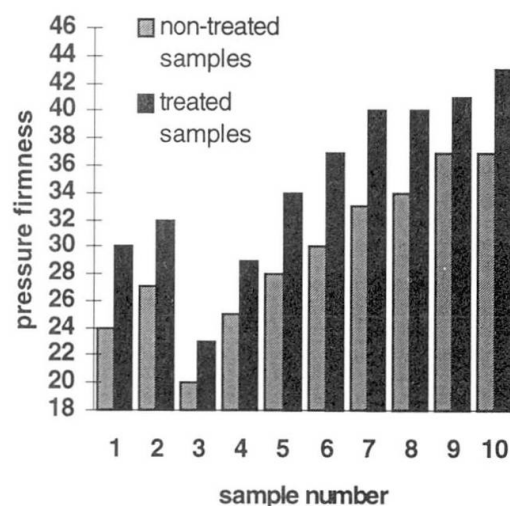
Fig. 3: Increase of compression strength
