Session 2: Structural safety and durability of existing buildings

Zeitschrift: **IABSE reports = Rapports AIPC = IVBH Berichte**

Band (Jahr): **77 (1998)**

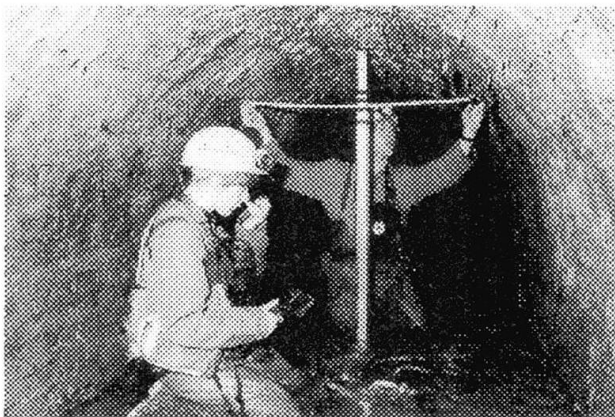
Fig. 2: Sewer system Schiffweiler - Neuland

The method was applied in a restoration project to calculate a first value for the safety level of a masonry sewer system, figure 2. In this application, reaching the compressive strength of the masonry was the only ultimate limit state considered: $g(x_1, x_2) = x_1 - x_2$. The calculated probability of failure amounts: $p_f = \Phi(-\beta) \approx 10^{-3}$.
