**Zeitschrift:** Swiss express : the Swiss Railways Society journal  
**Herausgeber:** Swiss Railways Society  
**Band:** 2 (1988-1990)  
**Heft:** 4

**Artikel:** The accident at Aigle CFF station  
**Autor:** Edwards, Ian  
**DOI:** <https://doi.org/10.5169/seals-855295>

## THE ACCIDENT AT AIGLE CFF STATION

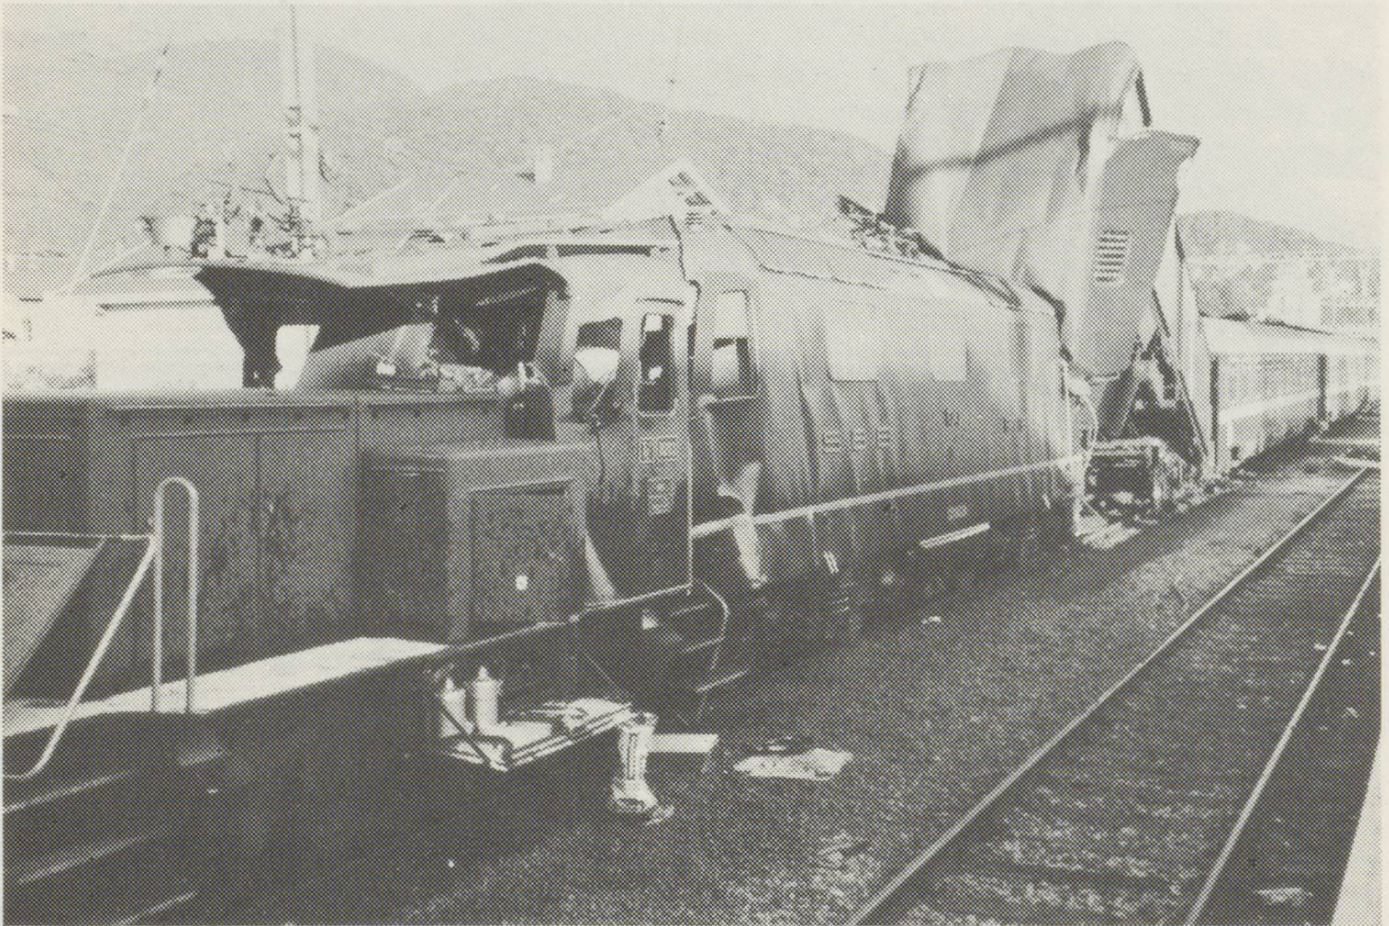
A local pickup freight train hauled by locomotive type Ae4/7 No. 11953 was stationary on the track at platform three, while a shunter type TeIV No. 8203 removed two of the parcel wagons and reversed down to the south end of the loop. In the meantime the main line route through the station was signalled for the passage of the 105 Km/h Milan to Geneva Eurocity express hauled by locomotive Re4/4 No. 11343. The initial impact at between 60 to 80 Km/h was between the express and the shunting locomotive, in which the TeIV and its two baggage wagons was pushed all the way back up the loop into the rear of the pickup freight. The second impact was between the express/shunter and the pickup freight.

*Collision of EC "Lemano" with freight train at Aigle.*

The impact with the pickup freight caused the destruction of a closed freight wagon, and forced one of the open wagons type Fs-u No. 987 up onto the overhead catenary gantry in doing so unloading vegetables onto both track and platform. The shunting engine was badly damaged both front and back and lost its pantograph in the accident. On the express train the damage consisted of; the locomotive was badly crushed in the front and the rear, the RIC Baggage coach Type D No. 51 85 92 70 107 located

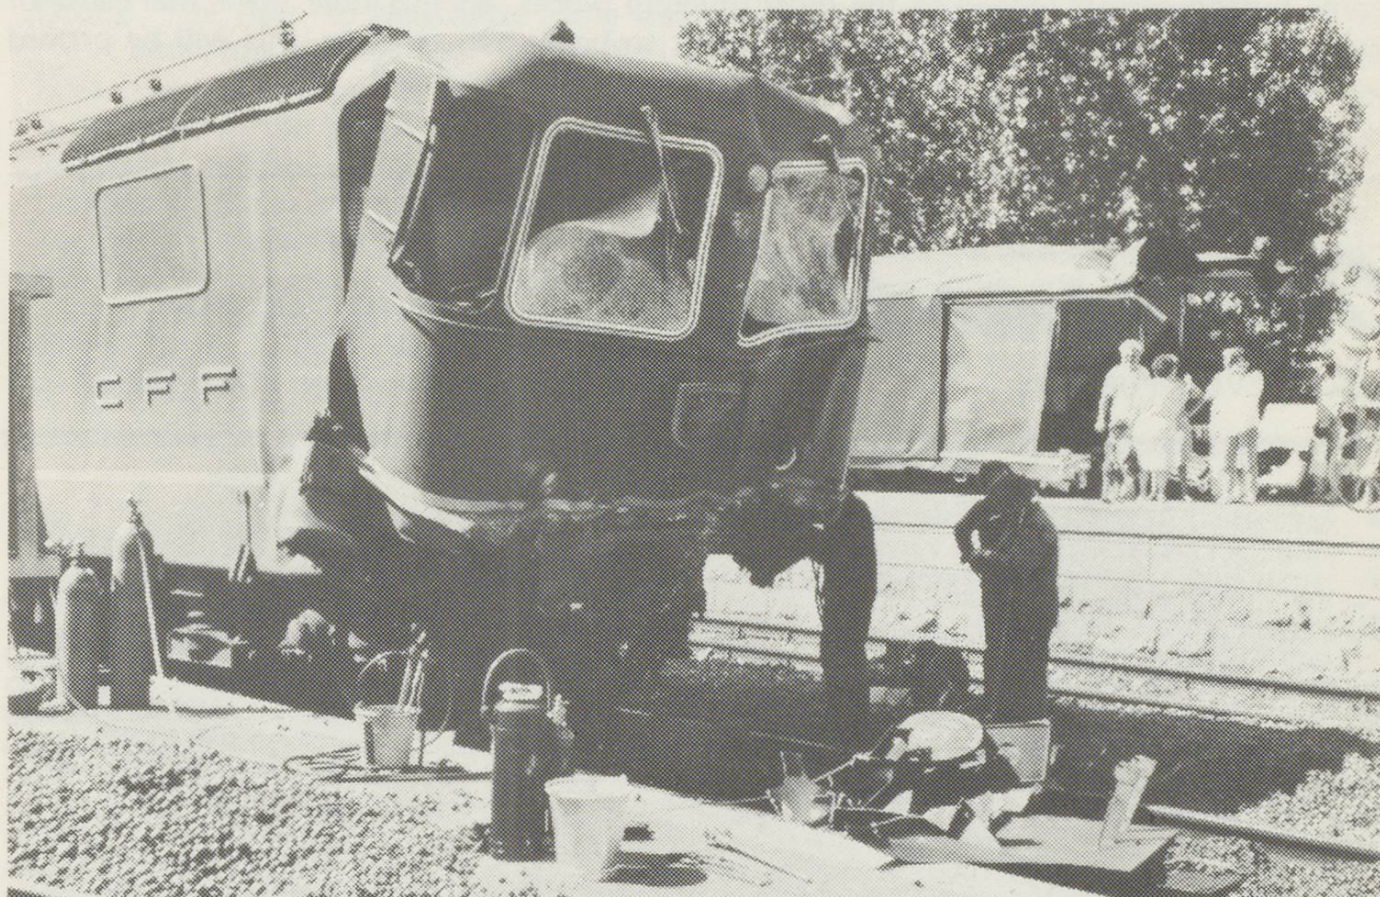
just behind the Re4/4 was bent double as it was pushed upwards through the front of the platform canopy before coming to rest above the locomotive, the first of the C.F.F. type Bpm coaches was damaged where the baggage coach had crumpled the front area, and the restaurant coach lost its pantograph as the overhead wires were dragged down. The rest of the coaches of the express appeared to be undamaged and remained on the track. Catenary wires through a large part of the station area were brought down. Amazingly, when the rescue teams arrived just minutes later they found that nobody was seriously hurt but about fifty people required treatment for minor injuries and shock. Fortunately the driver of the express escaped injury, as he could be seen walking around inside the locomotive looking for an exit as both doors had been crushed, eventually leaving via one of the side windows.

*Re4/4II locomotive No. 11343, showing damage to front area.*

The next morning when I returned to the station at 1000 hours, I found that during the night the double slip points at the entrance to the loop had been replaced. The RIC baggage coach had been cut into two pieces and deposited along with the remains of the freight wagon - which had ended up on the catenary gantry - on the goods platform. The coaches of the "Lemano" had been towed away during the night to St. Triphon just 5 kilometres south of Aigle. The two locomotives remained locked together until about 1400 hours, as they were parted the full extent of the damage to the Re4/4II locomotive could be seen. The pantograph was missing, the rear cab was completely crushed by the baggage coach, the front cab was pushed back by the impact

with the shunting locomotive, and the front bogie had been pushed back about 400 mm. Before the Re4/4 locomotive could be moved the buffers had to be cut away along with all equipment below the cab floor including the front part of the bogie itself. When this had been done the locomotive was jacked up to enable the bogie to be replaced onto the track, it was then towed away. Just after 1400 hours the remains of the pickup freight had been checked and any repairs that were required prior to moving it had been done, it was then taken away closely followed by the TeIV shunting locomotive.
