BRIENZ ROTHORN BAHN

A Swiss Heritage Railway goes searching for old skills

Michael Ellis

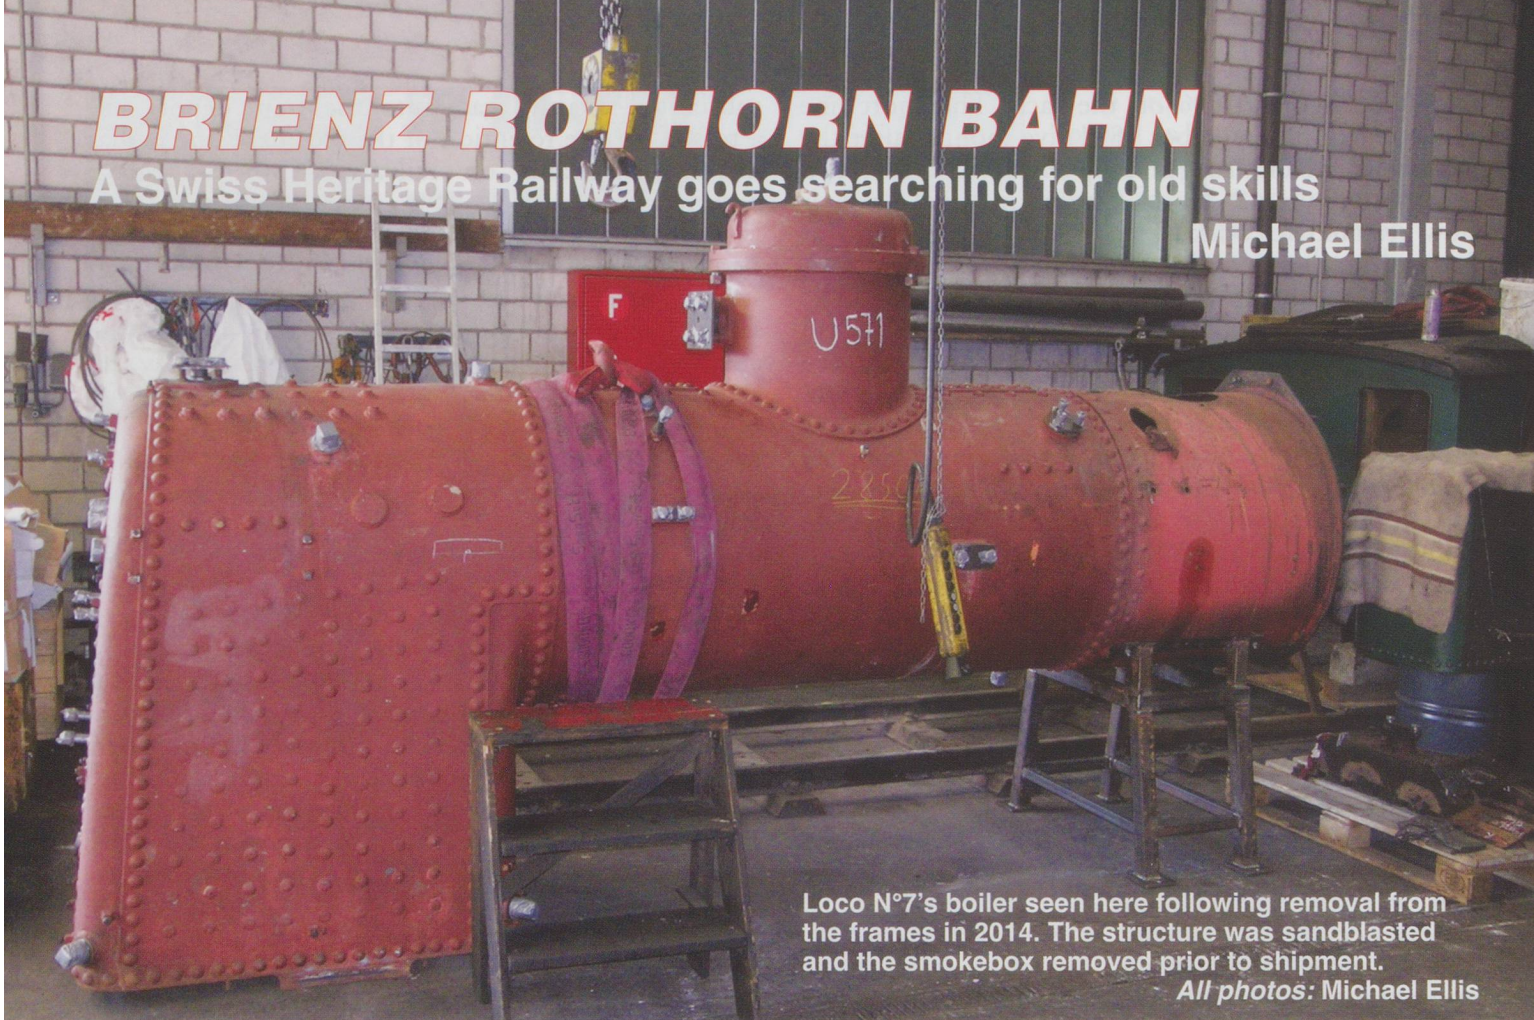
Loco N°7's boiler seen here following removal from the frames in 2014. The structure was sandblasted and the smokebox removed prior to shipment.

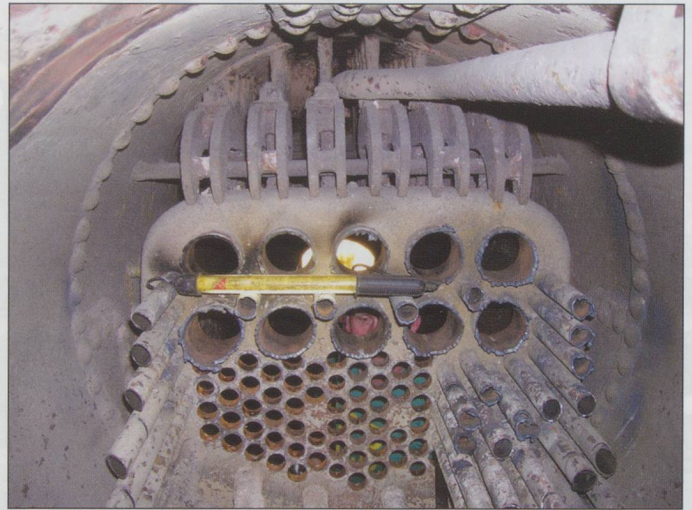
TOP: A great view taken inside the boiler. Here we see that the tubes have been cut away leaving only the ends to remove. The inner firebox construction (not original) is held in position at the top by the anchor brackets which allow for expansion movement. The steam pipe mentioned in the main text is the tube positioned top right. This connects the steam cavity in the dome to the regulator.

For the technically minded the work was to include: removal of the 'new' welded firebox installed in the 70's; removal and replacement of all boiler tubes; replacement of the steam pipe; renovation of the foundation ring; replacement of the inner firebox with a new copper (riveted) firebox as per original design circa 1932; new front tube plate and sundry other work. All in all a major rebuild to an old component. Would the Swiss Inspector, accept the plan? Richard and Steven were maybe a little too confident. Daniel and Mike were maybe a little too nervous and one poor translation between the English and Swiss German could screw it all up... Towards the end of the meeting Herr Kehrl, the Inspector, turned to me as the meeting translator. He clarified: We wanted to take an 85 year old boiler to England, dismantle it, replace and rebuild 60% of the construction, and, that with riveted not welded joints! And, to a design from 1932...? Were we serious? As calmly as I could, I said

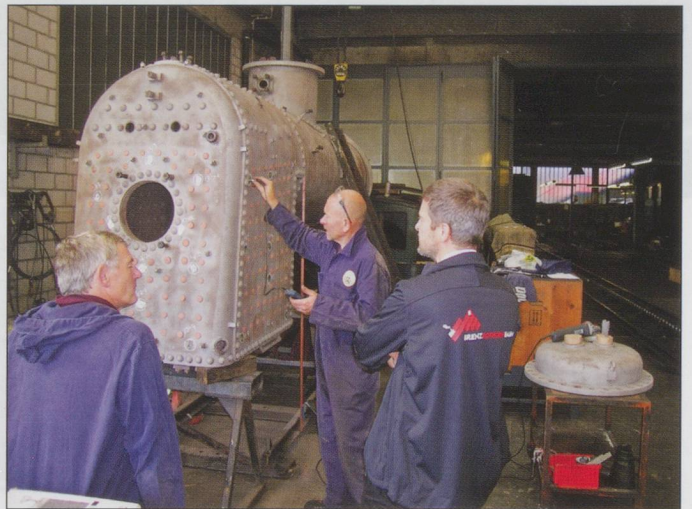
MIDDLE: Steven Latham from L&NWRH is seen here conducting the ultra sonic measurement of the outer firebox wall thickness. In places 85 years use had resulted in 0.7 mm erosion of 13 mm thick steel plate, still well within acceptable limits. L – R Richard Watkins, Steven Latham, Mike Ellis.

L&NWRH despatched Works Manager Steven Latham and Richard Watkins, his 'encyclopaedic' Boilersmith, to Brienz. The visit enabled them to undertake ultrasound tests and initially assess the boiler in order to advise us of what hidden horrors existed beneath the surface. This visit concluded with a meeting to which the Swiss Boiler Inspector was also invited, as his OK to the project was paramount.
