Ground improving injections underneath historical buildings: five case histories as an overview of a technique

Valentina Berengo¹

Abstract

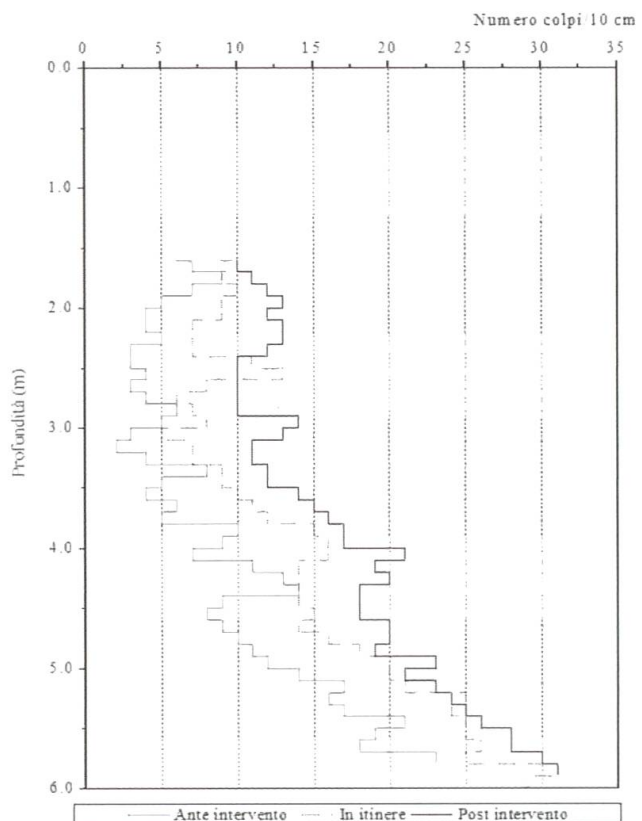
Fig. 4: Penetrometer tests before (light grey) and after (dark grey) intervention at Palatium Vetus [x-axis: number of strokes per 10 cm, y-axis: depth [m]].

To test the improvement of the soil resistance, fourteen comparative penetrometer tests were performed in the treated zones, in accordance with Italian regulation (NTC 2008). Fig. 4 shows that mechanical properties increased more than 40% in the critical points, even though the test itself has no more than comparative meaning.

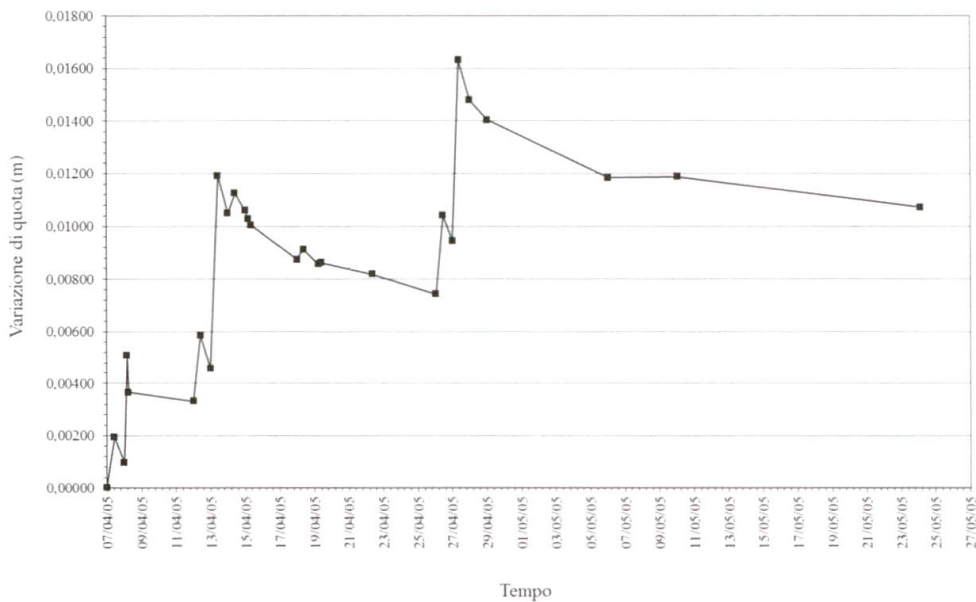
Fig. 9: Time-displacement measured curve for «point 17» [x-axis: date, y-axis: displacement rates in m].

Fig. 9 shows the time-displacement curve of the check point «17», close to the SL15

anchorage, on the «Canal Grande» side. The recovery is evident for each intervention phase.

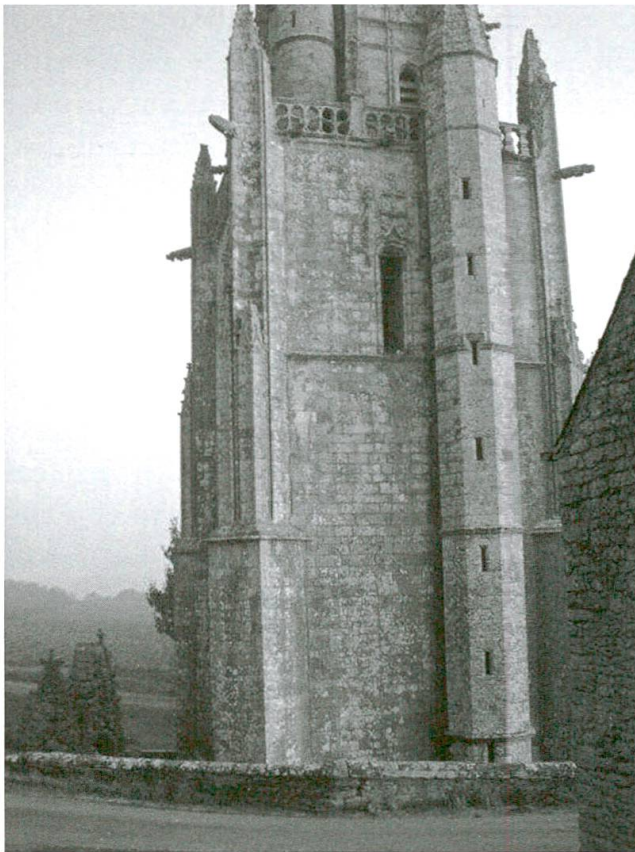
Fig. 11: The Chapelle Saint Nicodème leaning tower.

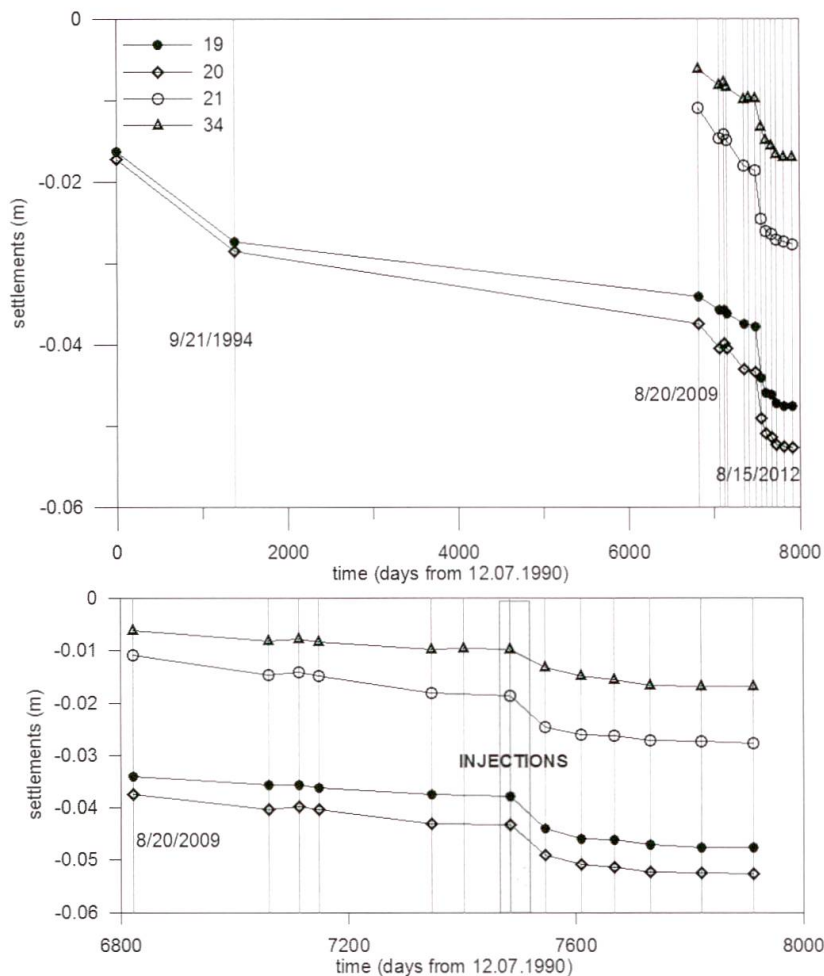
Fig. 14: Above: time-settlement curves of several anchorages. Below: enlargement of the measurements just before and after intervention.

In Fig. 14 the settlement trend is plotted over

time in correspondence to fixed control points. It is clear that the settlement stabilized after the injection procedure. The injections cause a slight localized settlement due to the procedure itself, but the graph shows that the settlements which were increasing over time prior to the intervention have almost stopped.

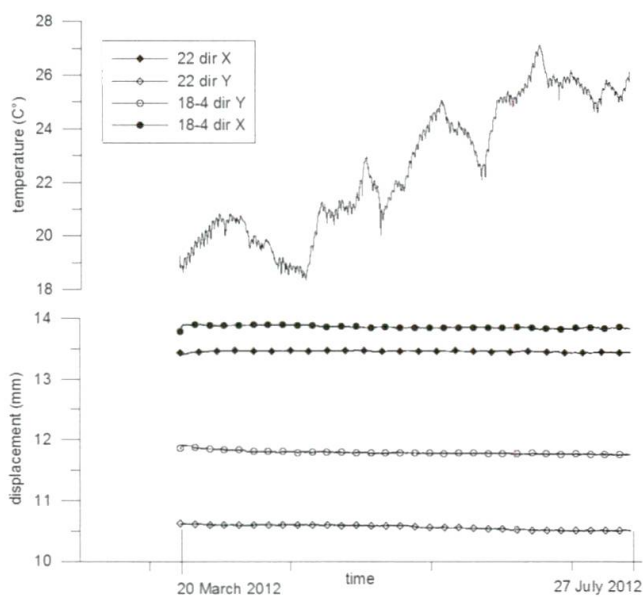
Fig. 16: Time- displacement-temperature curves for two cracks (in X and Y directions).

The monitoring results are shown in Fig. 16. The cracks stabilized since no more displacements occur along the X or Y directions, even when the temperature varied.
