**Zeitschrift:** Swiss bulletin für angewandte Geologie = Swiss bulletin pour la géologie appliquée = Swiss bulletin per la geologia applicata = Swiss bulletin for applied geology

**Artikel:** Ground improving injections underneath historical buildings : five case histories as an overview of a technique

# Ground improving injections underneath historical buildings: five case histories as an overview of a technique

Valentina Berengo<sup>1</sup>

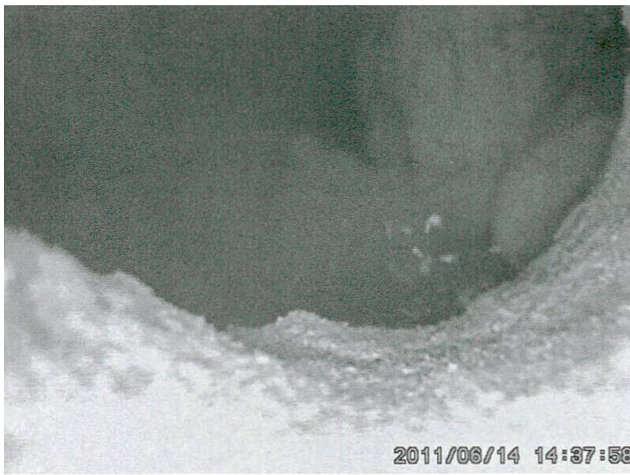
Visible differential settlements had already occurred at the time of construction, since the side laying directly on the soil started settling immediately. The first measurements go back to 1976 and now the maximum differential settlement between the two sides reaches 20 cm, while the rate of settlement is eight times faster than the initial one. The subsoil was also found to be constituted by several cavities, as detected during geotechnical preliminary surveys (Fig. 13).

Fig. 13: Cavities in Geneva subsoil.
