**Artikel:** The detached wall paintings from the attic of the monastery church St.  
Johann in Müstair in the collection of the Swiss National Museum :  
research and development of a conservation and restoration concept

# The detached wall paintings from the attic of the monastery church St. Johann in Müstair in the collection of the Swiss National Museum – research and development of a conservation and restoration concept

by NATALIE ELLWANGER, TIZIANA LOMBARDO, PATRICK CASSITTI, CAMILLA MARTINUCCI, ALBERTO FELICI, MARTA CAROSELLI, MARKUS LEUTHARD and RUFINO EMMENEGGER

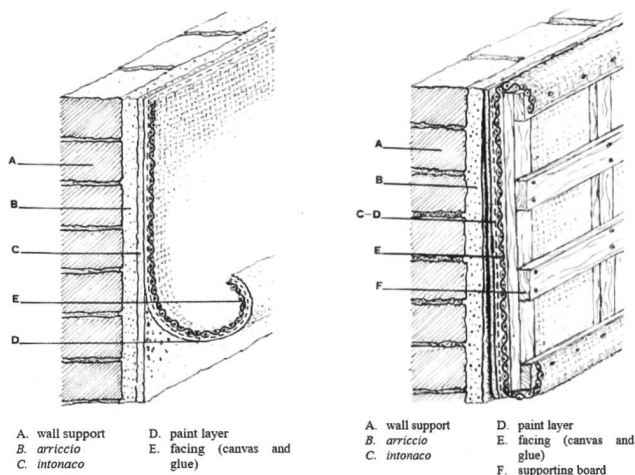
For a better understanding, the two ways to detach wall paintings are explained here in very abbreviated form.<sup>9</sup> In both procedures, the wall surface is covered with two layers of fabric (facing). In the case of *strappo*, the adhesive is chosen to ensure that, during the drying,

Figure 3. Schematic diagrams of the set-up for the strappo and stacco technique.<sup>1</sup>

process the strength of its contraction and its shrinkage is stronger than the adhesion of the paint layer so it can be removed. After drying, the fabric and the layer of paint can be stripped off the wall like skin. Occasionally, parts of the *intonaco* (render) are also detached, which is not desirable. The detached painting is then transferred to a textile support. After this the facing will be removed. In the *stacco* process, the adhesive should not shrink during drying. By hammering and beating the surface and mechanical manipulation, a thicker layer of *intonaco* is detached from the wall and then transferred to a rigid support.

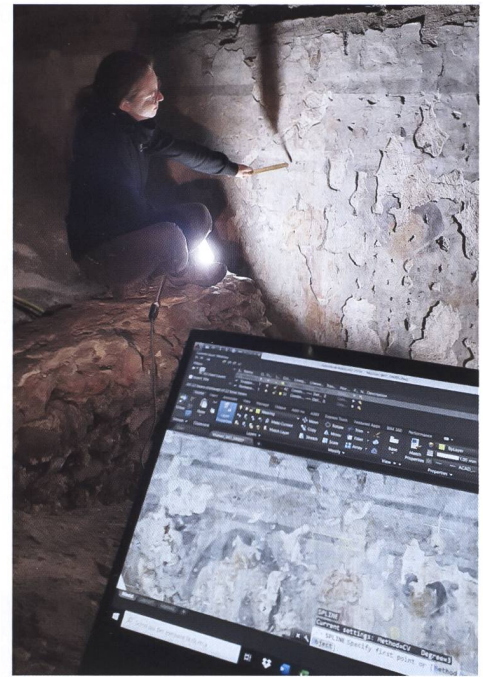
Figure 6. Examination and mapping on the east wall in the Müstair attic.

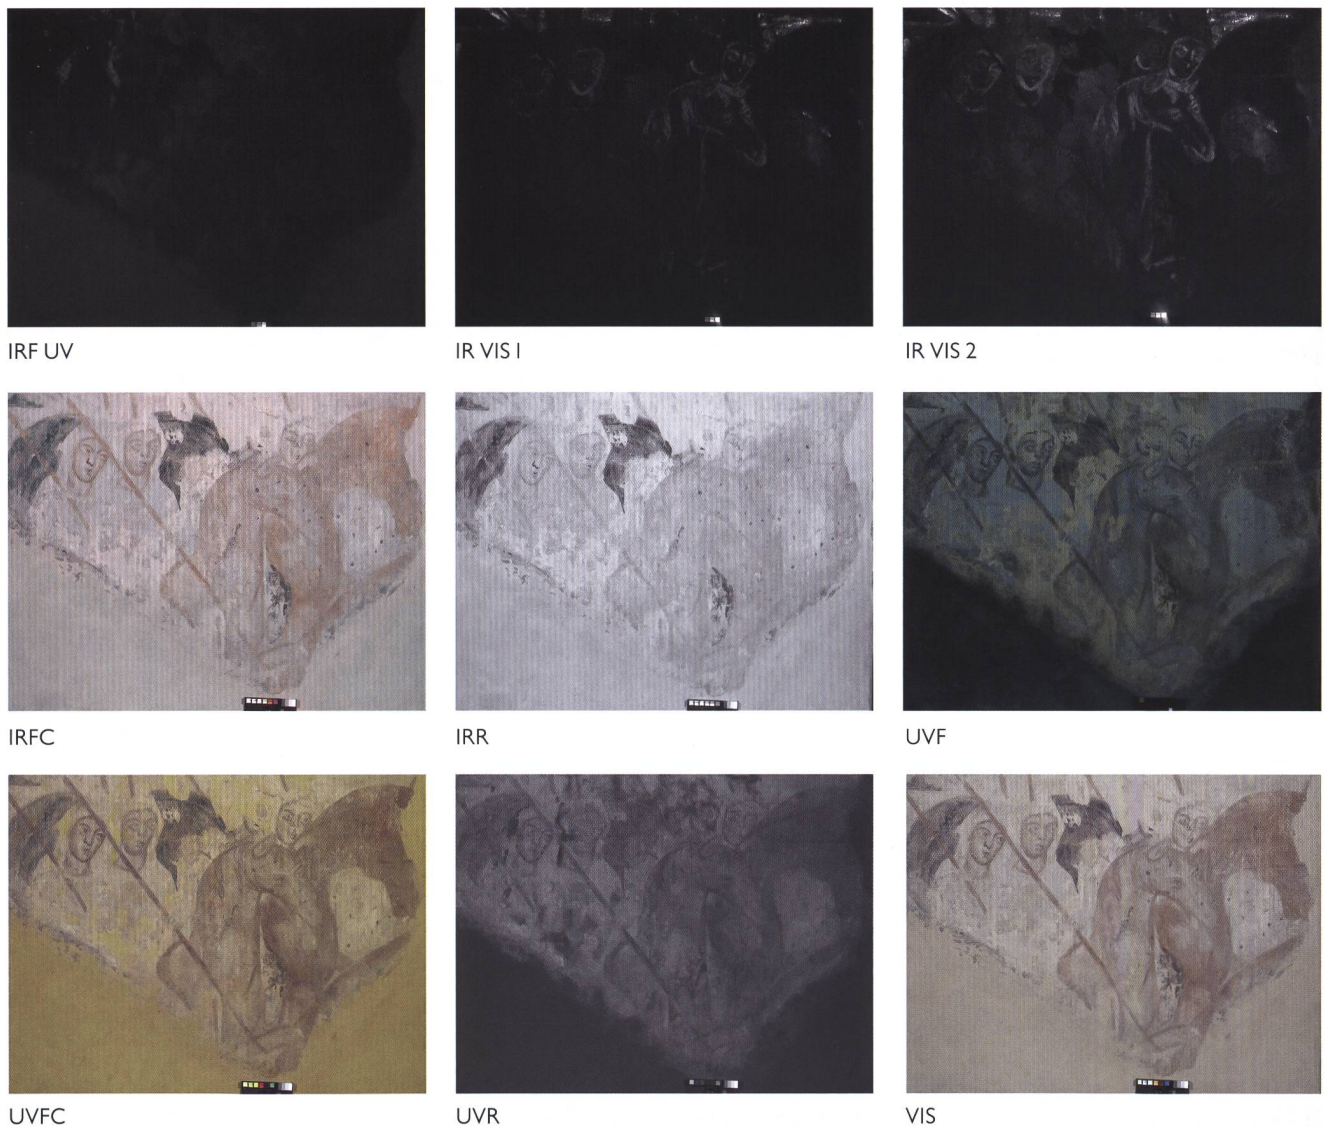
Annette Keller, artIMAGING, Berlin executed multispectral photography. Conclusions can be drawn about the use of certain materials (pigments, coatings, etc.), which in turn serve as a basis for more specific measurements and sampling.

An example of a multispectral investigation is presented in Fig. 7.

Fig.7. Multispectral images from the same detail in LM-II991.6.

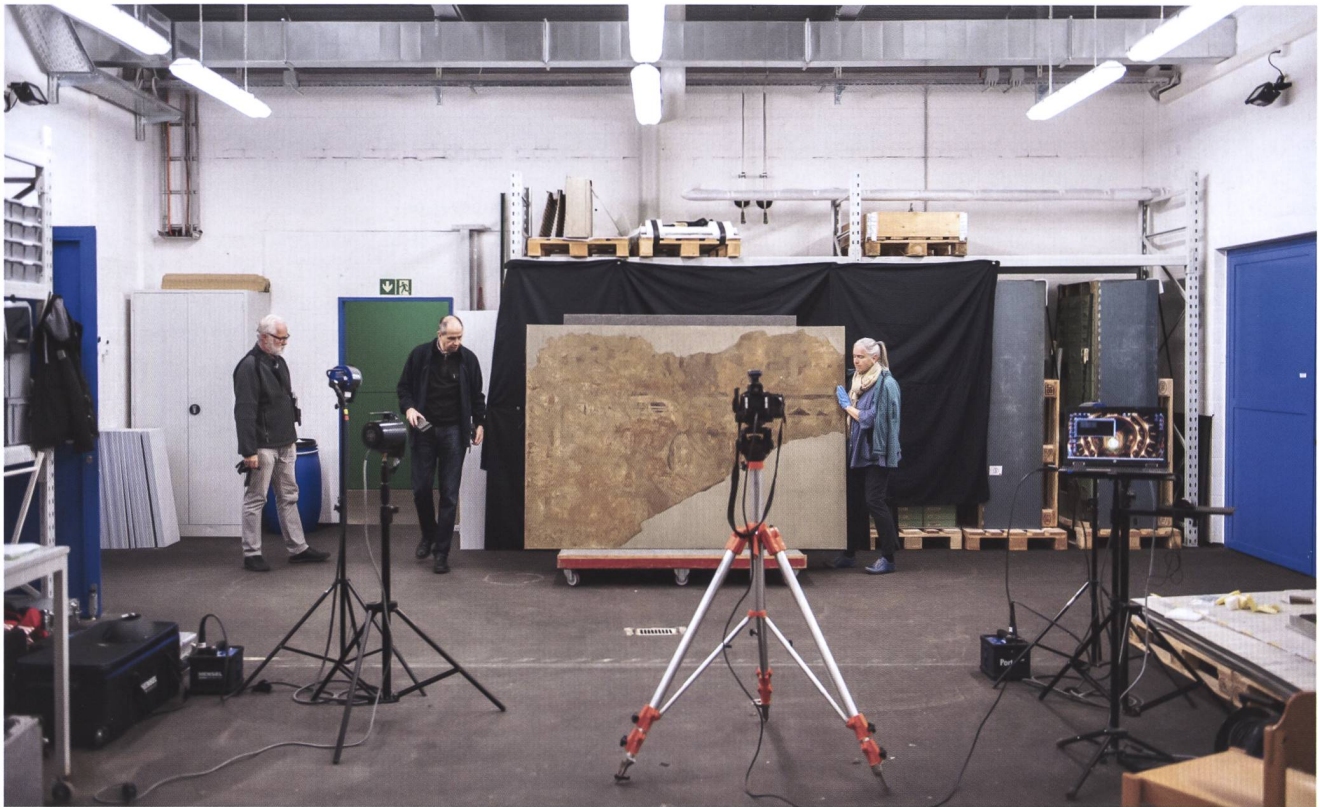
Photogrammetric documentation was executed by Mr. Gisbert Sacher, fokus GmbH Leipzig (Fig. 8).

Figure 8. Setting during the photogrammetric photography in the SNM Collection Centre.

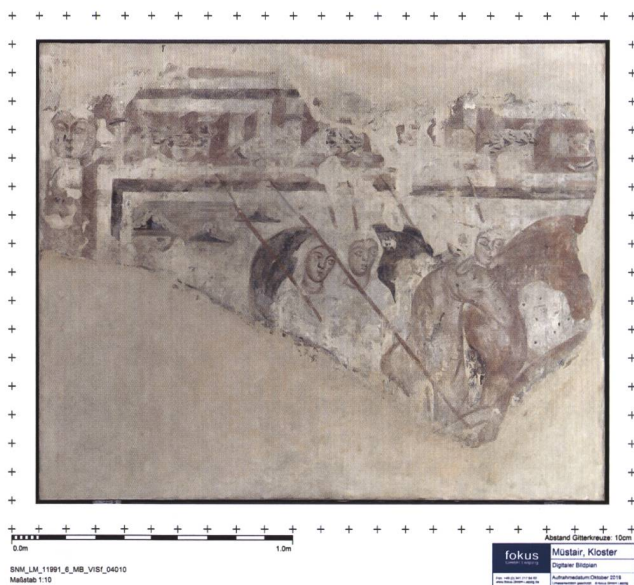
A rectified, high-resolution orthophoto was created for each painting in the possession of the SNM (Fig. 9). In the attic, each wall was captured in a single image. These orthophotos served as basis for the mapping carried out in WP2 during the documentation of the current state of conservation. An example of this is given in Fig. 10.

Figure 9. Orthophoto of LM-11991.6 Departure of David's Horsemen.

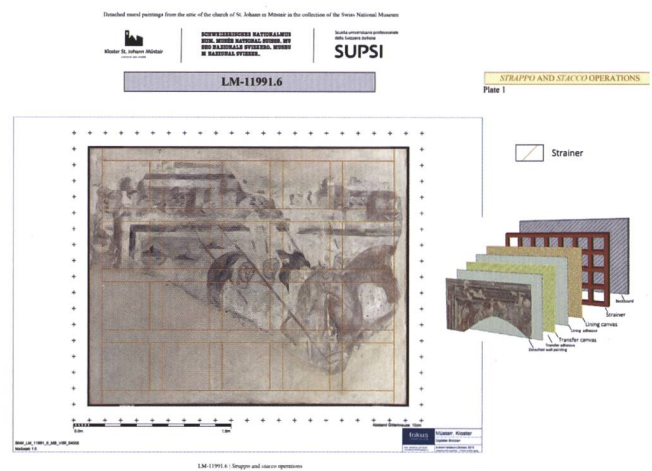
Figure 10. Mapping strappo and stacco operations of LM-11991.6.

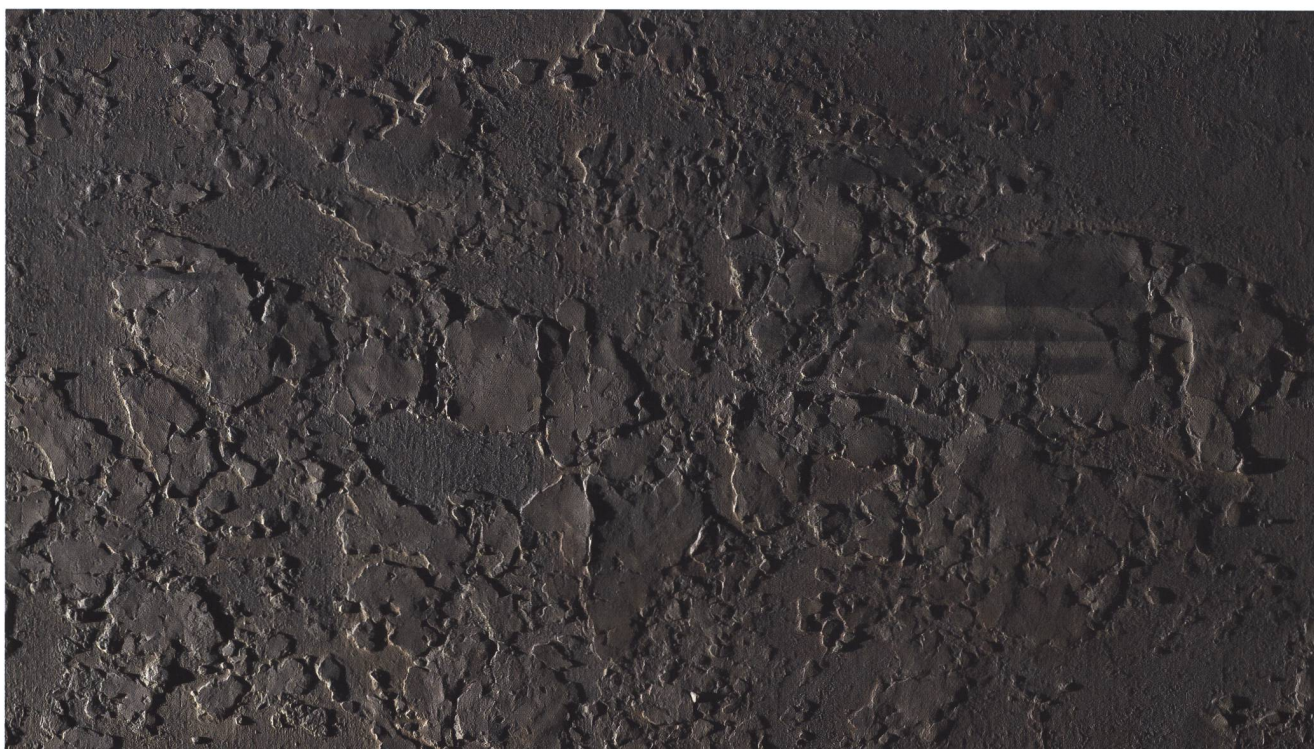
Many *strappi* require closer examination to determine whether the render residues and the paint layers no longer

adhere to the textile support (Figs. 12 and 13). As a consequence, losses can be expected during any manipulation.

Figure 13. LM-II991.5 Detail in raking light. Paint layer, which is cracked, loose, lifted and contains cavities.

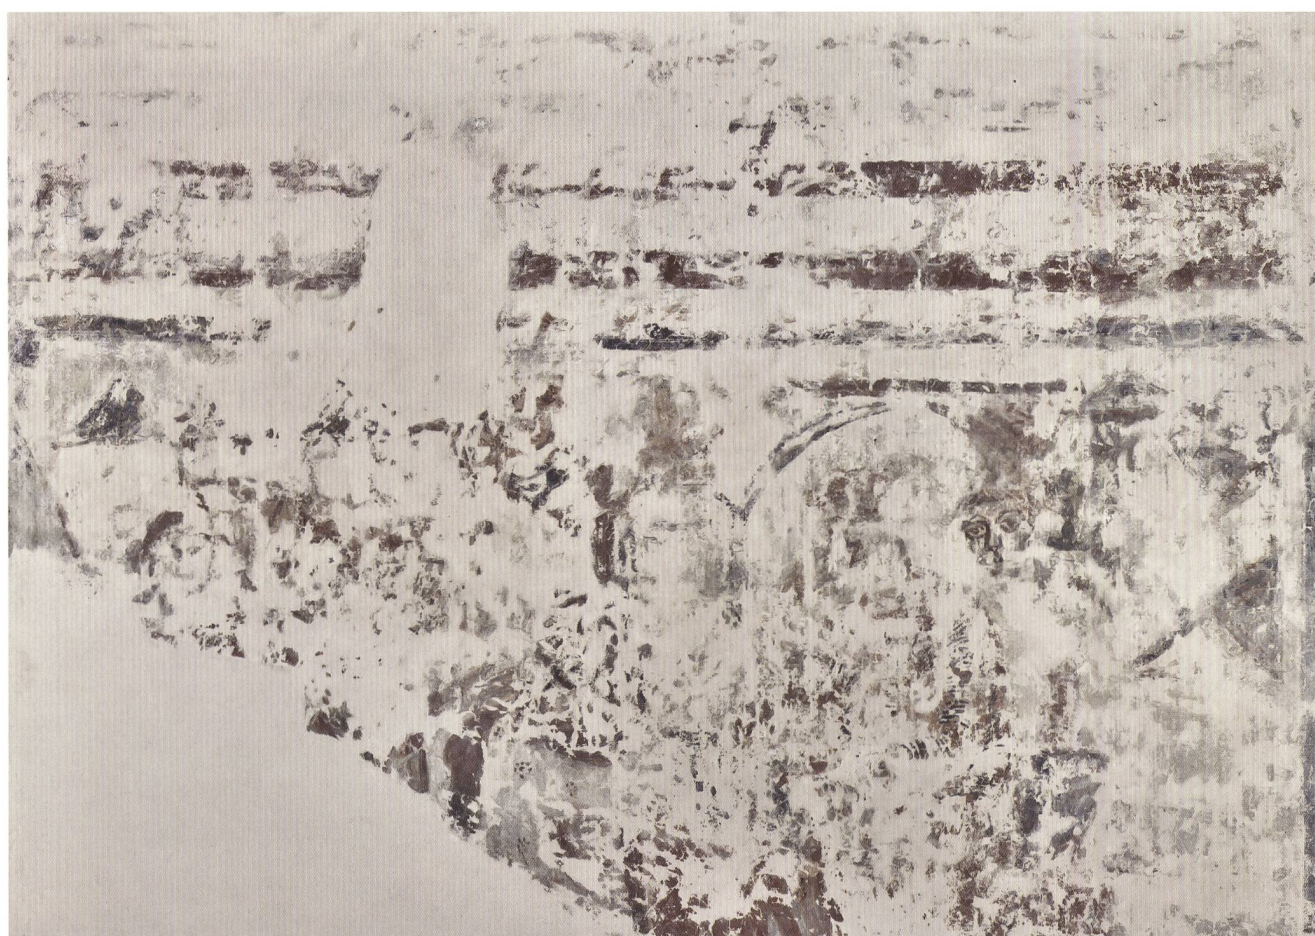
Another group of three objects (LM-11991.6–8) from the north wall also underwent extensive conservation and de-restoration treatments during the late '60s and early '70s. Their appearance today can be described as fragmentary (Fig. 15).

Figure 15. LM-II1991.8 David Mourns for Absalom.
