Artikel: Repair of the Todsburg Bridge (Fed. Rep. of Germany)
Autor: Hoscheid, R.
DOI: https://doi.org/10.5169/seals-20941

11. Repair of the Todsburg bridge (Fed. Rep. of Germany)

Owner:	*Federal Republic of Germany*
Year of construction:	*1936/37*
Repairs carried out in:	*1983*
Under the supervision of:	*Heidenheim Motorway Authority*
Contractors:	*Weidle and Ludwig Fischer*

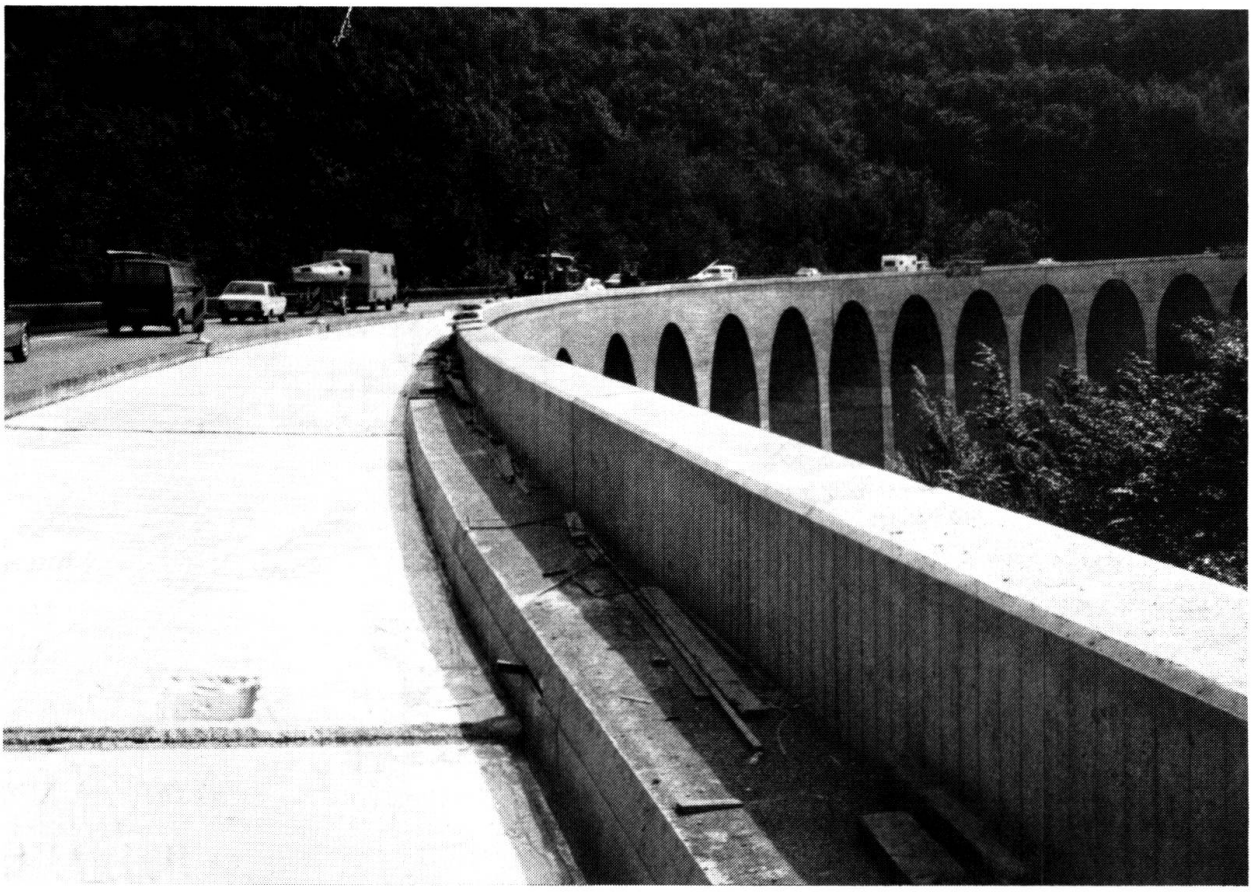
The Todsburg bridge (Fig. 1) is located on the A 8 Autobahn between Stuttgart and Munich – one of the busiest sections of motorway in Germany. It stands between Stuttgart and Ulm at a point where the road climbs up into the Swabian Alb. For structural reasons, the two roadway sections are completely separate from each other. Some 30 000 vehicles pass over the bridge in each direction every day. By the beginning of the 1980's the concrete structure was in urgent need of repair – this stretch of motorway now being over 50 years old.

Fig. 1 The Todsburg bridge

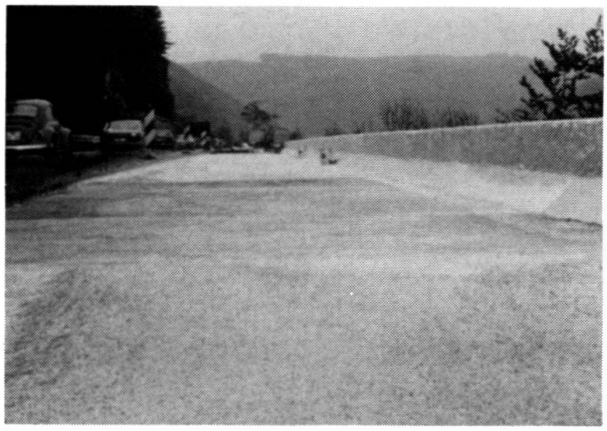
Fig. 2 The finished waterproofing membrane

5. Cleaning the area with high-pressure water jets
6. Applying epoxy mortar to the roadway platform to level those areas where concrete had been chipped away
7. Applying a bonding agents (1-component PU) and covering with silica sand 0.7–1.2 mm
8. Spraying on the liquid plastic waterproof membrane to a thickness of approx. 3 mm (Fig. 2)
9. Applying a bonding agent to the plastic membrane and covering it with granules to improve the shear bond between the membrane and the asphalt layers (the bridge has a gradient of approx. 6% along its length, and 3–5% from side to side)
10. Reconstruction of the new parapet on top of the waterproof membrane (Fig. 3)
11. Applying the bituminous mastic concrete protective layer, the bituminous mastic concrete load-bearing layer and the wearing layer (Fig. 4).

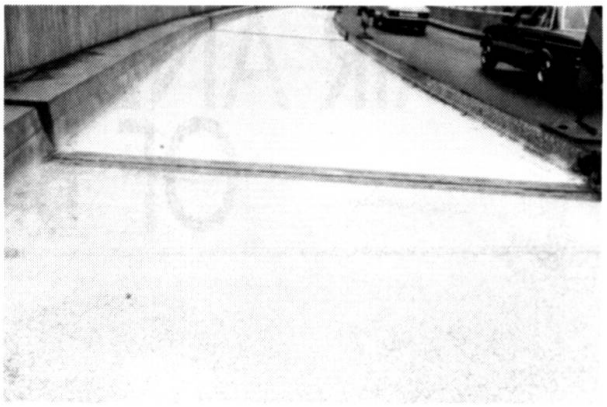
Fig. 4 The bridge complete with its new parapet before surfacing with bituminous mastic concrete
