5. TIG Arc Remelting as a Repair Method for Steel Railway Bridges (Japan)

Owner: Central Japan Railway Co.
Engineer: Central Japan Railway Co.
 Railway Technical Research Institute
Date of Construction: 1964
Date of Repair: 1987

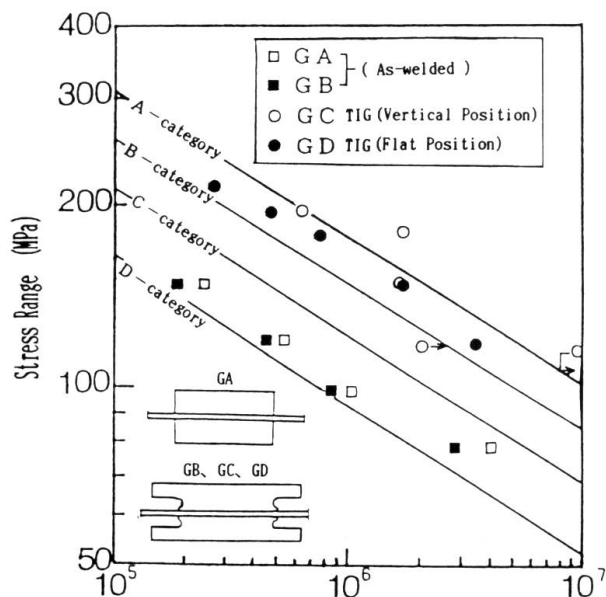
Fig. 4 Results of Fatigue Test

Fatigue tests were performed to confirm the effect of this treatment on improvement of fatigue strength. The fatigue strength of a joint subject to TIG arc remelting was much higher than that of an as-welded joint as shown in Fig. 4.
