The Collapse and Reconstruction of a Prestressed Concrete Box-Section Girder

Hugo Bachmann

Werner Horisberger,

During the construction of a prefabricated hall roof, a 25 m long prestressed box-section girder collapsed. The major cause of the failure was an inadequate structural design of the support regions. There was no transverse end beam present and support bearing points were not placed beneath the webs of the girder. The resulting transverse bending together with insufficient end anchorage led to the collapse. 45 similar beams, of which half were already erected, were in consequence locally strengthened in the support regions. Thus an original remedial solution, scarcely externally visible, was developed and tested through an on-site load test.

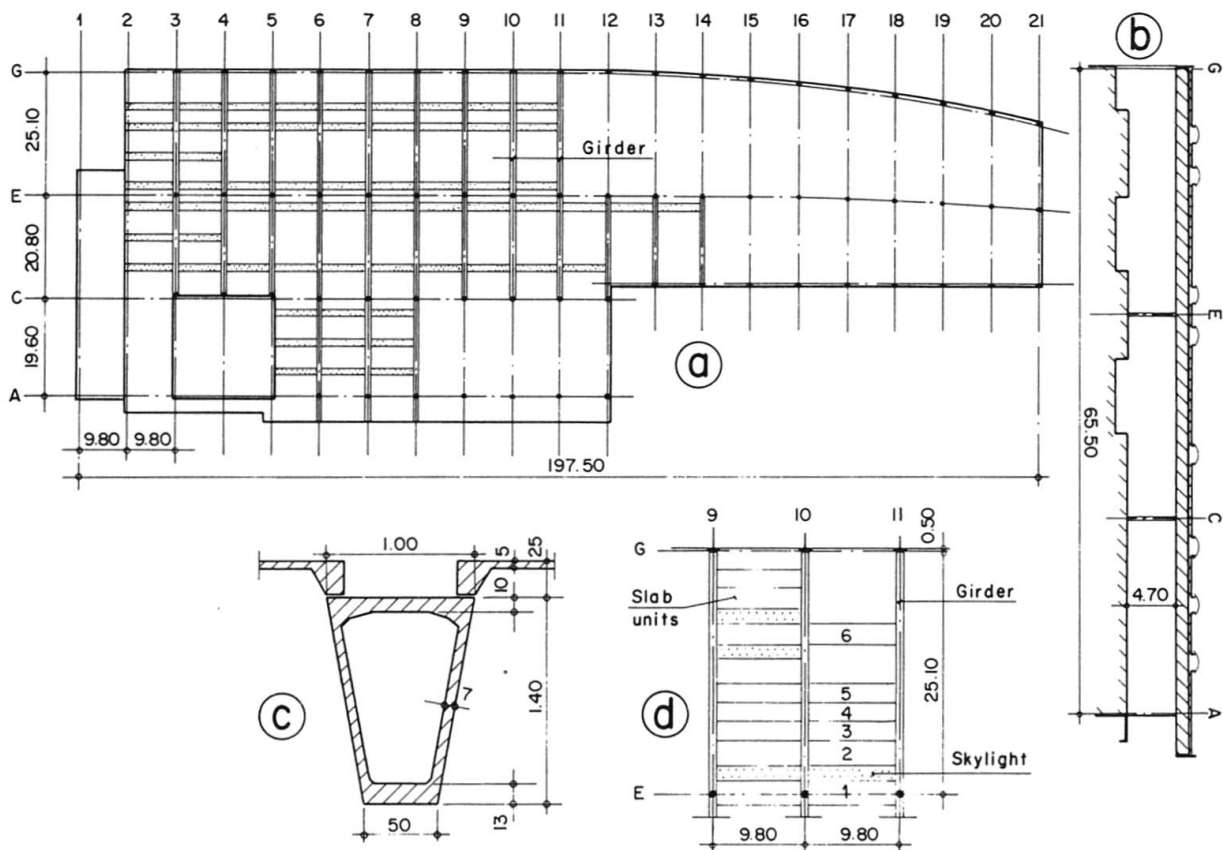
Fig. 1 Rapid goods station Berne

- a) Hall floor plan (position of construction at the time of collapse)
- b) Hall section on grid line 8
- c) Girder cross-section
- d) Plan of the collapse section

The collapse occurred after about half the hall roof was erected. The day before the collapse, the girder 10/E-G and the slabs in section 9-10/E-G had been placed. The next day the erection of the girder 11/E-G and a large part of the slabs in section 10-11/E-G was carried out. Several minutes after the placing of slab unit No. 6 the girder 10/E-G failed. This was without additional external loading (see Fig. 1).

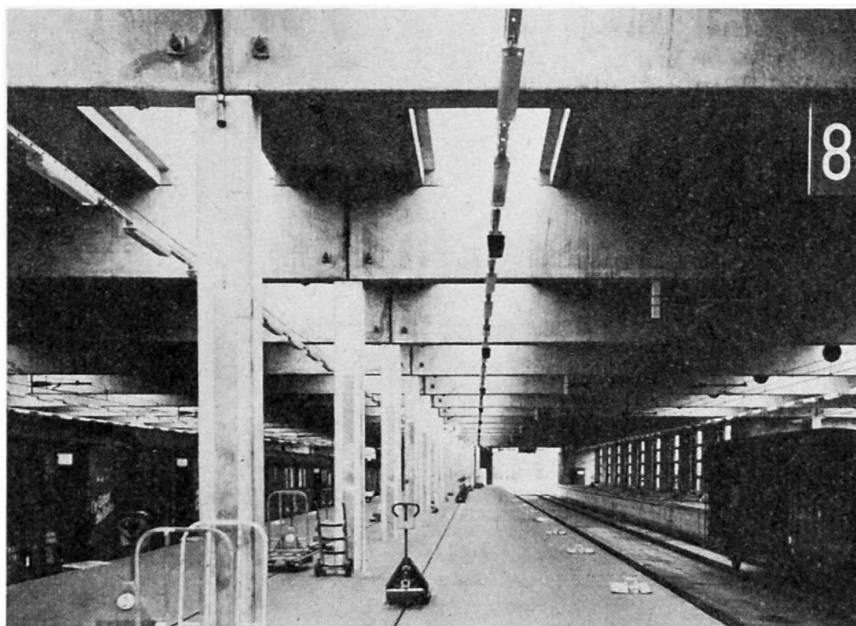
Fig. 24 View of the completed hall

Code safety requirements, service requirements (placement of conduits, accessibility) and aesthetics were all adequately met with this remedial solution. Fig. 24 shows an interior view of the hall after the successful reconstruction.
