The Collapse and Reconstruction of a Prestressed Concrete Box-Section Girder

Hugo Bachmann

Werner Horisberger,

SUMMARY

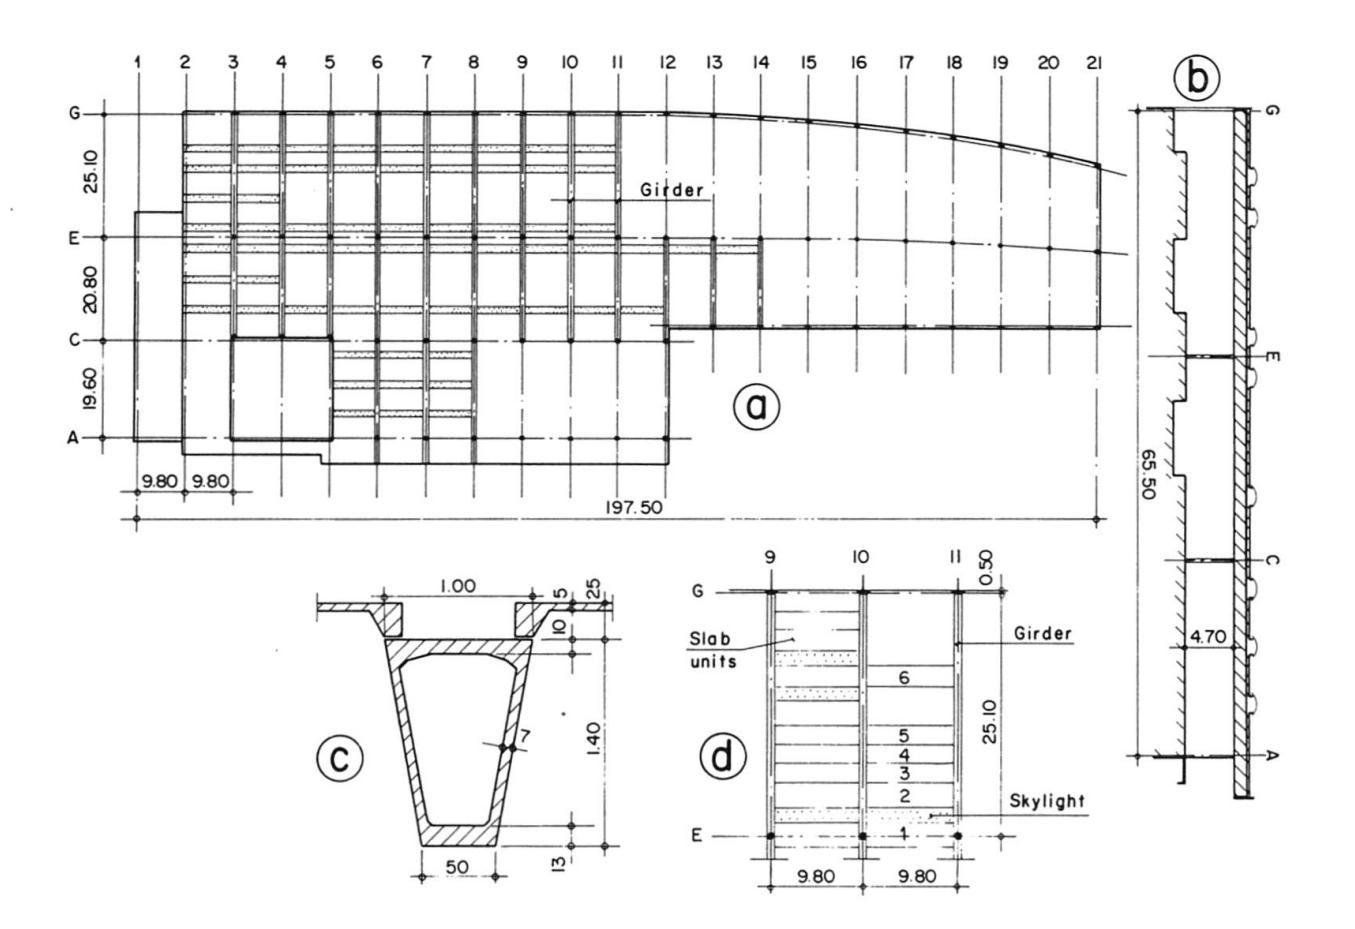
Fig. 1 Rapid goods station Berne

- a) Hall floor plan (position of construction at the time of collapse)b) Hall section on grid line 8
- c) Girder cross-section
- d) Plan of the collapse section

The collapse occurred after about half the hall roof was erected. The day before the collapse, the girder 10/E-G and the slabs in section 9-10/E-G had been placed. The next day the erection of the girder 11/E-G and a large part of the slabs in section 10-11/E-G was carried out. Several minutes after the placing of slab unit No. 6 the girder 10/E-G failed. This was without additional external loading (see Fig. 1).

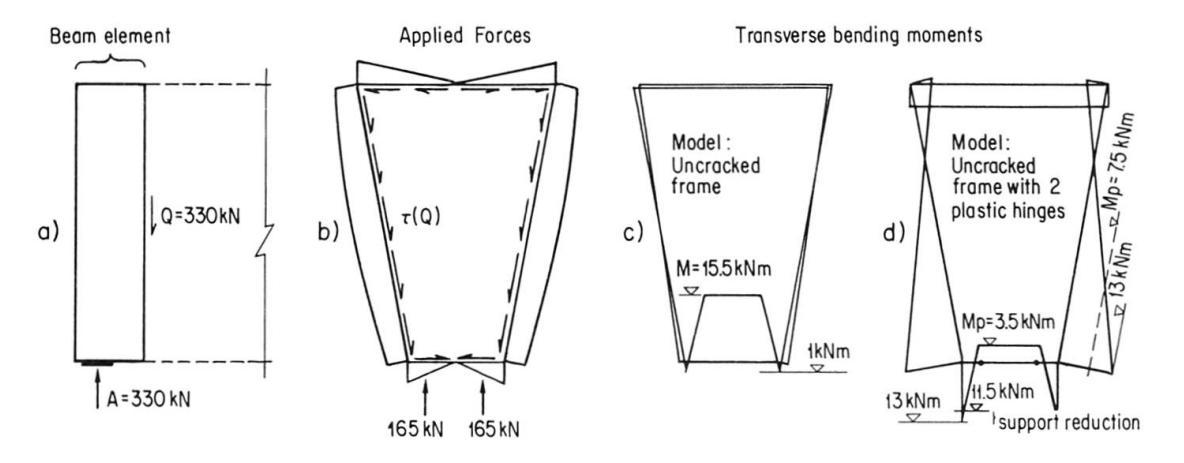
Firstly the transverse beinding should be estimated for a concentric loading of the basic structural system's dead weight i.e. for a support reaction of 330 kN. A beam element at the end of the box-section girder, shown in Figs. 9a and 9b, is considered for this purpose. A closed frame is formed which is acted upon by the shear flow of the shear force and by the support reactions. Since both support bearing points are not located beneath the webs, considerable transverse bending moments arise. These, for the assumption of an uncracked section, are shown in Fig. 9c. The moment in the bottom flange comes to 15.5 kNm. With the reinforcement present over a locally supported width of 30 cm the corresponding yielding moment comes to only 3.5 kNm. This means that over both the support bearing points a plastic hinge must be assumed to occur. When one calculates for the remainder with the assumption of an uncracked frame, then the moment diagram of Fig. 9d results. Here the existent yielding moment in the web of 7.5 kNm is considerably exceeded. Thus a possible equilibrium condition can likewise not be found. That the beam did not collapse earlier with a smaller load therefore requires some explanation:

Due to the formation of the plastic hinges at the support bearing points considerable displacements arise. These cause a certain shifting through the neoprene pads of the produced reaction forces towards the webs. Thus the transverse bending is significantly reduced.

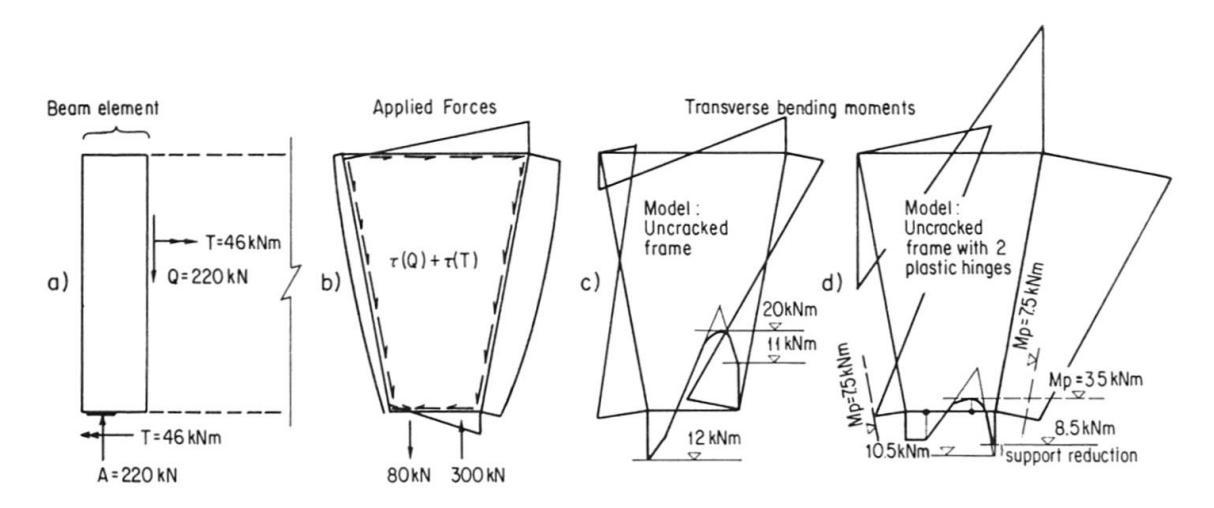
The concentric loading comes to 220/330 = 2/3 of the previously analysed loading. Each support reaction comes to +110 kN. The torsional loading consists of a constant shear flow τt and equal but opposite reactions of \pm 190 kN. Fig. 10b gives for the sum of both load cases the shear flow and support reactions of 110 \pm 190 = +300 kN or -80 kN.

By a similar procedure to that in the previous section for firstly an uncracked frame, the moment diagram shown in Fig. 10c results. This however can not occur since the existent yielding moments(resisting) are exceeded. After the introduction of plastic hinges over the right support bearing point and at the transition of the bottom flange to the left web, the moment diagram in Fig. 10d results. This is however likewise not possible. As described in the previous section, there is a possible sidewards displacement of the support reactions towards the webs. This is caused by plastic deformations and should be taken into consideration if an equilibrium condition is to be found.

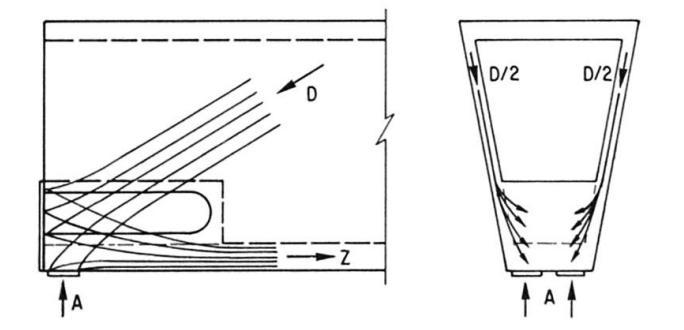
Fig. 16 Flow of the forces with the remedial solution "cast-in concrete strengthening at the support".

The inclined compressive force must be able to be in equilibrium with the support force and the bottom chord tensile force (truss model). The inclined compressive force transfers from the webs through the bond stresses (horizontal prestress) to the new concrete section. It is then taken out through the steel plate and the support. With this the transverse bending of the bottom flange is eliminated or carried by the new concrete section. The horizontal component of the inclined compressive force is taken by the end plate welded to

This proposal concerns strengthening of the inside of the box section girder in the support region (see Fig. 17, Variants A + B). The girder end is concentrated for a length of one meter with an internal depth of 37 cm. This new concrete is reinforced, the longitudinal bars having an end plate welded to them which spreads over the adjacent webs and also the bottom flange. The new concrete is connected to the girder with vertical and horizontal prestressed rods.

This solution with its small costs causes the least disturbance on the total form of the hall. Therefore it was decided to take only this solution further.

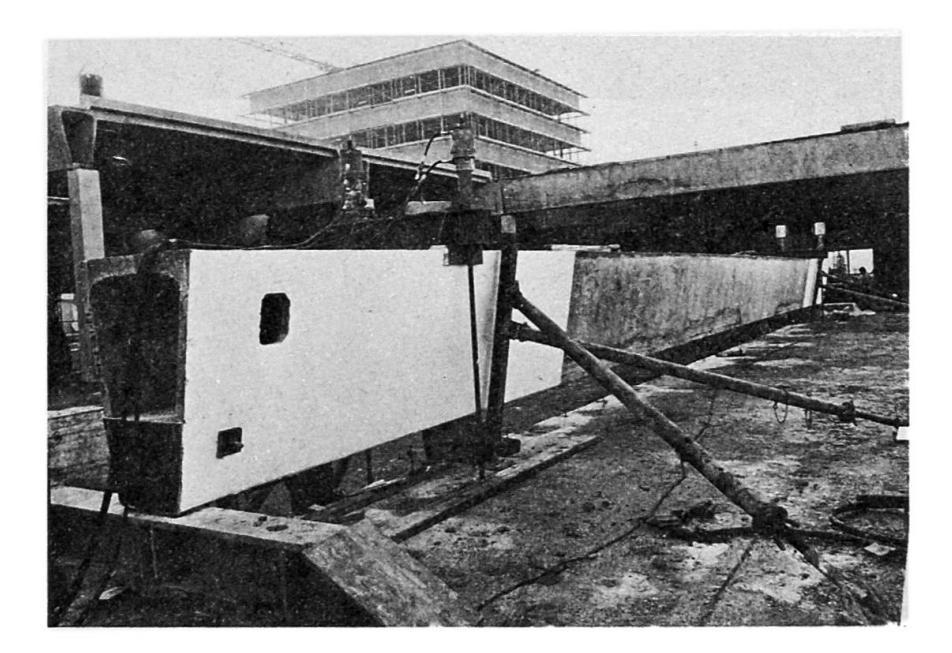
A view of the test arrangement is given in Fig. 19. The girder with 25 m span was placed over a wall of the very stiff lower storey. The centre point of the neoprene lay only 7 cm from the girder end which corresponded to the most possible extreme position in the system.

Since the girder was to be tested only for shear force action (relative to the support condition) and not for bending the required loading was applied by means of prestressing jacks only 2.5 m from the support. In order to see the cracks clearly the girder ends were painted white. The loading was applied at each load point initially in steps of 100 kN and later of 50 kN.

Fig. 19 Test at the building site

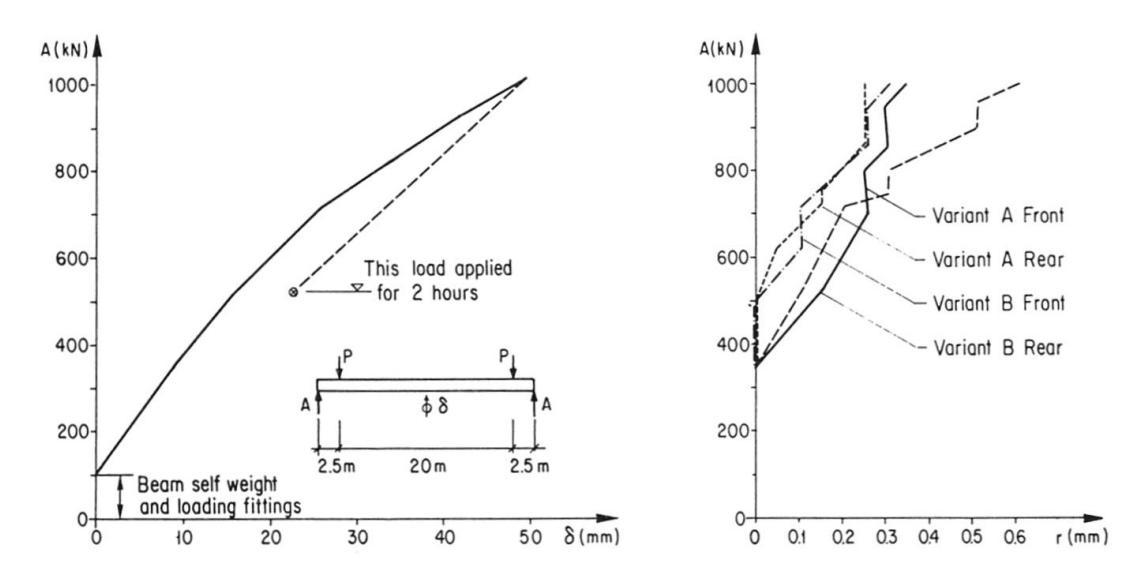
Both remedial solutions showed themselves to be workable. The self weight of the beam and the test fittings led to a support reaction of 115 kN. With a support reaction corresponding to that of a full working load i.e. with $Q(g+p) \geq 500$ kN there first appeared a few cracks in the web of maximum width 0.15 mm. The midspan deflection (without self weight) was 16 mm. Following on from here a load giving a support reaction corresponding to twice the working load reaction, i.e. $2Q(g+p) \geq 1000$ kN, could be obtained without fracture. Under this maximum loading the largest crack width in the webs was 0.60 mm and the deflection midspan = 50 mm. Fig. 20 shows the midspan deflection and also the crack widths as functions of the support reaction. Fig. 21 shows the crack pattern at the girder end A.

Fig. 20 Midspan deflection of the girder and also the largest crack width r in the webs as a function of the support reaction
