# Techniques for Testing, Analyzing and Rehabilitation of Terra-Cotta

**Sven E. THOMASEN** Consultant Wiss, Janney, Elstner Assoc. Emeryville, CA, USA

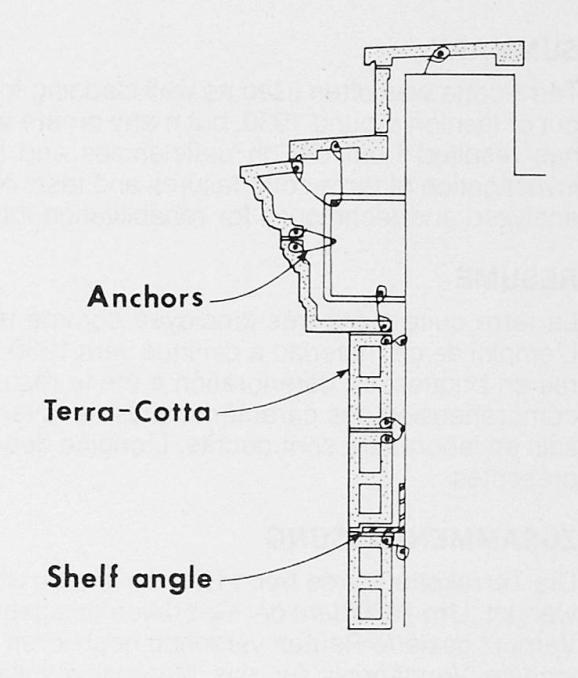
Fig. 1: Terra-Cotta Anchors

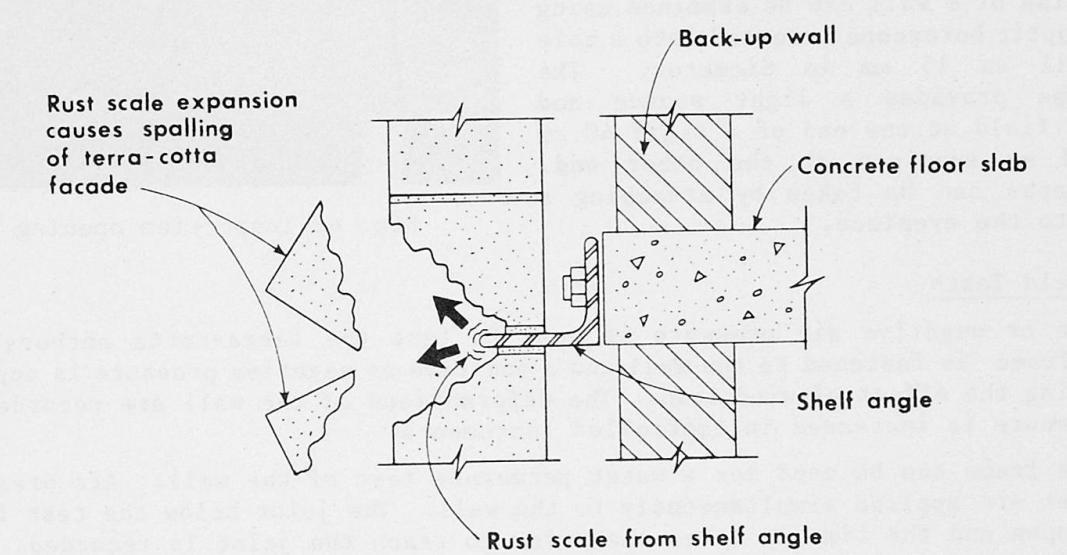
Spalling of the glaze and cracks caused by expansion allows water to enter the wall and results in further damage to the terracotta from freeze/thaw action. The moisture corrodes the anchors and the pressure from the volume expansion of the rust cracks the blocks, as seen in Figure 3.

Fig. 3: Terra-cotta spalling caused by corrosion of shelf angle.
